Fox Den Home Inspections  
204 Aspen Avenue  
Elon NC 27244

## Confidential Inspection Report

3649 Guess Road  
Durham NC 27705

**Inspected by:  
Michael Fields  
NC License #3674**

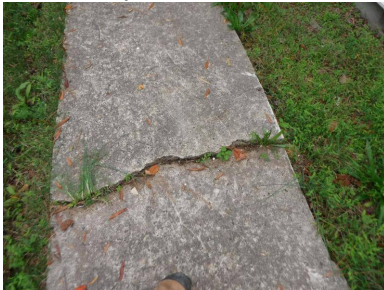
There were raised sections of the concrete sidewalk on the left side of the house that created a trip hazard. There was an inch or more height difference on the sidewalk.

A qualified concrete contractor should be called to evaluate the sidewalks. The contractor should make the needed repairs to ensure the sidewalks are safe to use.

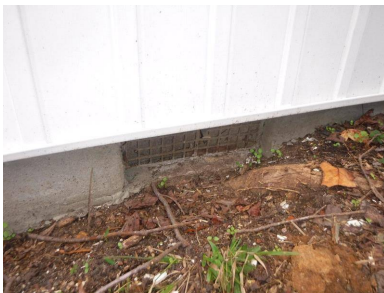
**3.2 Foudation Vents:**

The bottom of the foundation vents on the right side of the house were very close to the exterior finished grade level. Water can enter the crawlspace through the vents if they are below finished grade. The outside grade level should be lowered at the vents or protective vent wells should be installed to prevent water intrusion.

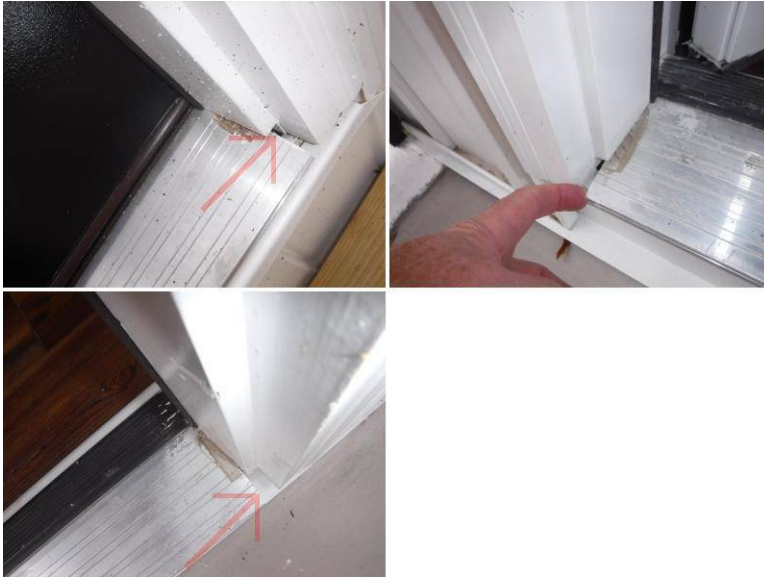
**3.5 Front entry door:**

The front and rear exterior doors were spread apart and the threshold was not connected to the frame any longer. The thresholds are now loose and can eventually dislodge. A qualified door contractor should be contacted to evaluate and make repairs or Replacements as needed.

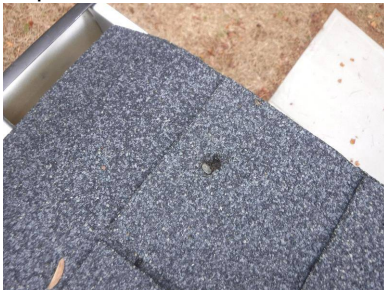
There was one nail sticking through a shingle on the rear of the roof. Damaged shingles may leak and the surrounding materials can be water damaged if not repaired.

A qualified roofing contractor should be called to inspect the shingle and make repairs or replacements are required.

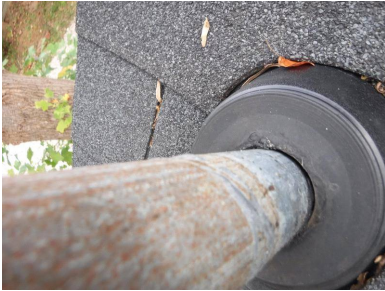
**4.4 Boots:**

One of the plastic boots on the PVC exhaust pipes coming through the roof was not fitting tightly on the galvanized pipe and had a gap. When the boots split or there are gaps, there is a good chance they will leak in the future and cause water damage to surrounding materials. The damaged boot should be replaced by a qualified roofing contractor.

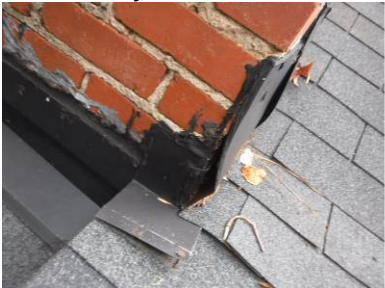
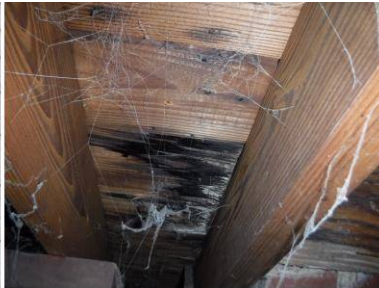
#### **4.5 Flashing:**

There was darkened (water stained or damaged) roof sheathing noticed from inside the attic at the chimney. The metal flashing on the shingles at the chimney was poorly installed. There either was a leak or is a current leak. Further investigation is needed.

A qualified roofing contractor should be called to evaluate the dark sheathing in the attic and the flashing on the roof around the chimney. The contractor should repair any damaged sheathing and then properly flash the chimney to ensure that there is no future water intrusion.

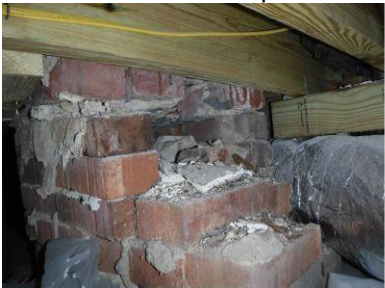
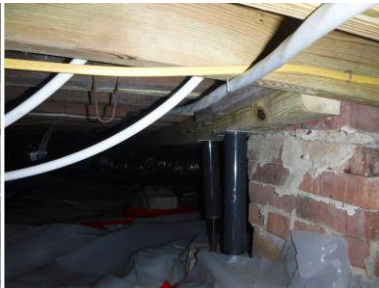
Once the crawlspace was entered, the chimney was inspected and found to have voids and missing brick. There were lots of added posts and 4x4s around the chimney area and some were heavily deflecting. There may be structural deficiencies with the chimney. A licensed general contractor should be contacted to evaluate and make repairs as needed.

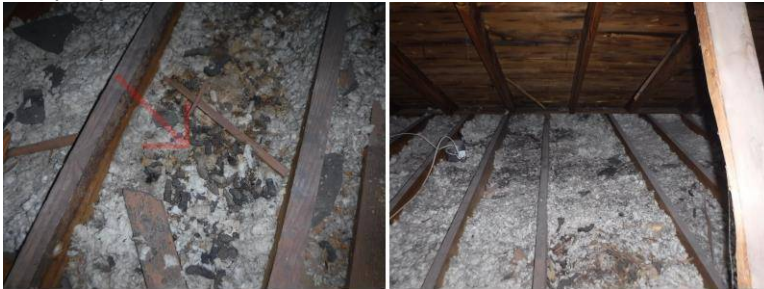
There was also fecal matter seen in the Attic area. This should all be cleaned by a qualified cleaning company.

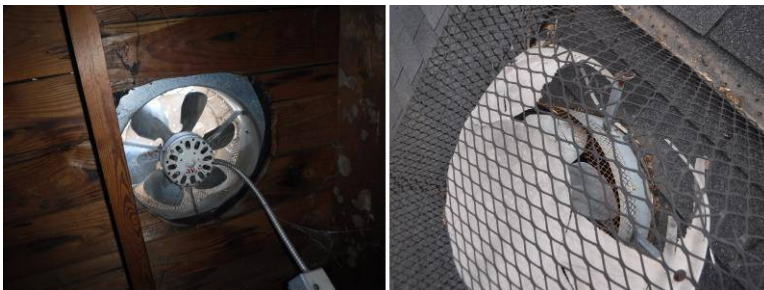
#### **4.11 Ventilation:**

There was a damaged attic ventilation fan which was disconnected. The rain Hood was damaged and cracked and could continue to deteriorate and allow water to enter into the Attic. A qualified roofing contractor should be contacted to evaluate and remove the fan and Patch the area.

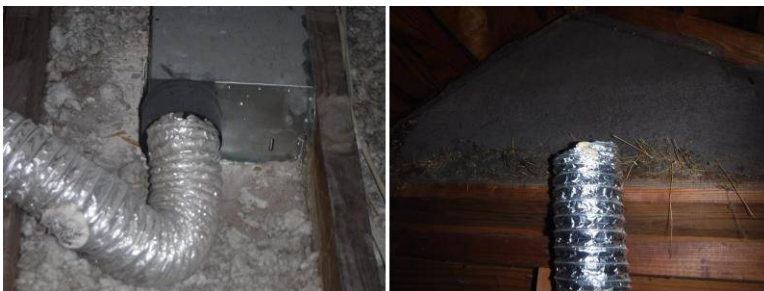
The bathroom ventilation fan in the attic was not vented properly to the outside of the attic space. The fan was not connected well to the exhaust pipe either. Bath fans need to be properly vented to the outside of the house so that warm moist air is not blown into the attic. This can cause moisture issues in the attic. A licensed HVAC contractor should be called to vent the bath fan properly so that it vents to the outside of the house as intended.

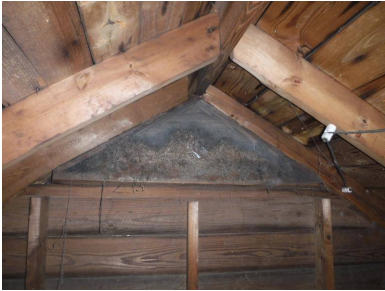
The gable vents on the house both had some type of nests in them. Small animals and pests can cause damage to surrounding materials. A qualified contractor should be contacted to clean out the gable vents and install some type of screen on the exterior to prevent pests or small animals from nesting in the future.

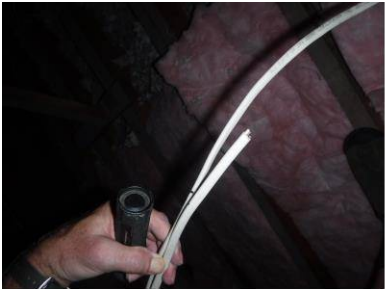
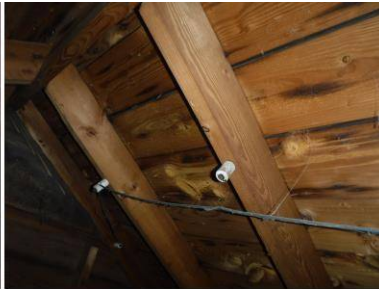
#### 4.12 Electrical:

There was a new electrical line laying in the Attic which was not connected to anything. There was also signs of old knob and tube wiring. The licensed electrician should be contacted to evaluate and make repairs as needed.

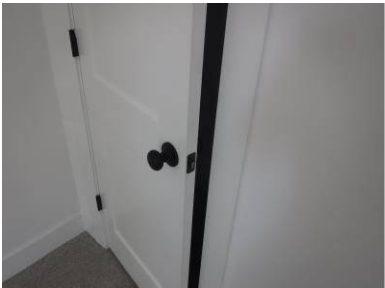
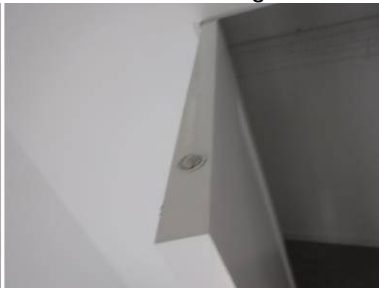
The closet doors in the left rear bedroom were missing the latch plates.

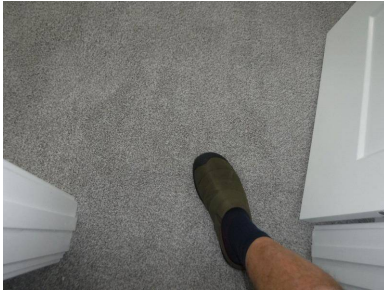
#### 5.5 Floor:

After walking around inside the house, there were several areas where the subfloor was not at the same height as other areas of the home. These areas will create a wear mark wear mark in the carpet.

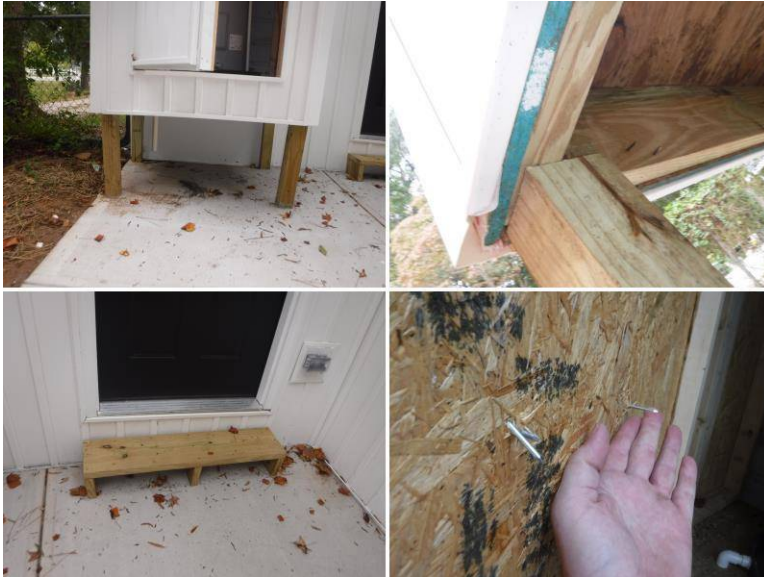
The water heater is located in a and built enclosure on the exterior rear of the home. This enclosure did not have proper bracing nor were the posts mechanically attached to the framing. There were also protruding siding nails on the interior of the door which can cause injuries.

Also, the step at the rear exterior door was not properly attached to the home. A licensed general contractor should be contacted to evaluate and make necessary repairs to the framing of the water heater stand and step.

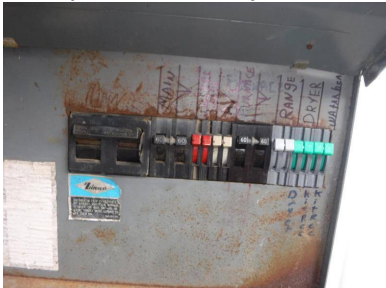
The main electrical panel was a 'Zinsco' brand electrical panel. These panels have had multiple safety issues in the past and are no longer used in residential construction. Anytime a Zinsco panel is discovered then we recommend that a licensed electrician inspects the panel for safety issues.

A licensed electrician should be called to fully evaluate the Zinsco panel. The electrician should determine if the panel is a safety issue and make recommendations to the seller for repairs or replacements if needed.

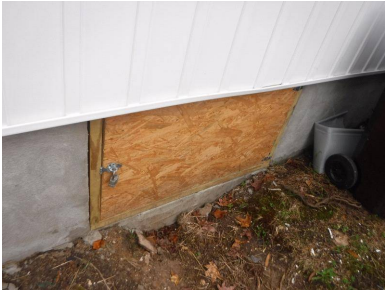
The crawl space access door was not pressure treated nor was it painted. This OSB will deteriorate much quicker if not primed and painted with an approved exterior grade paint. A qualified paint contractor should be contacted to evaluate and make repairs as needed.

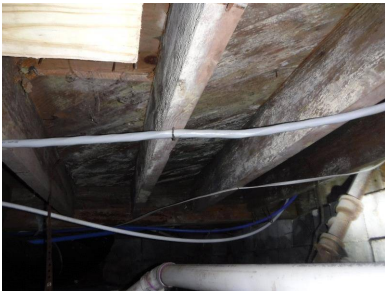
#### **10.6 Moisture Level:**

There was fungal growth noticed on several floor joists below the kitchen area.

A qualified contractor (that has experience with damp crawl spaces) should be called to evaluate the entire crawl space for moisture related issues.

The contractor should make recommendations for changes and/or repairs that need to be made to get the moisture level in the crawl space to an acceptable level. If there are moisture related issues then the contractor should make recommendations for repairs to the buyer.

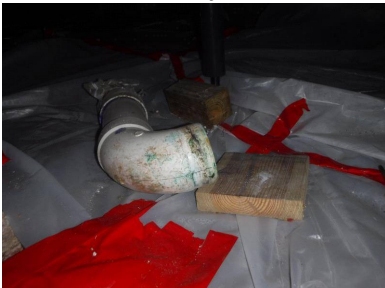
#### **10.7 Beams/Underfloor:**

There was wood debris laying on the ground inside the crawlspace. If the wood gets wet or damp then there can be fungal growth and wood boring insect will be attracted. The wood needs to be removed.

I recommend inspecting the entire crawlspace for wood materials and other debris and removing all items found immediately.

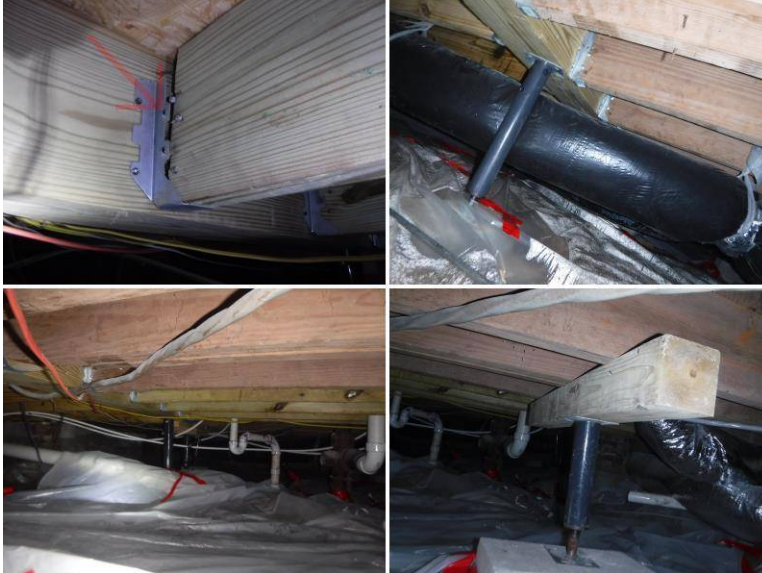
There were several support beams and metal posts added in the crawl space under several rooms. The repairs seen did not appear to be professionally performed nor did they look like they were permitted. The joist connections to some of the girders was poor and the incorrect Fasteners were used. Standard bright Nails will deteriorate quickly in the pressure treated material because of the chemicals of pressure treating. The posts were not anchor to the beams and there were no footers below the support posts, they were just sitting on flat rock pieces. Anytime posts are added then they should be attached properly have a proper concrete or masonry block footer.

A licensed general contractor should be called to evaluate the support beams and post that were added. The contractor should make repairs as needed to ensure that the posts are installed correctly.

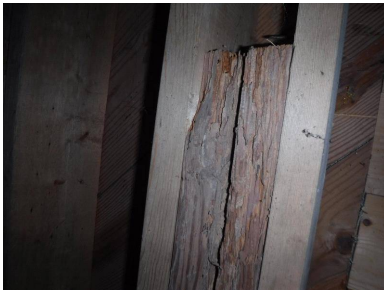
There were multiple areas around the crawl space where water or insect damage had occurred. There have been repairs in the past. We would highly recommend that a pest inspector be contacted to evaluate to ensure there are no active wood destroying insects.

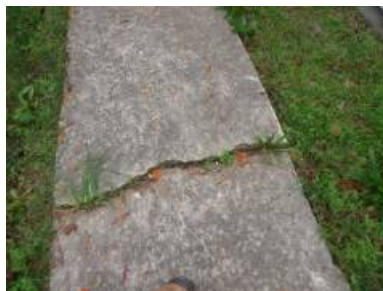
**There were raised sections of the concrete sidewalk on the left side of the house that created a trip hazard. There was an inch or more height difference on the sidewalk.**

**A qualified concrete contractor should be called to evaluate the sidewalks. The contractor should make the needed repairs to ensure the sidewalks are safe to use.**

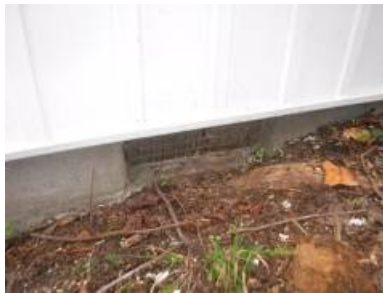
3.2 Foundation Vents:

**The bottom of the foundation vents on the right side of the house were very close to the exterior finished grade level. Water can enter the crawlspace through the vents if they are below finished grade. The outside grade level should be lowered at the vents or protective vent wells should be installed to prevent water intrusion.**

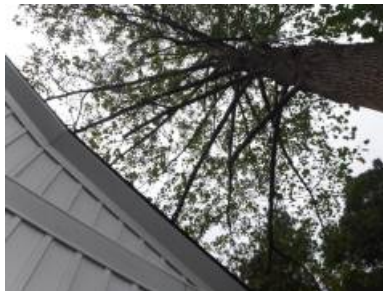
There was a tree growing against the roof on the right side of the house. Limbs from plants can damage the windows, shingles and exterior finishes of a house.

The tree limbs should be trimmed away from the house by a qualified professional to prevent any chance of damage.

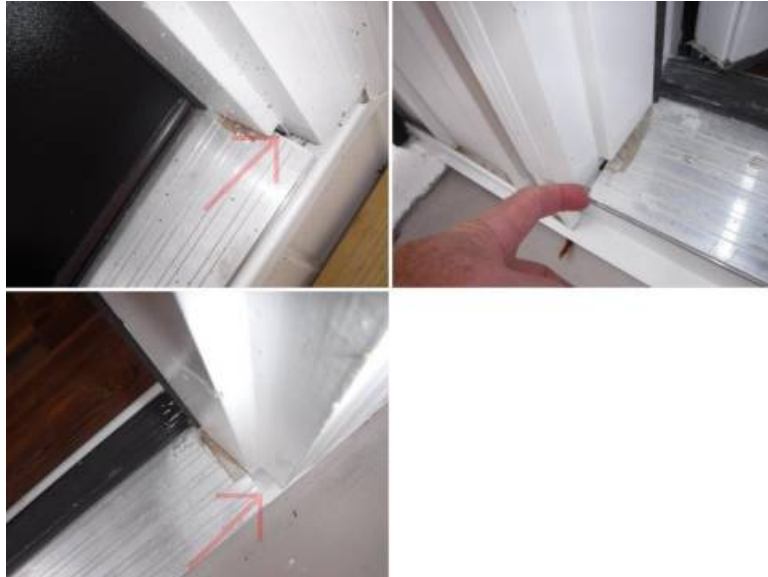
3.5 Front entry door:

**The front and rear exterior doors were spread apart and the threshold was not connected to the frame any longer. The thresholds are now loose and can eventually dislodge. A qualified door contractor should be contacted to evaluate and make repairs or Replacements as needed.**

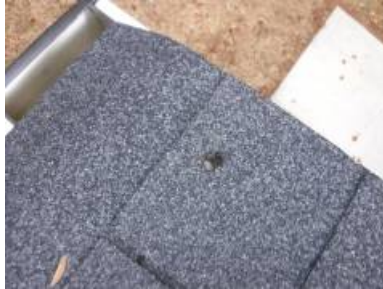
There was one nail sticking through a shingle on the rear of the roof. Damaged

shingles may leak and the surrounding materials can be water damaged if not repaired.

A qualified roofing contractor should be called to inspect the shingle and make repairs or replacements are required.

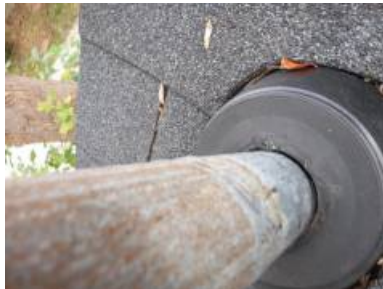
#### 4.4 Boots:

One of the plastic boots on the PVC exhaust pipes coming through the roof was not fitting tightly on the galvanized pipe and had a gap. When the boots split or there are gaps, there is a good chance they will leak in the future and cause water damage to surrounding materials. The damaged boot should be replaced by a qualified roofing contractor.

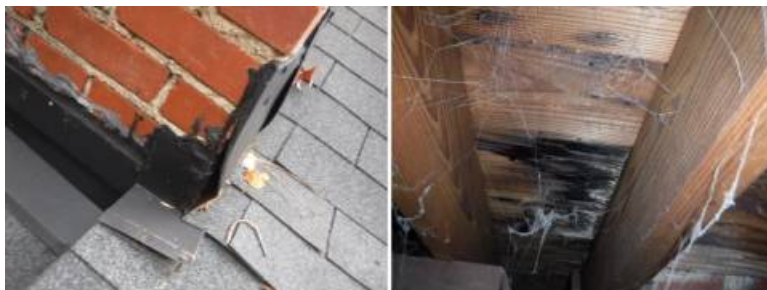
#### 4.5 Flashing:

There was darkened (water stained or damaged) roof sheathing noticed from inside the attic at the chimney. The metal flashing on the shingles at the chimney was poorly installed. There either was a leak or is a current leak. Further investigation is needed.

A qualified roofing contractor should be called to evaluate the dark sheathing in the attic and the flashing on the roof around the chimney. The contractor should repair any damaged sheathing and then properly flash the chimney to ensure that there is no future water intrusion.

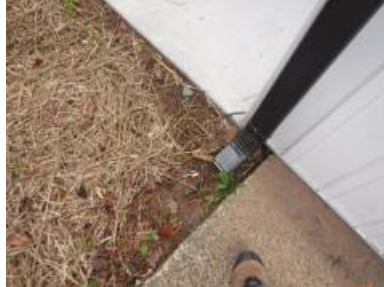
The gutters around the house were filled with leaves and debris. If the gutters are clogged then they will not collect and drain water away from the house as intended. This can lead to standing water which can cause damage to

I recommend installing splash blocks at all gutter down spouts.

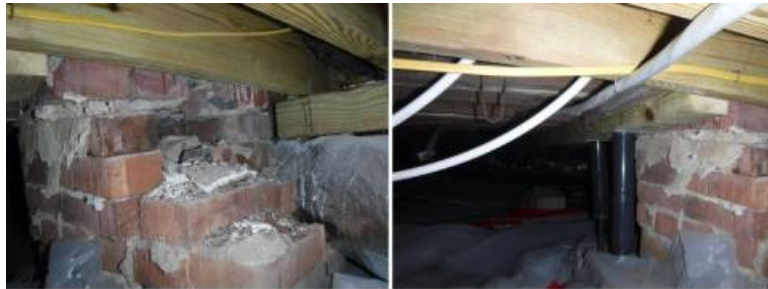
**4.8 Stack:**

Once the crawlspace was entered, the chimney was inspected and found to have voids and missing brick. There were lots of added posts and 4x4s around the chimney area and some were heavily deflecting. There may be structural deficiencies with the chimney. A licensed general contractor should be contacted to evaluate and make repairs as needed.

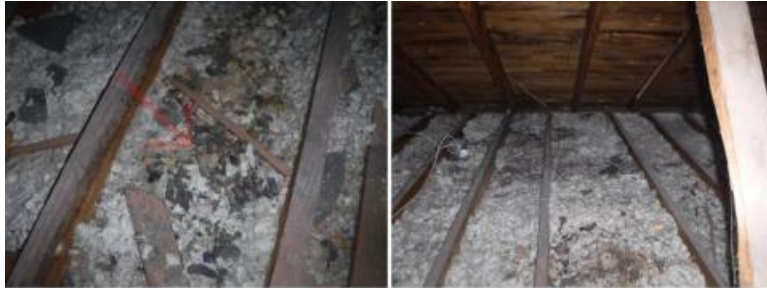
**There was also fecal matter seen in the Attic area. This should all be cleaned by a qualified cleaning company.**

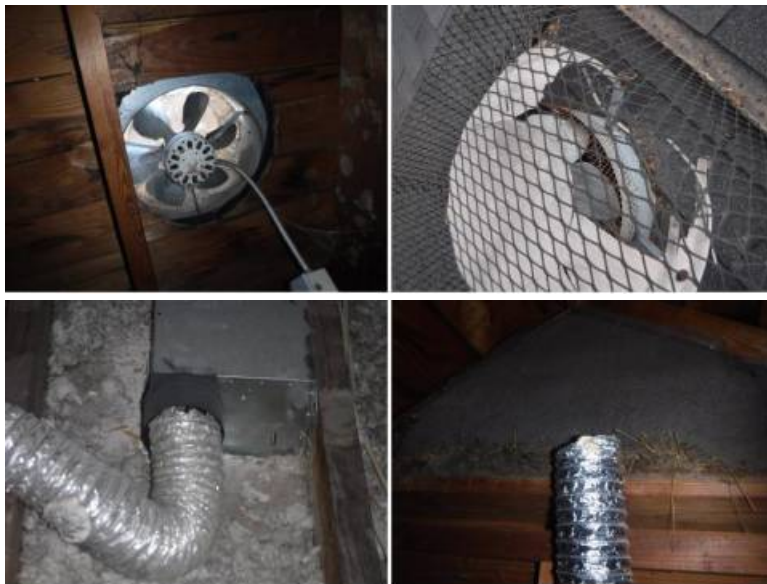
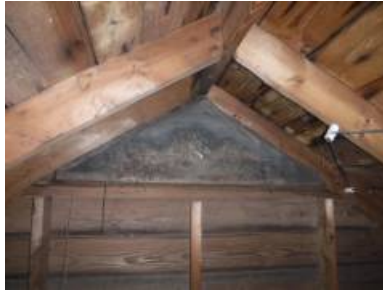
#### 4.11 Ventilation:

There was a damaged attic ventilation fan which was disconnected. The rain Hood was damaged and cracked and could continue to deteriorate and allow water to enter into the Attic. A qualified roofing contractor should be contacted to evaluate and remove the fan and Patch the area.

The bathroom ventilation fan in the attic was not vented properly to the outside of the attic space. The fan was not connected well to the exhaust pipe either. Bath fans need to be properly vented to the outside of the house so that warm moist air is not blown into the attic. This can cause moisture issues in the attic. A licensed HVAC contractor should be called to vent the bath fan properly so that it vents to the outside of the house as intended.

The gable vents on the house both had some type of nests in them. Small animals and pests can cause damage to surrounding materials. A qualified contractor should be contacted to clean out the gable vents and install some type of screen on the exterior to prevent pests or small animals from nesting in the future.

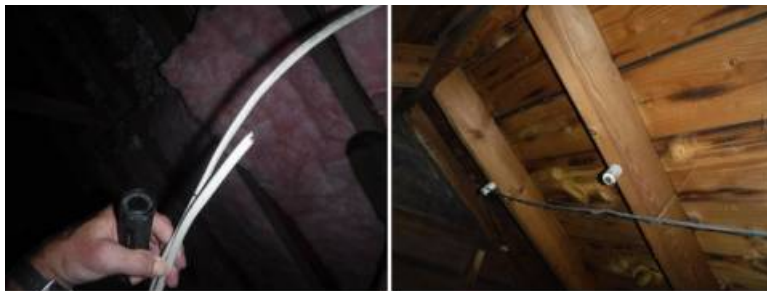
4.12 Electrical:

There was a new electrical line laying in the Attic which was not connected to anything. There was also signs of old knob and tube wiring. The licensed electrician should be contacted to evaluate and make repairs as needed.

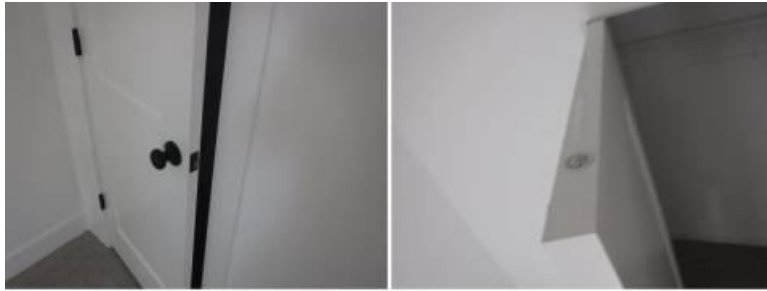
The closet doors in the left rear bedroom were missing the latch plates.

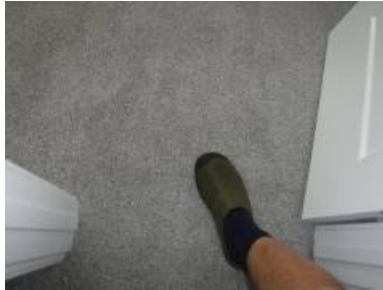
### 5.5 Floor:

After walking around inside the house, there were several areas where the subfloor was not at the same height as other areas of the home. These areas will create a wear mark wear mark in the carpet.

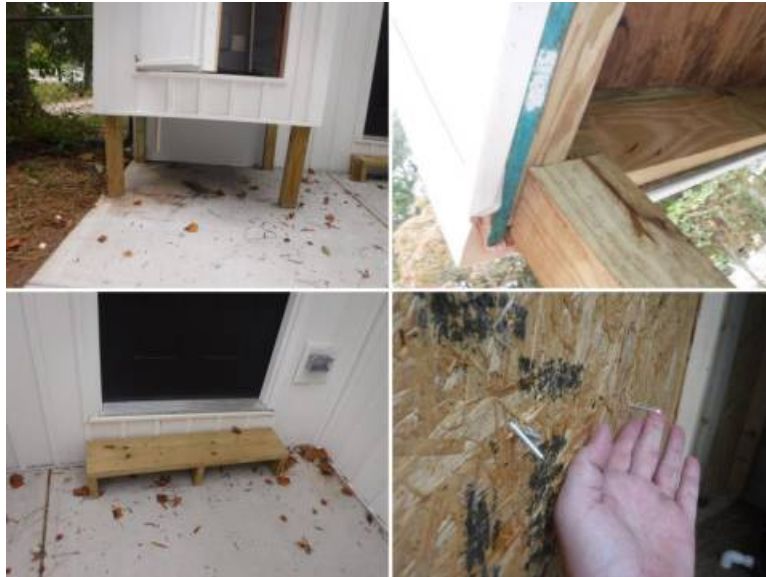
**Also, the step at the rear exterior door was not properly attached to the home. A licensed general contractor should be contacted to evaluate and make necessary repairs to the framing of the water heater stand and step.**

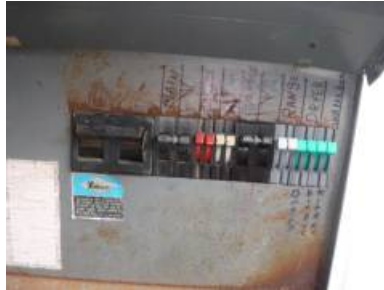
**construction. Anytime a Zinsco panel is discovered then we recommend that a licensed electrician inspects the panel for safety issues.**

**A licensed electrician should be called to fully evaluate the Zinsco panel. The electrician should determine if the panel is a safety issue and make recommendations to the seller for repairs or replacements if needed.**

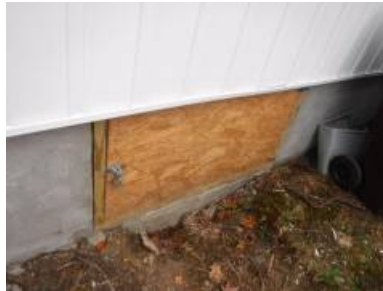
The crawl space access door was not pressure treated nor was it painted. This OSB will deteriorate much quicker if not primed and painted with an approved exterior grade paint. A qualified paint contractor should be contacted to evaluate and make repairs as needed.

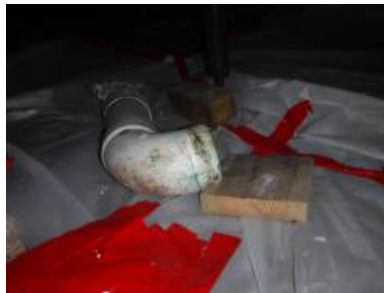
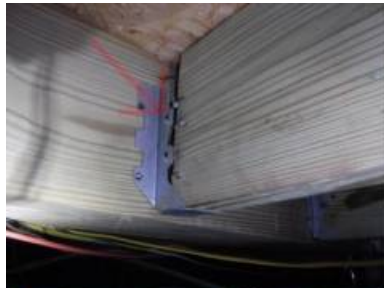
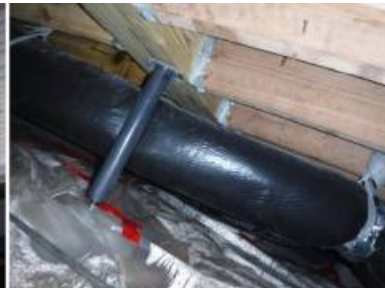
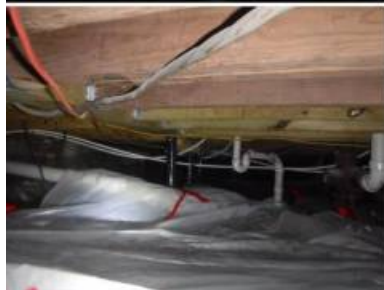
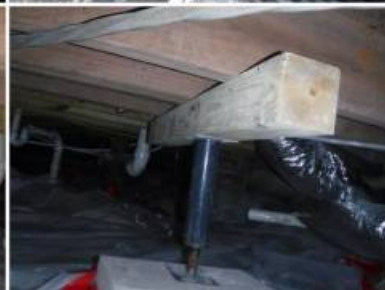
There were multiple areas around the crawl space where water or insect damage had occurred. There have been repairs in the past. We would highly recommend that a pest inspector be contacted to evaluate to ensure there are no active wood destroying insects.
