# Inspection Report

938 N Gayoso St  
New Orleans, LA 70119

**Inspection Date:**  
Monday, December 1, 2025

RE: Report No. 19955  
938 N Gayoso St  
New Orleans, LA  
70119

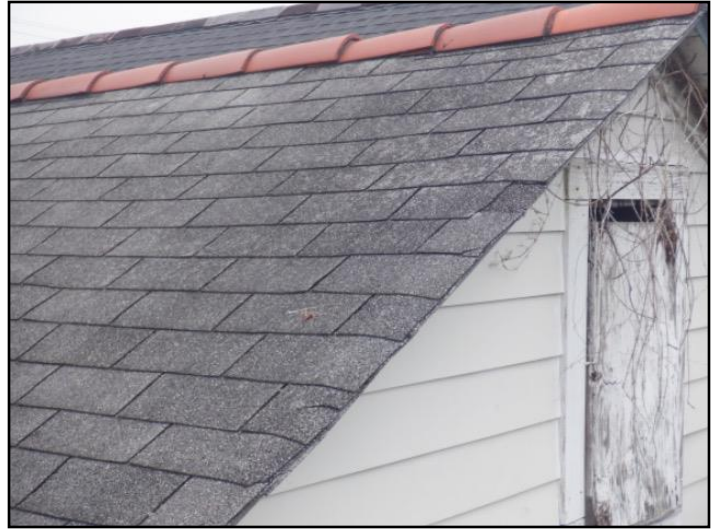
*Missing, loose or torn*

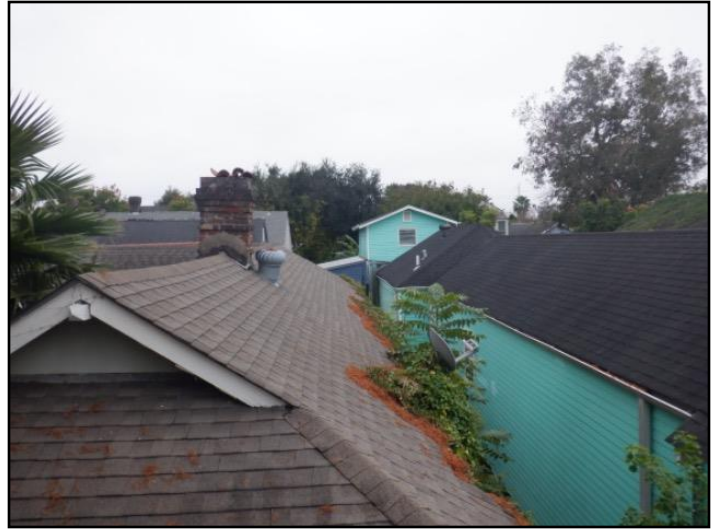
*Vines on roof covering*

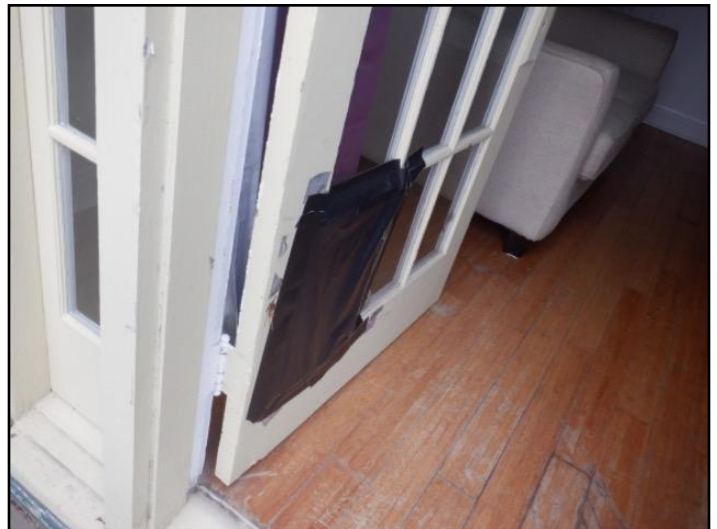
Moisture damage, cracks/openings, peeling paint, and general or isolated disrepair. Openings in exterior may also attract wood destroying insects to structure, and may cause hidden possible damage and mold growth. These issues should be addressed before further material deterioration occurs.

Deferred maintenance

**Task:** Repair.

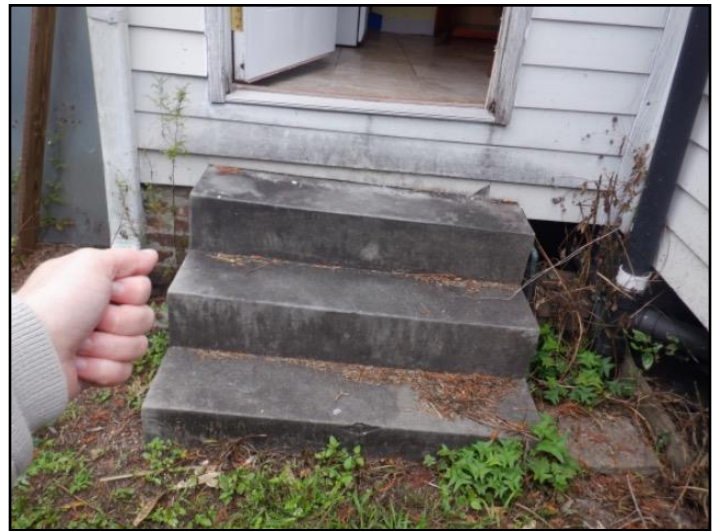
Steps with four or more risers or rising more than 30 inches in height should have a handrail installed along one side for safety. Railings should be sturdy enough to resist a person's weight and balusters spaced no more than 4". Railings should not be loose or climbable, and should be high enough to provide adequate protection; 36 inches is common. Stair hand railings should be graspable; a 2x4 is not adequate.

Missing stair handrail

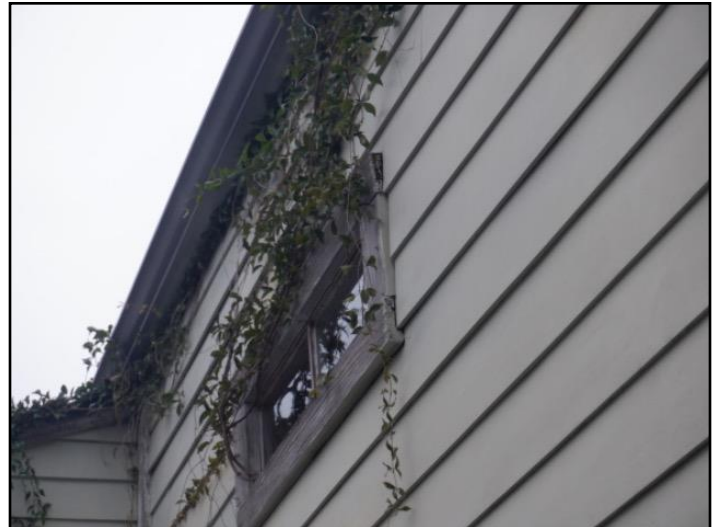
*Vines can damage siding by trapping moistur...*

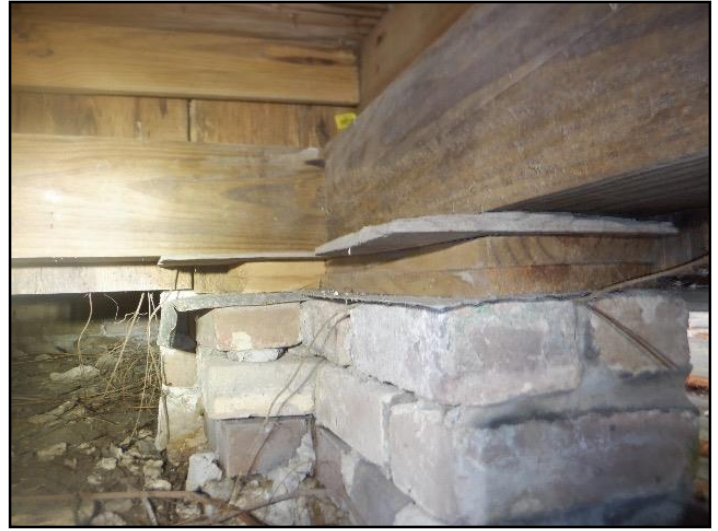
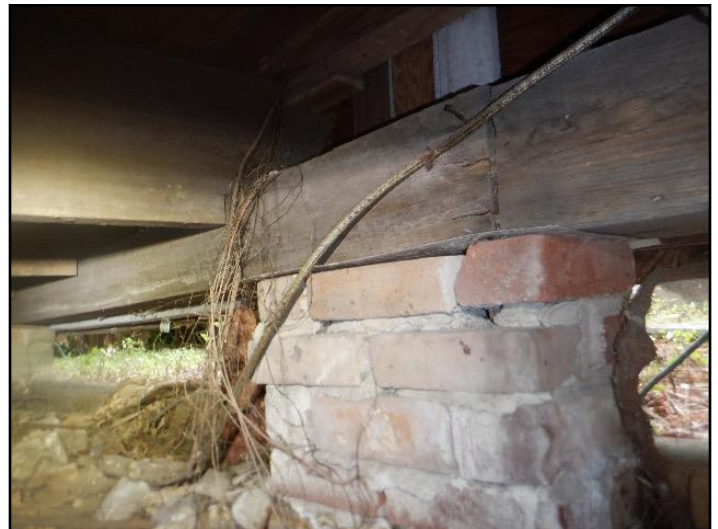
*Mortar and/or brick deterioration*

**Task:** Repair

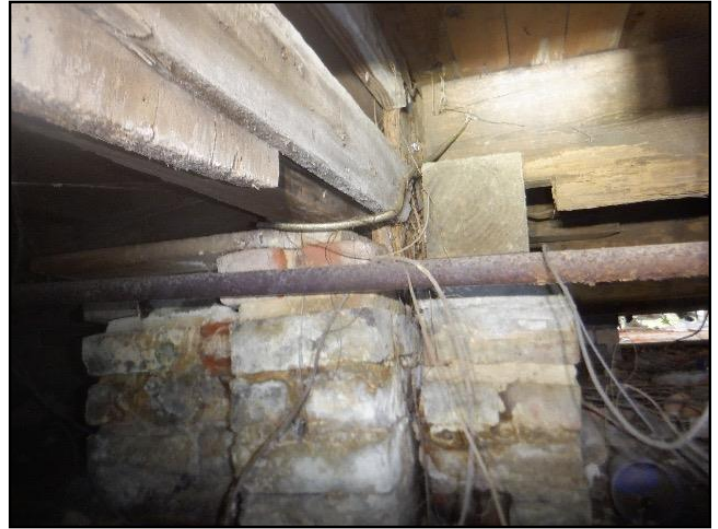
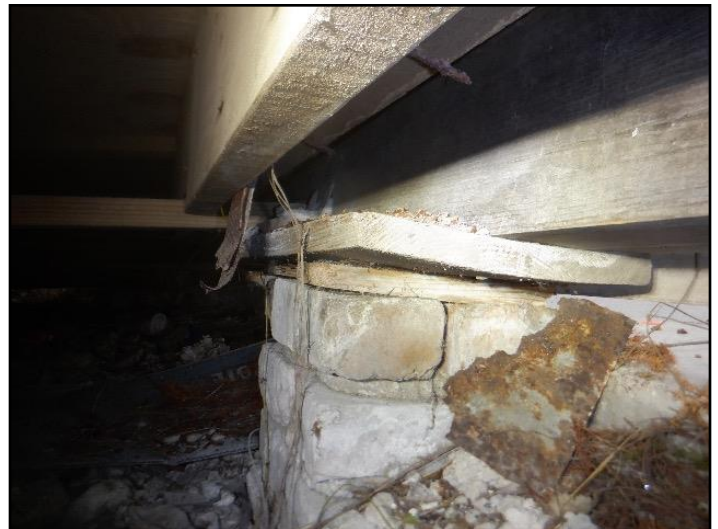
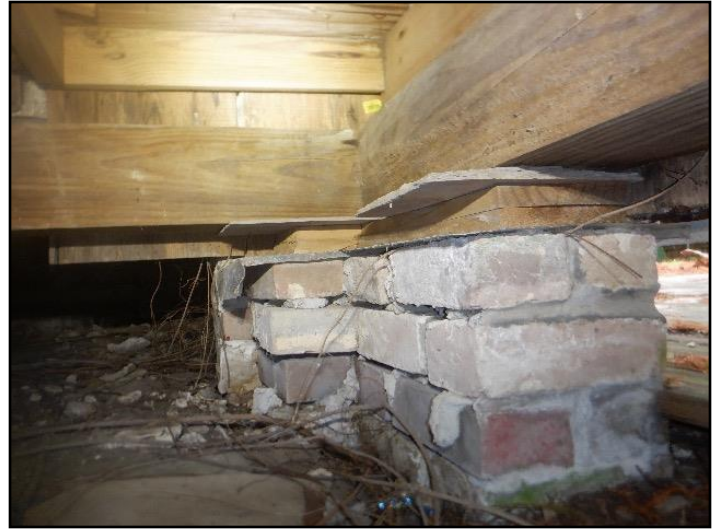
Shims should have full bearing on both the sill and pier. Inadequately sized shims will cause concentrated loads on structural members and may cause damage or movement. Shims should be made of a non-compressible material such as metal, masonry, hard plastics, slate, or fiber cement. No more than one to two shims should be used with a maximum total depth of two inches.

*Excessive, or improper shims*

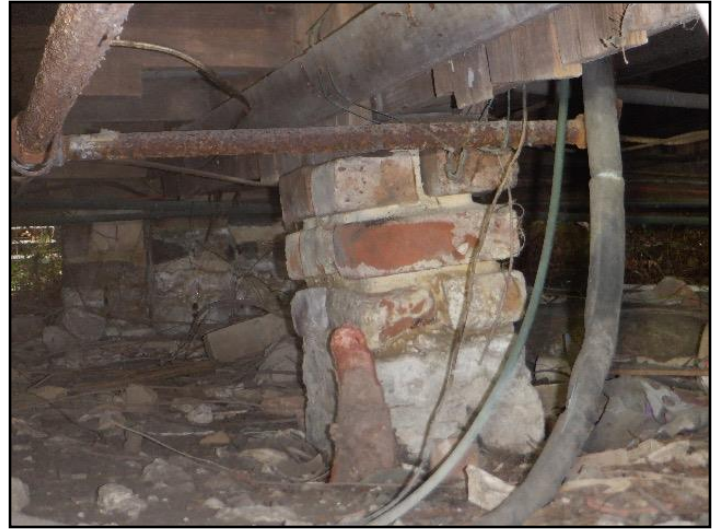
*Leaning*

**Task:** Repair.

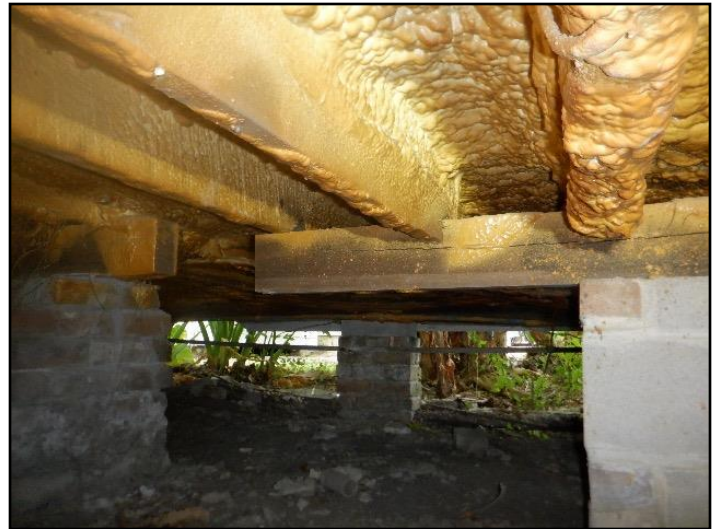
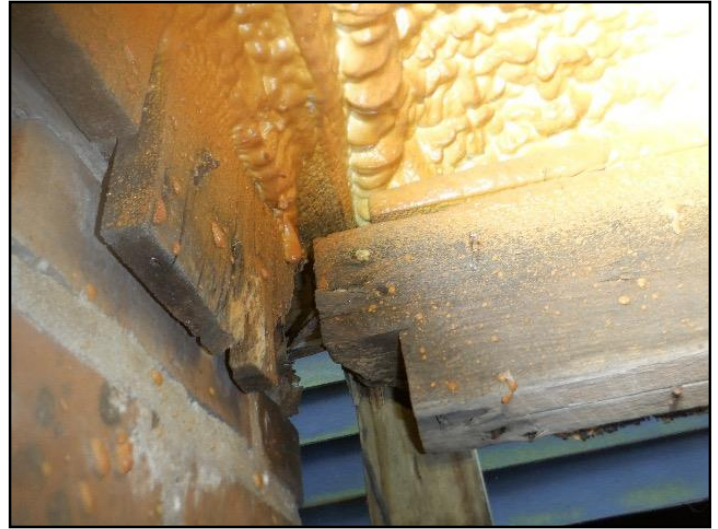
*Missing*

Missing

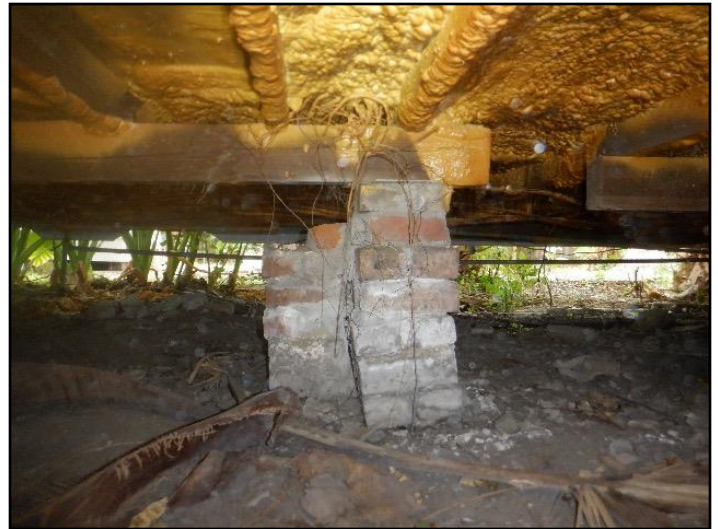
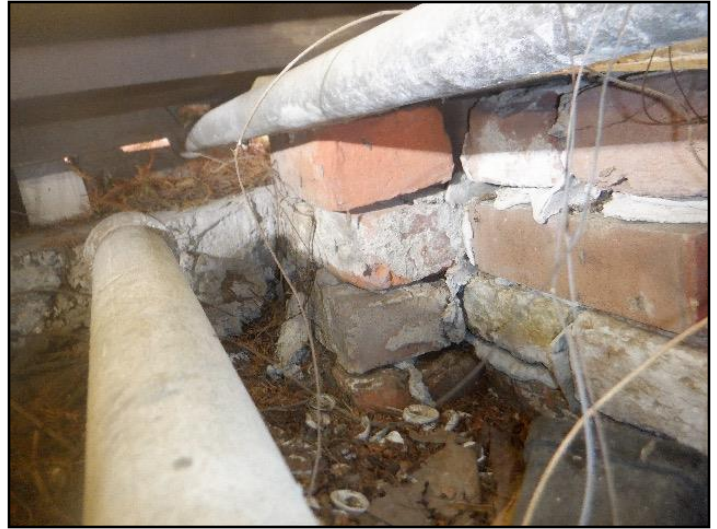
Loose or missing brick or block

*Loose or missing brick or block*

**Task:** Repair or replace.

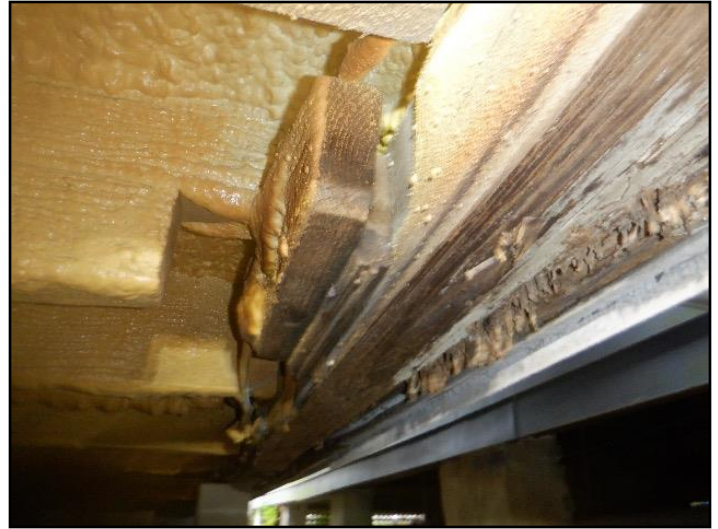
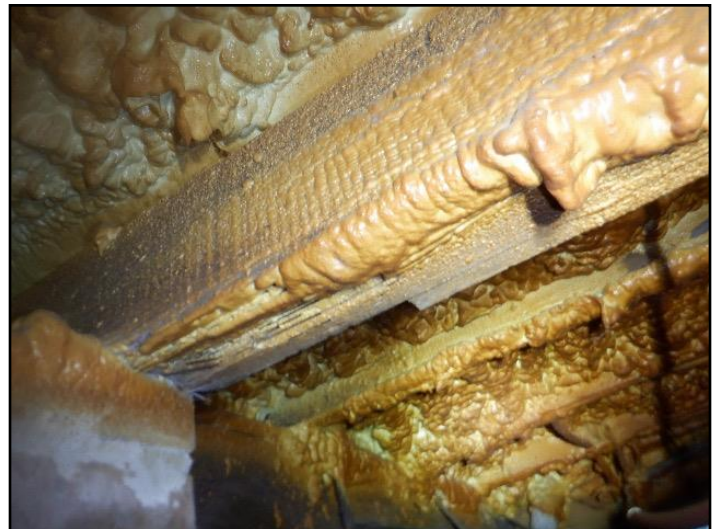
*Rot or insect damage*

It is highly recommended for termite shields to be installed when sills are replaced and piers are repaired.

**Task:** Further evaluation. Replace.

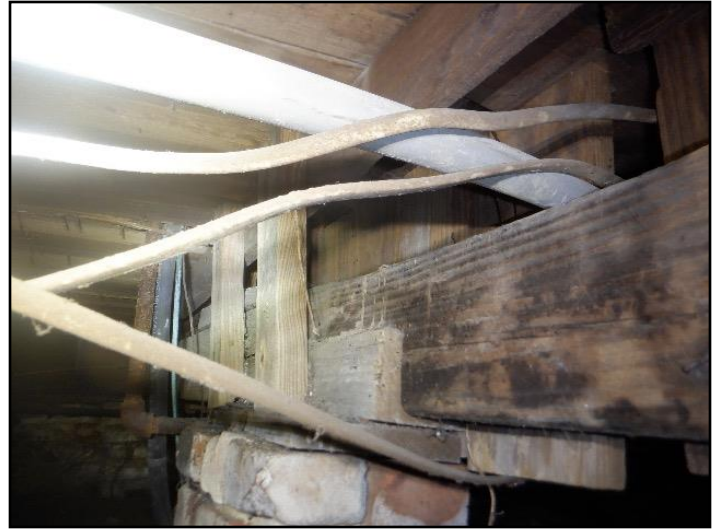
*Improper splicing*

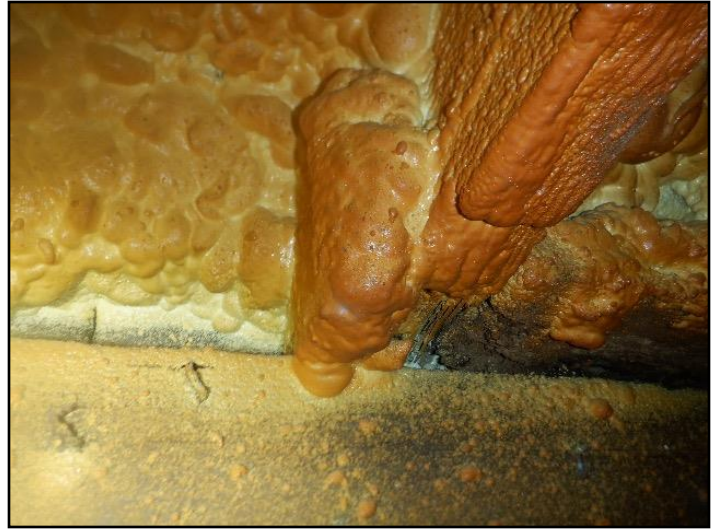
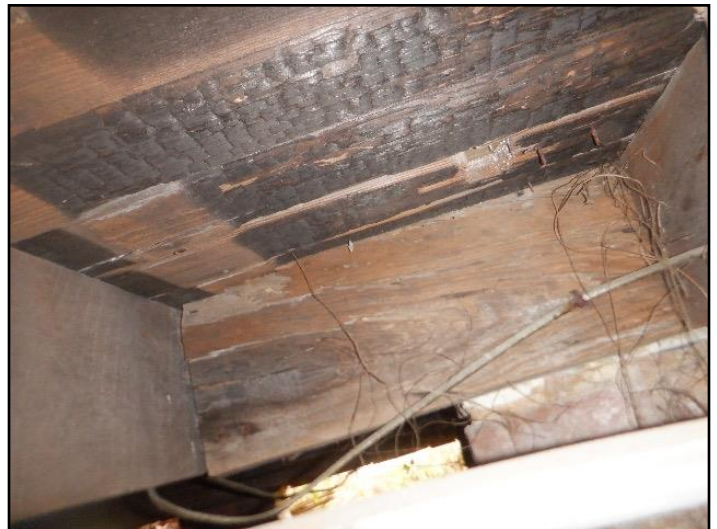
Damaged joists have lost some structural integrity from rot and/or insect damage. Repair by sistering is recommended. Sistering is adding a new joist to the old, attaching a same dimensional member to the damaged one with nails or bolts. The sister member should span the supporting piers if possible and this may require the area to be raised a quarter inch by jacking, in order to place the new joist into position.

*Rot and/or insect damage*

**Task:** Repair should be done by a licensed contractor.

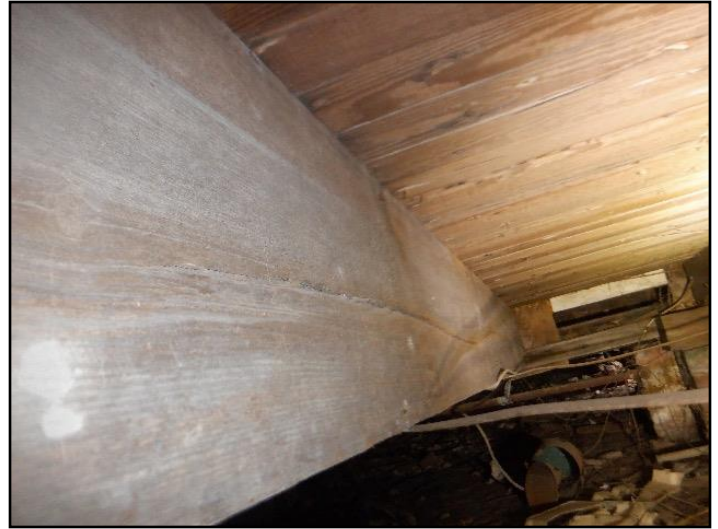
*Split or damaged*

**Task:** Repair.

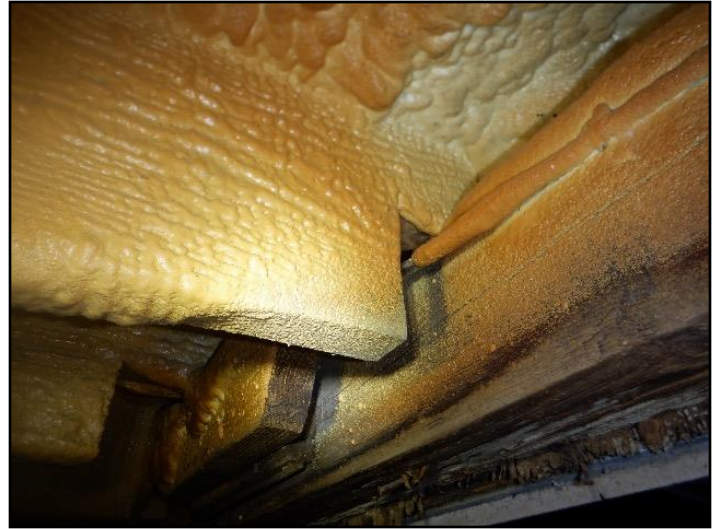
A fair amount of joists have been excessively notched when sills were replaced. The joists were originally only slightly notched and then pocketed inside the sill. When the sill was replaced, the joist was notched further to then rest on the new sill. This additional notch is excessive and greatly reduces the structural capacity of the joist, increasing the likelihood of splitting, damage, and structural movement. Sometimes a joist hanger installed under the notch can provide support. In some cases the notch is too large or too far away from the sill, where a ledger board or bounce beam may be more appropriate. Consult with structural contractor for repair options.

*Notched post-pocket*

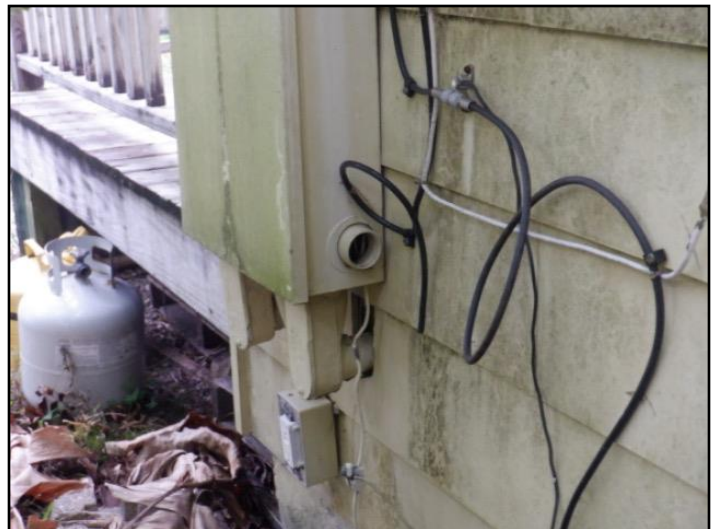
Openings in panel

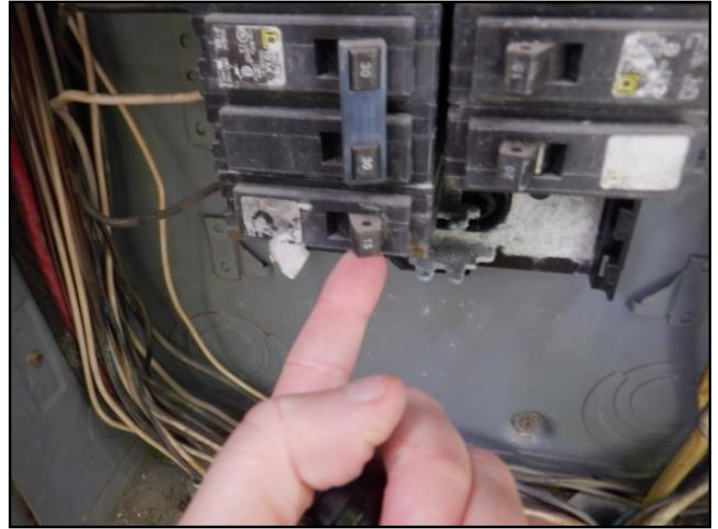
*Undersized breakers may cause frequent...*

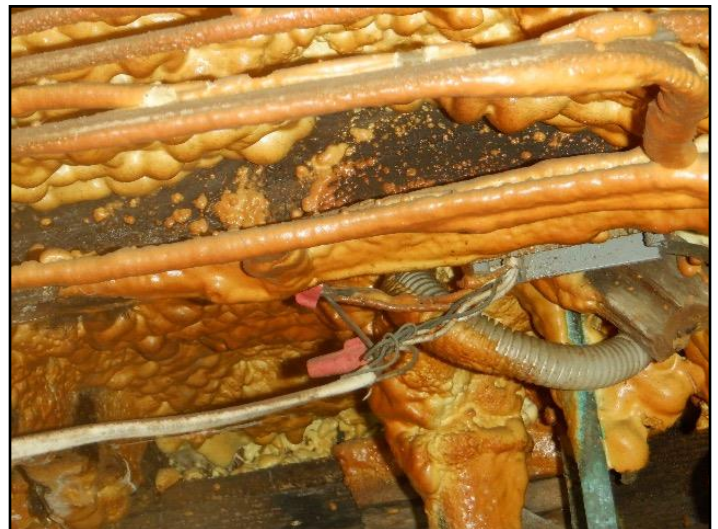
*Open splices*

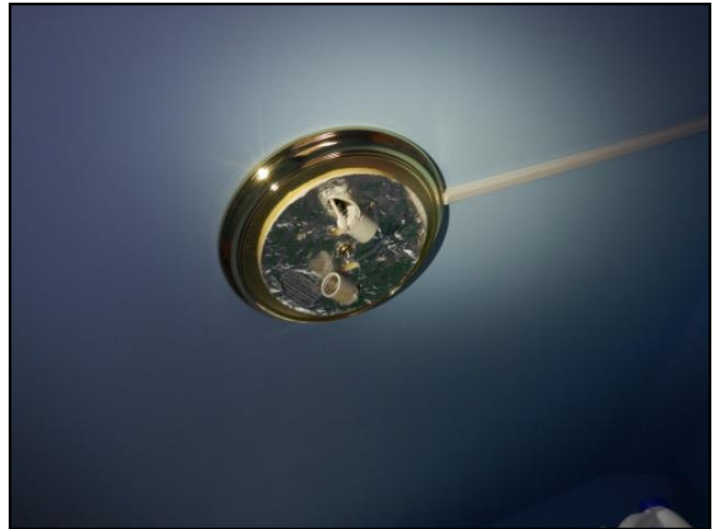
*Trim kit or globe is loose or missing*

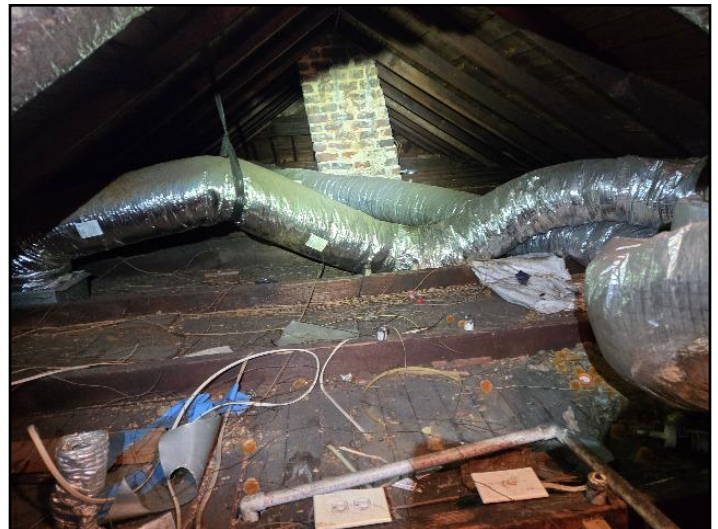
Poor support

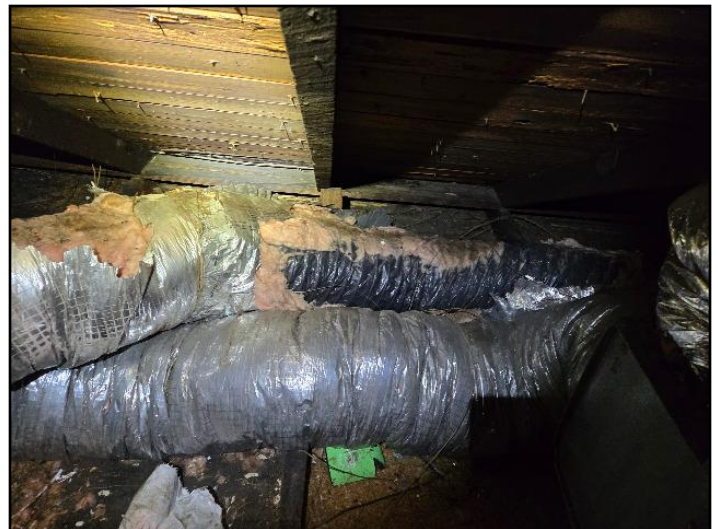
Damaged insulation is torn and missing in many places, exposing the metal duct. Insulation should completely cover duct from air handler to register.

*Damaged*

**Task:** Repair or replace

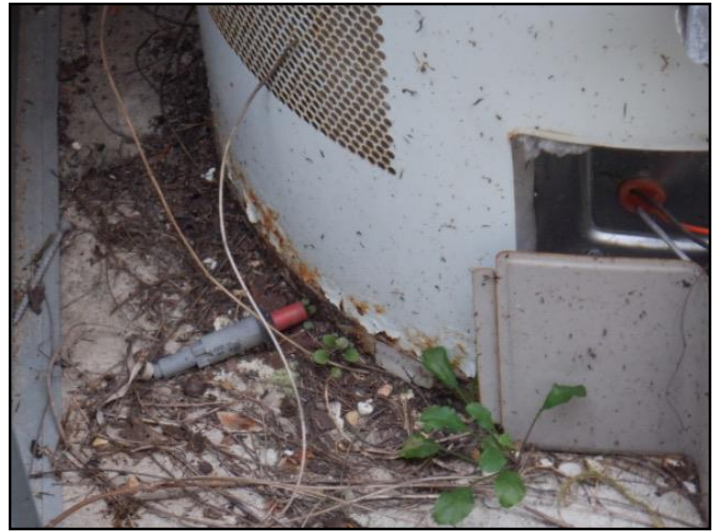
Rust

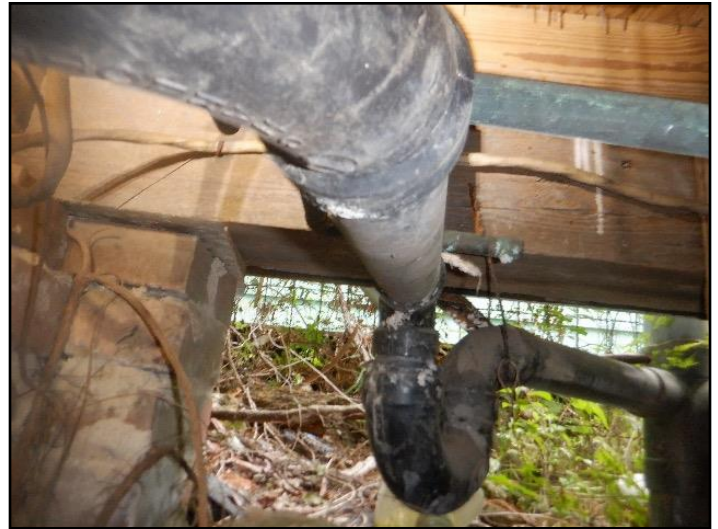
Leak

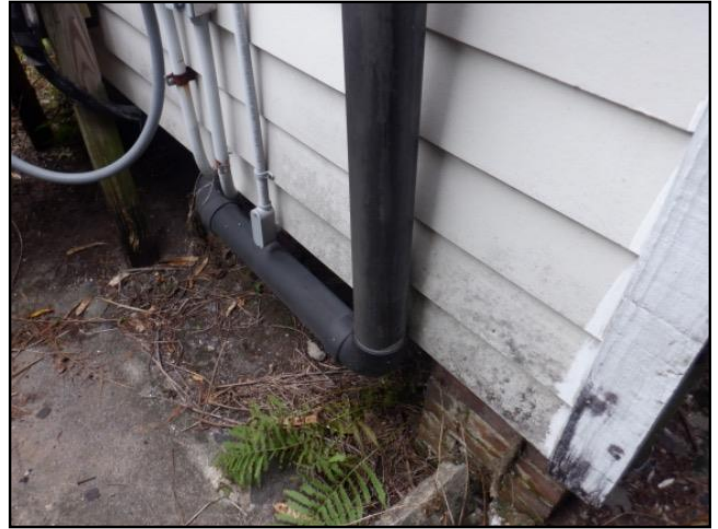
*ABS is susceptible to UV damage and should...*

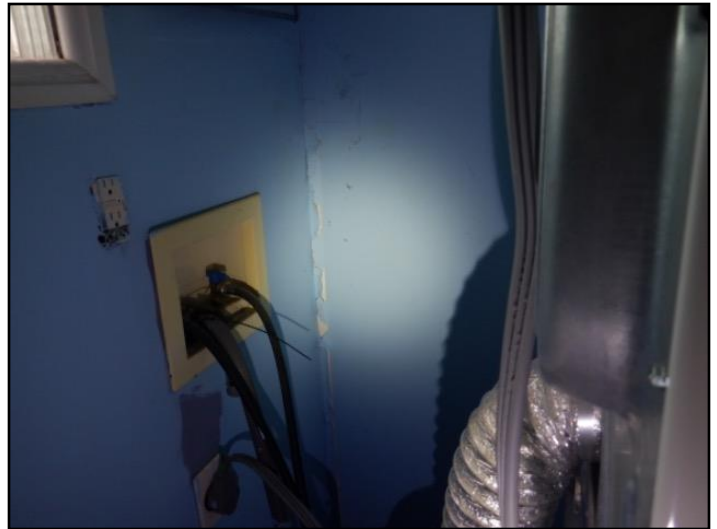
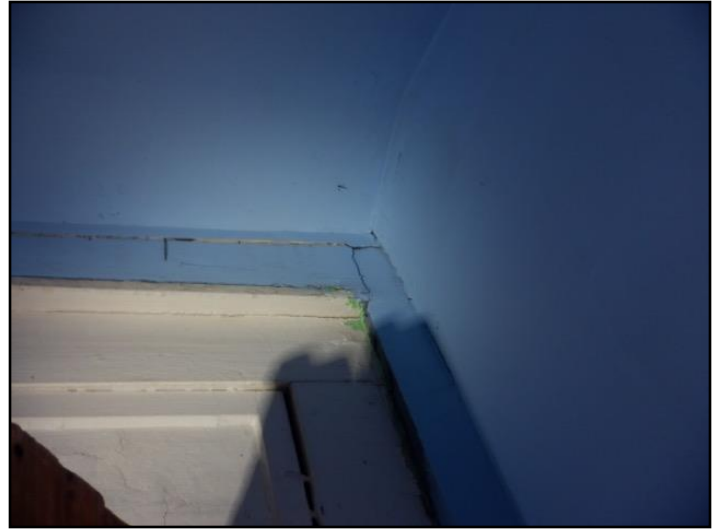
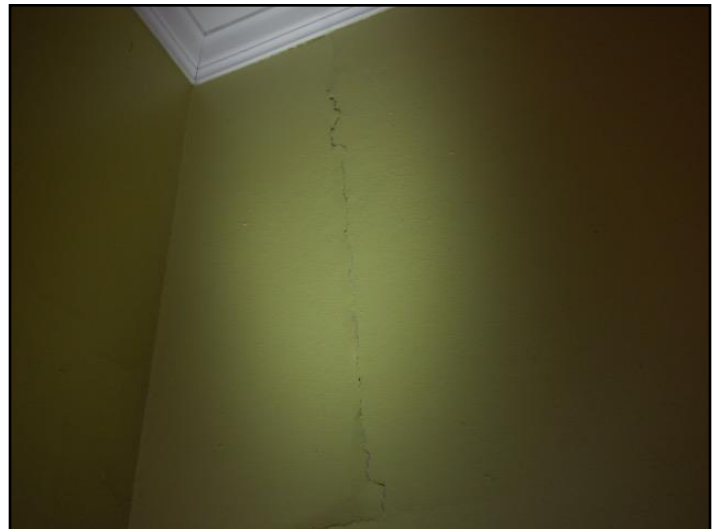
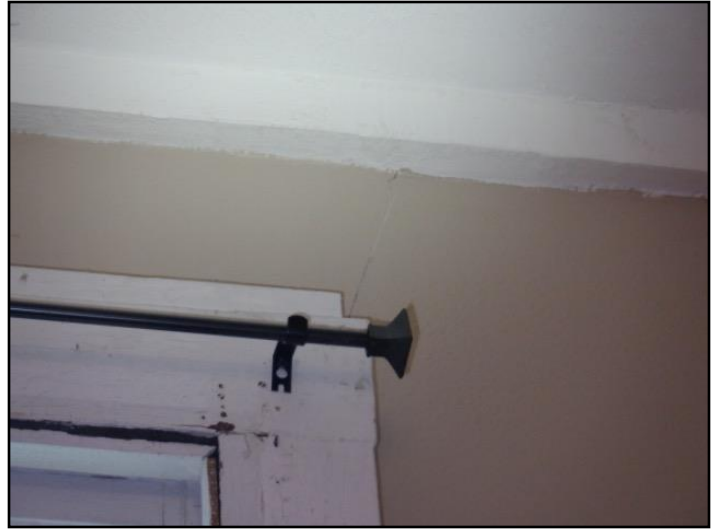
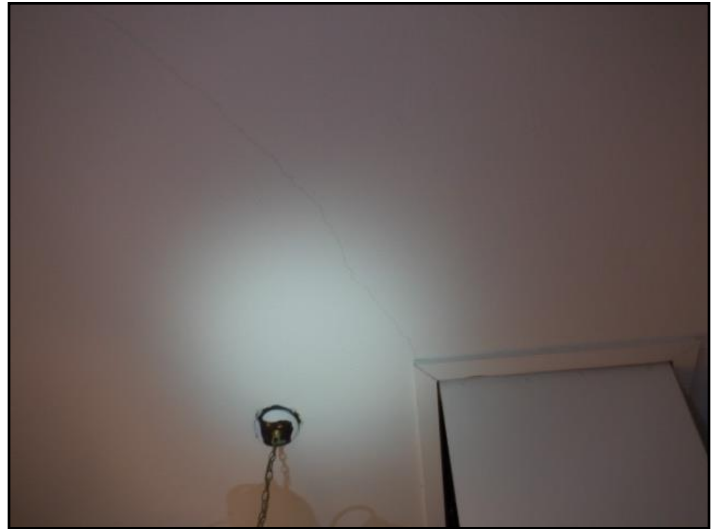
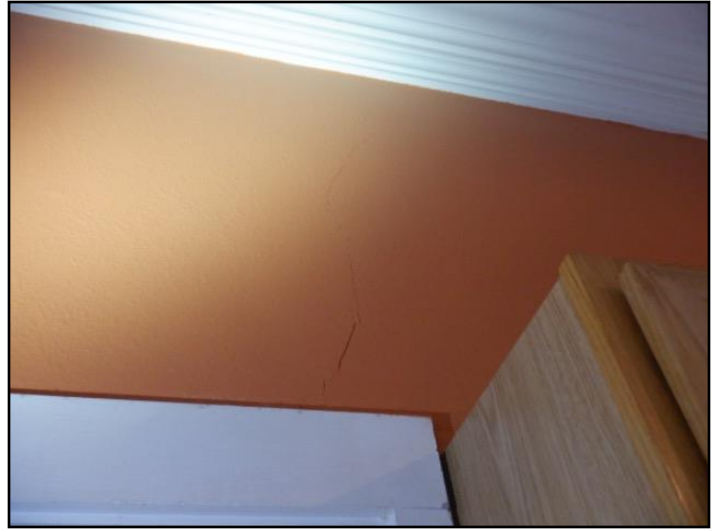
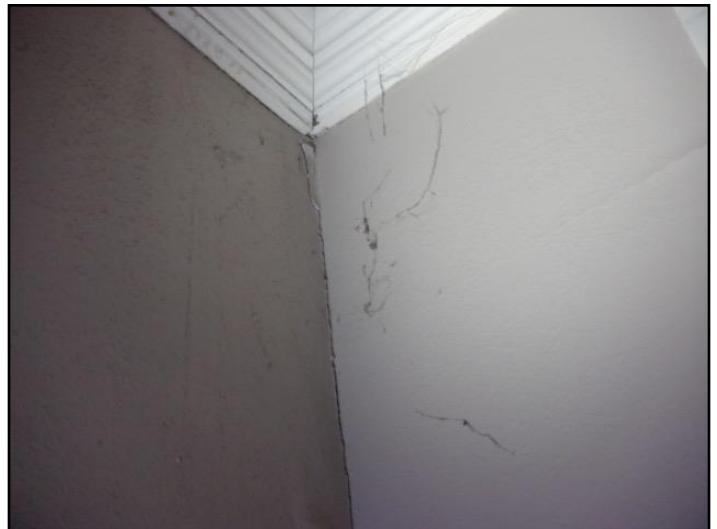
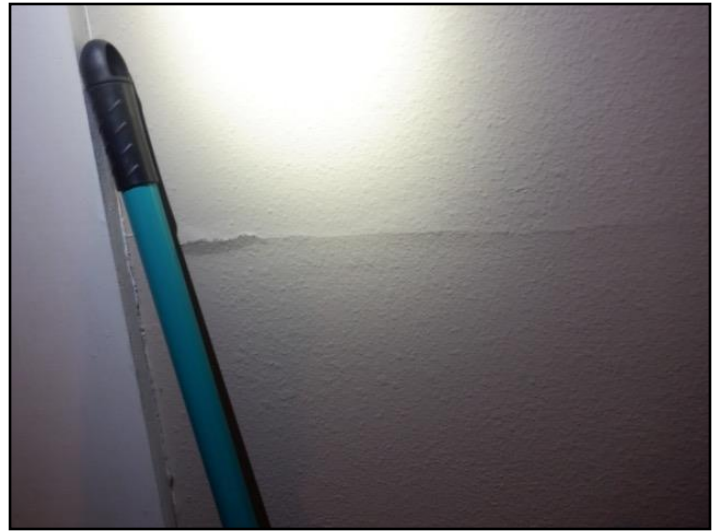
Cracks

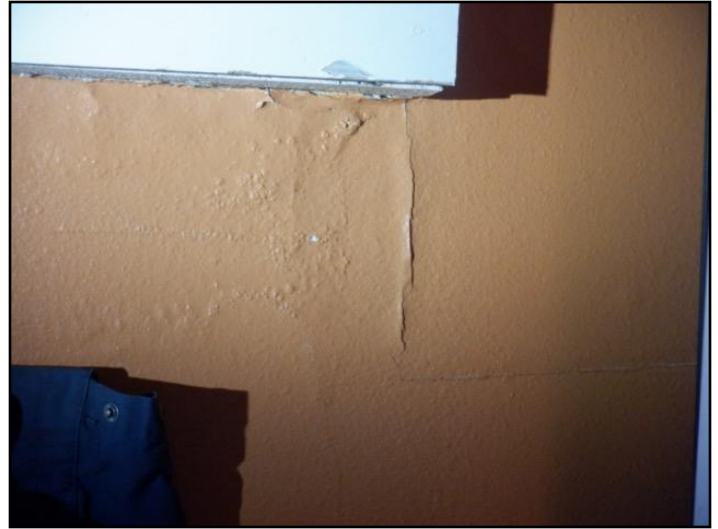
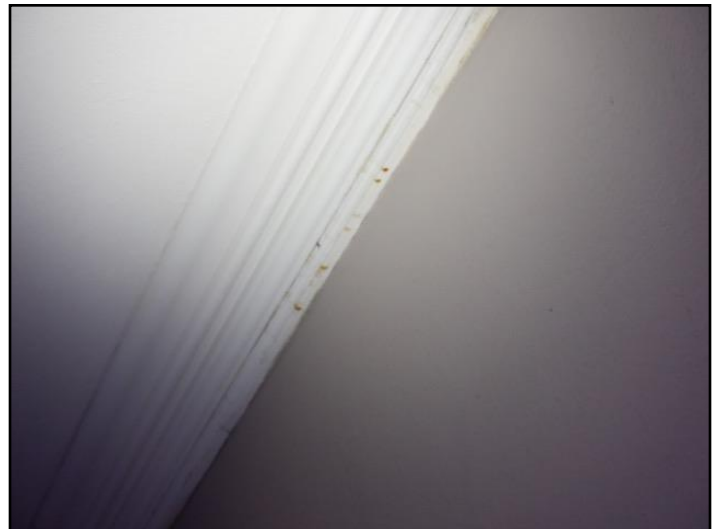
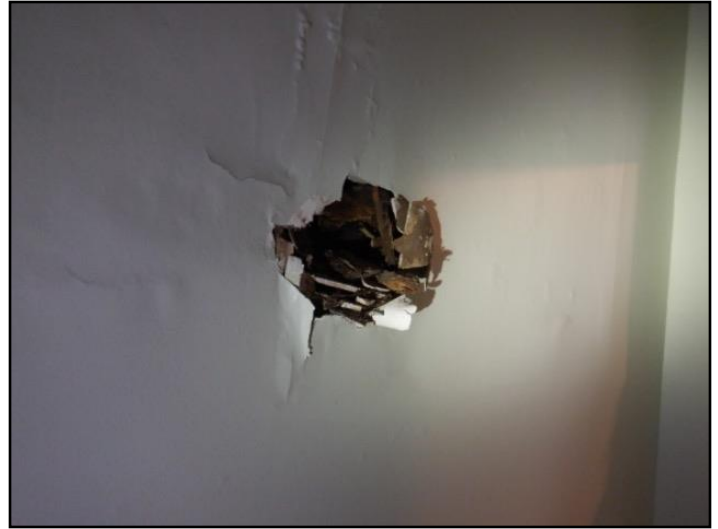
*Water damage*
