## General Summary

### Pinnacle Residential Inspections, LLC

956 E Durness Ct  
Wake Forest NC 27587

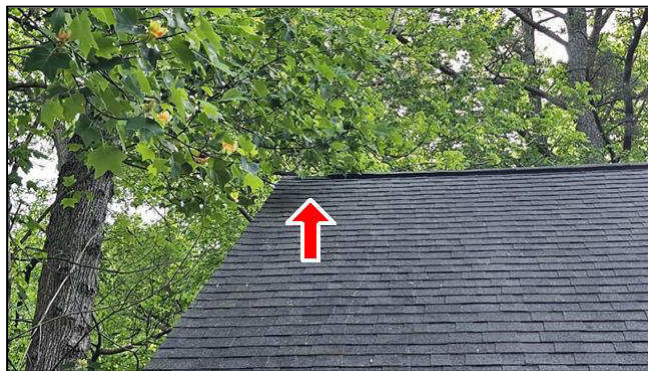
A. Item 1(Picture) front garage roof

(1) The tree limbs that are in contact with roof or hanging near roof should be trimmed to prevent damage. Have a licensed Contractor further review and repair as needed.

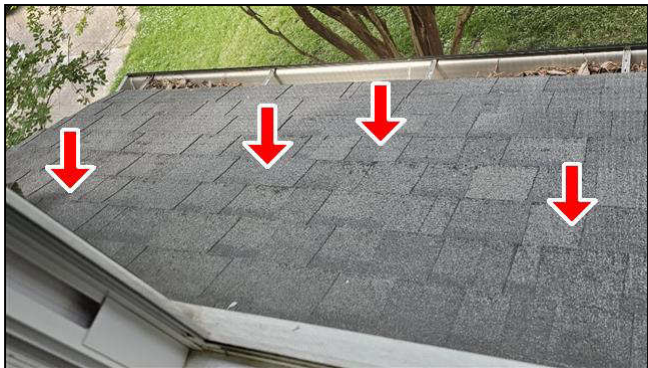
A. Item 2(Picture) front porch roof

(2) Damaged/missing shingles were noted as listed below. A damaged shingle can allow water to penetrate the sheathing and the structure. Have a licensed Contractor fully inspect the roof and repair/replace as needed.

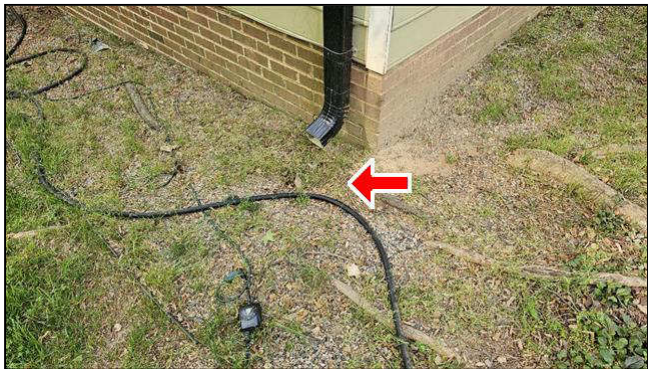
D. Item 1(Picture) rear left corner

(1) Splash blocks are missing at the base of the gutters. This can allow water to discharge at the foundation and can lead to erosion. Have a licensed Contractor further review and install as needed.

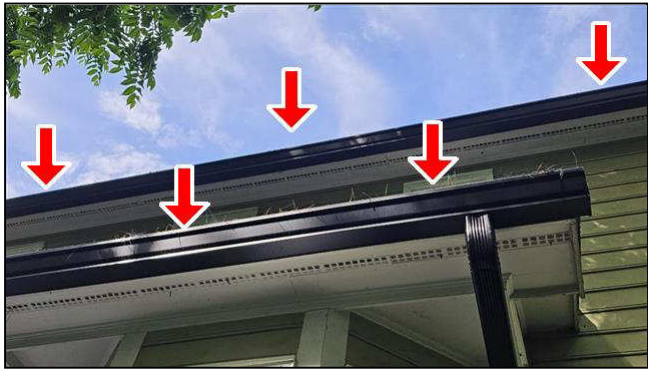
D. Item 2(Picture) rear roof

(2) The gutters are full of debris in areas and needs to be cleaned. The debris in gutters can also conceal rust, deterioration or leaks that are not visible until cleaned, and I am unable to determine if such conditions exist. Have a licensed Contractor further review and repair or replace as needed.

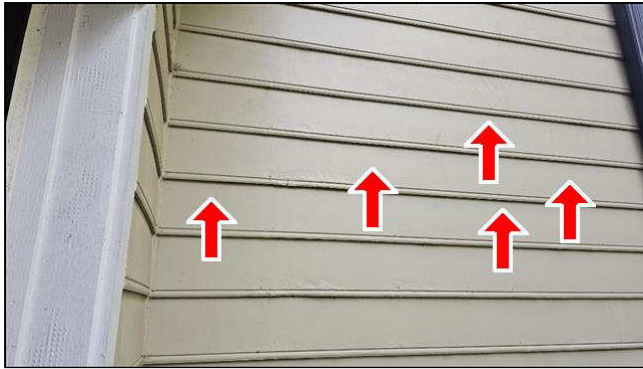
A. Item 1(Picture) left side wall by garage door

Deteriorated siding and trim boards were noted in the areas below. These areas will continue to deteriorate until corrected. Have a licensed Contractor fully review all siding and trim areas and repair/replace as needed.

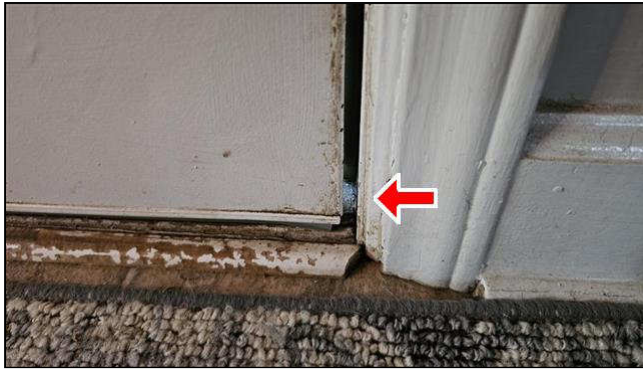
B. Item 1(Picture) door to garage

(1) The door to the home listed below did not fully seal. This can allow water and exterior unconditioned air to penetrate the home. Have a licensed Contractor further review and repair/replace as needed.

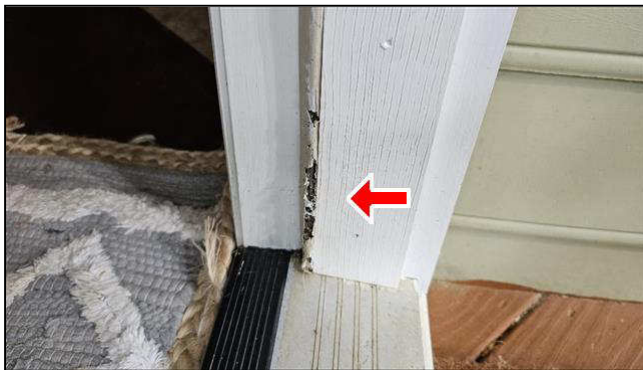
B. Item 4(Picture) rear door

(2) The door listed below was noted to have damaged weather stripping. This prevents the door from sealing which can allow unconditioned air as well as water to penetrate the home. Have a licensed Contractor fully review and repair as needed.

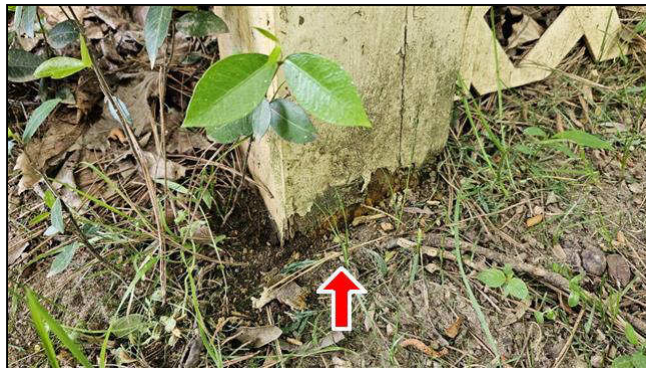
D. Item 1(Picture) rear deck

(1) The deck posts listed below were noted to have deterioration in areas. This can lead to failure of the deck post. Have a licensed Contractor fully review the deck and repair or replace areas as needed.

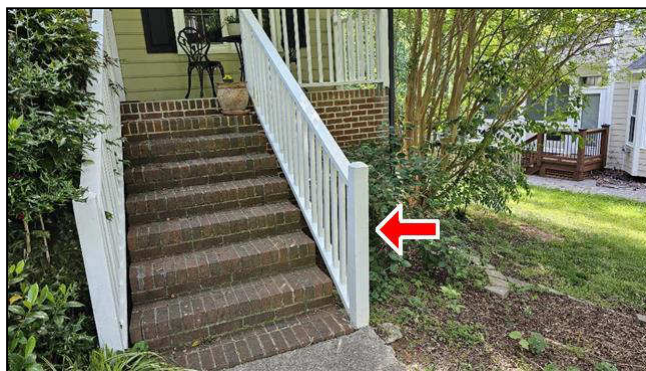
D. Item 2(Picture) front steps

(2) The post and/or railing(s) listed below was noted to be loose. This can be a hazard in the event of a trip or fall. Have a licensed Contractor further review and repair or replace as needed.

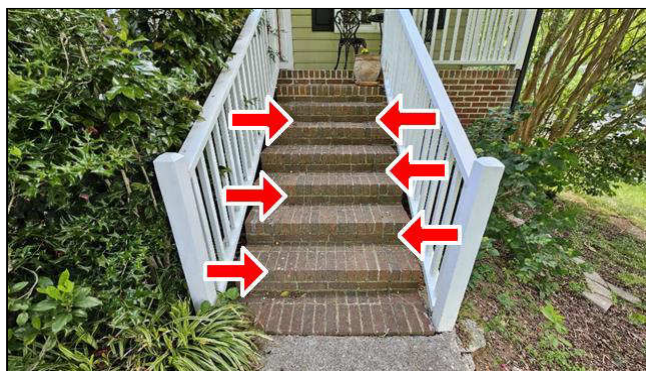
D. Item 3(Picture) front steps

(3) The front porch steps were noted to have cracks in the mortar in the areas listed below. This can be in entry point for water which can freeze in colder months leading to further damage. Have a licensed Contractor further review and repair/replace as needed.

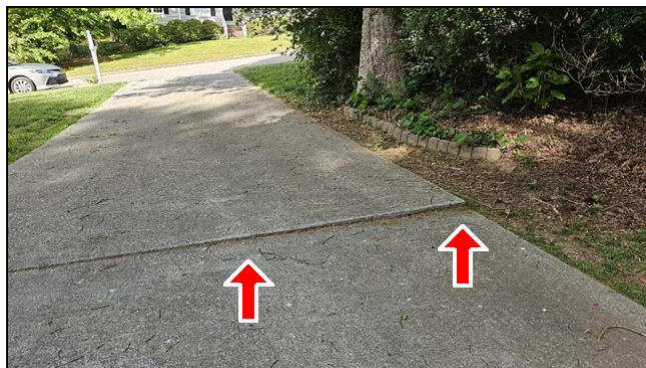
E. Item 1(Picture) driveway

(1) The driveway was noted to have experienced movement in the areas listed below. This movement can lead to damage of the surrounding areas as well as create issues that can effect proper drainage. This also creates a trip hazard. Have a licensed Contractor further review these areas and repair as needed

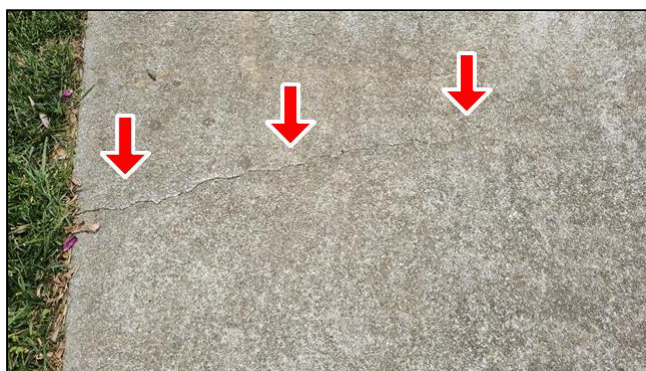
E. Item 2(Picture) driveway

(2) The concrete drive at the front of home is cracked in areas. Water can cause further deterioration if not repaired and sealed properly. A licensed contractor should inspect and repair as needed.

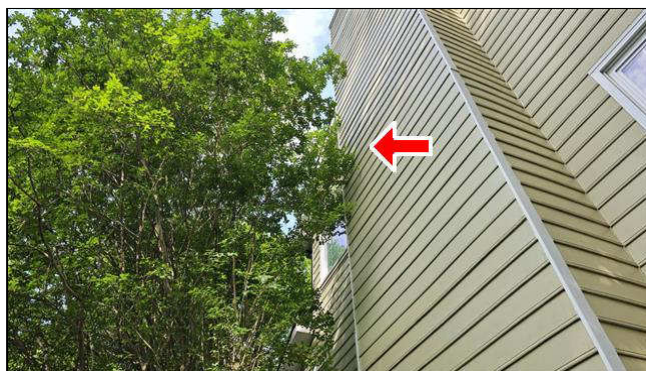
E. Item 3(Picture) right side wl

(3) Shrubs and plantings at the area of the home listed below is growing against the structure. This can prevent the siding from drying properly and can promote mildew on the siding. Have a licensed Contractor prune the plantings away from the home.

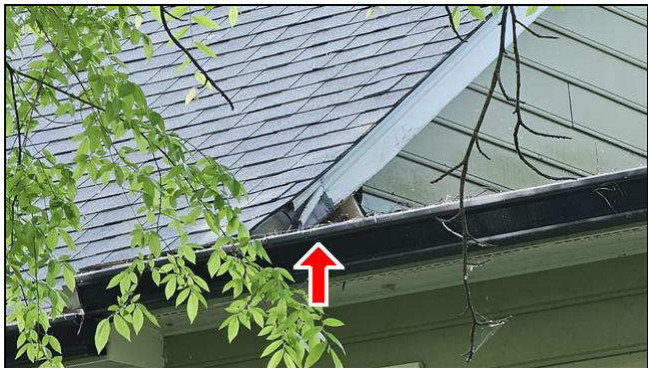
F. Item 1(Picture) rear roof

Fascia boards were noted to be damaged/deteriorated in the areas noted below. These areas will continue to deteriorate until corrections are made. Have a licensed Contractor fully review all trim areas and repair/replace as needed.

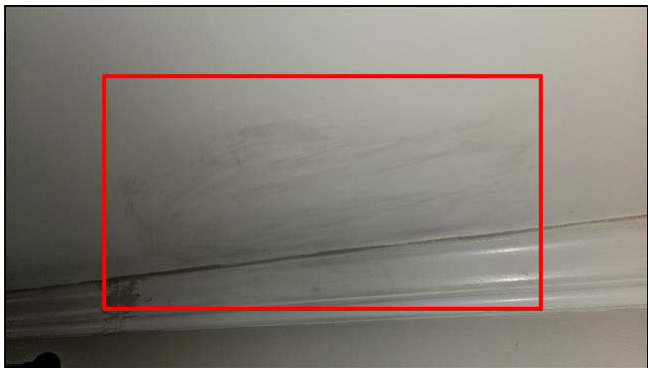
A. Item 1(Picture) family room

The ceiling in the areas listed below were noted to have stains and/or evidence of repairs. This area appeared to be dry at the time of inspection. I could not confirm if a leak was active. Ask the current owner for any and all information. If further concern exists have a licensed Contractor further review and repair or replace as needed.

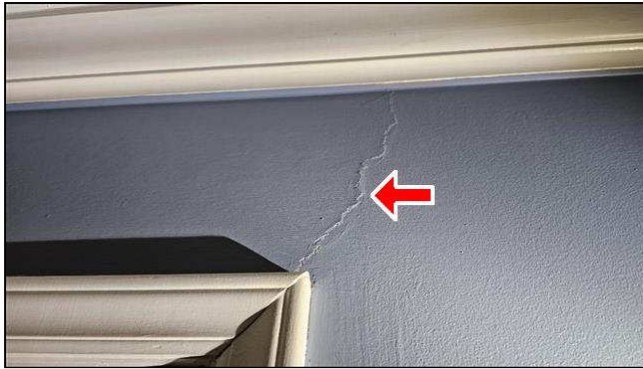
B. Item 1(Picture) dining room entry to kitchen

Light crack was noted in the areas listed below. This crack appears to be typical but can be an indication of slight movement in the structure at some point. If further concern exists I suggest having a Structural Engineer and/or licensed General Contractor further review and repair/replace as needed.

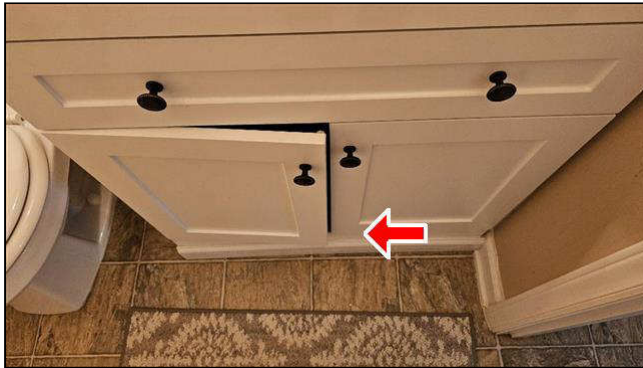
E. Item 1(Picture) downstairs bathroom sink

(1) The cabinets in the areas noted below rubbed when opened and closed. This can lead to damage to the cabinets. Have a licensed Contractor further review and repair/replace as needed.

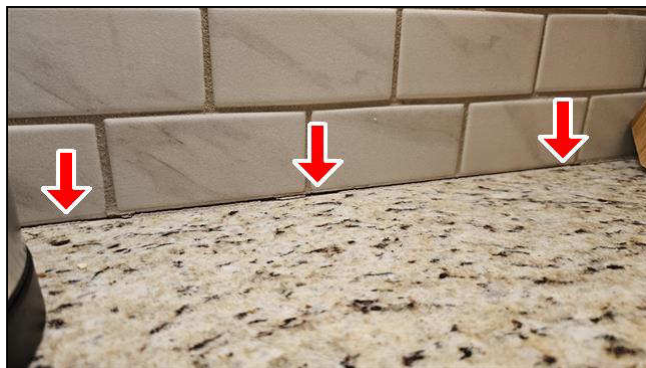
E. Item 2(Picture) kitchen sink

(2) Gap was noted at the backsplash of the countertop in the areas listed below. This can allow water to penetrate areas outside the sink and countertop areas. Have a licensed Contractor further review and repair/replace as needed.

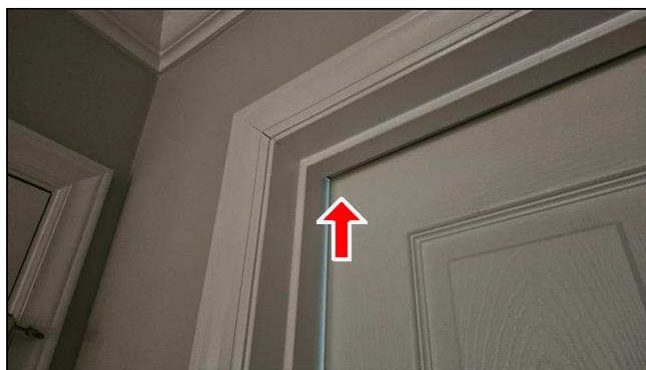
F. Item 1(Picture) dining room entry to kitchen

Doors in the rooms noted below rubbed the door frame and/or flooring as noted. This prevented the door from closing properly. Have a licensed Contractor further review and repair/replace as needed.

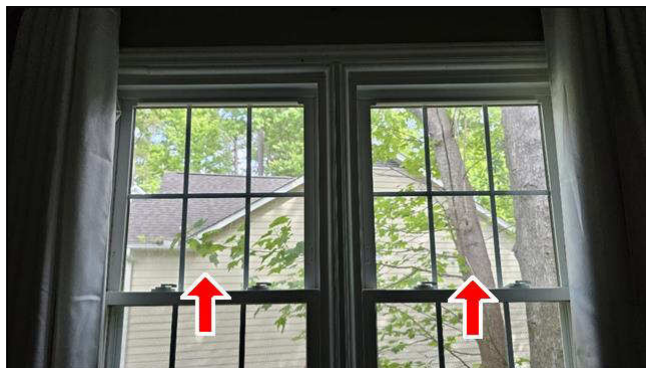
G. Item 1(Picture) left side bedroom window

The window UV coating was noted to be failing in the window(s) listed below. UV coating protects the home and aids in energy efficiency. Have a licensed Contractor further review and repair or replace as needed.

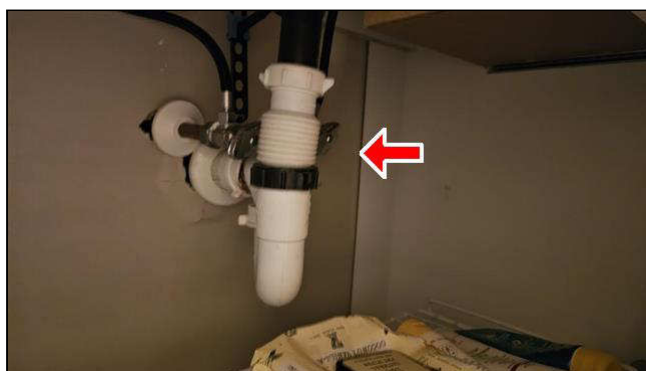
A. Item 1(Picture) downstairs bathroom sink

(1) Flex piping was noted to be installed in the areas listed below. This is an unapproved plumbing pipe as it can trap water and debris which can reduce the effectiveness of the drain line. Have a licensed Plumber further review and repair/replace as needed.

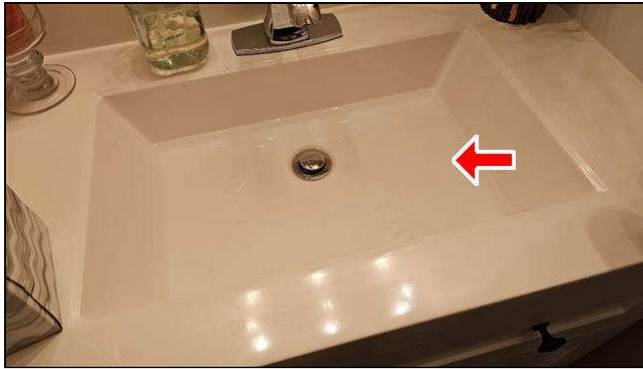
A. Item 4(Picture) downstairs bathroom sink

(2) The sink and/or tub in the areas listed below were slow to drain. This is an indication of a blockage. have a licensed Plumber further review and repair/replace as needed.

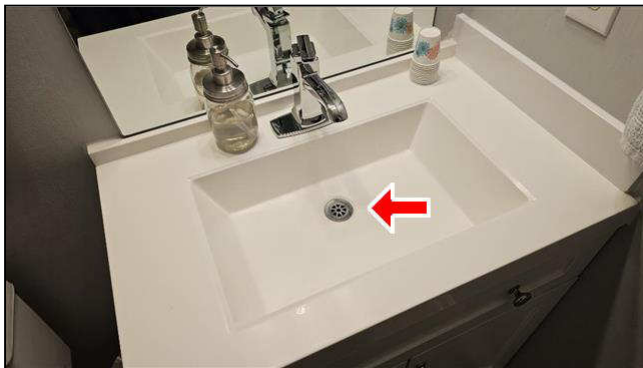
A. Item 5(Picture) upstairs hall bathroom sink

(3) The drain stopper was missing or not functioning properly in the sinks or tub noted below. This prevents water from being filled in the when needed. Have a licensed Plumber further review and repair/replace as needed.

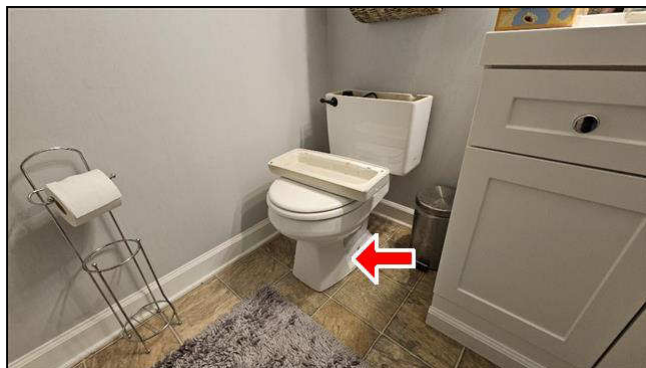
A. Item 8(Picture) upstairs hall bathroom

(4) The toilet is slightly loose at floor at the bath listed below. Repairs may involve re-setting the toilet on a new wax seal. I recommend a qualified licensed plumber & contractor fully review the toilet and including the subflooring and then repair or correct as needed.

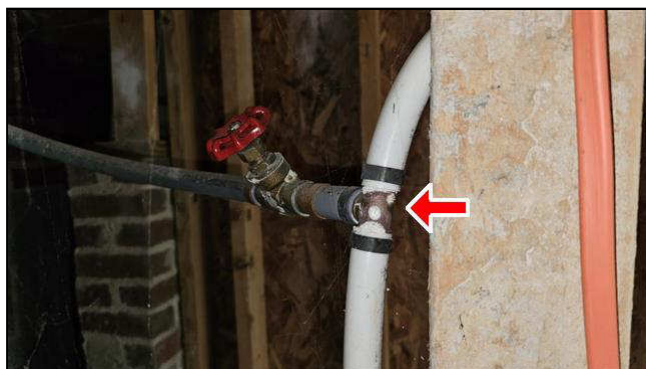
B. Item 1(Picture) at water heater

(1) The plumbing supply lines in the area listed below were noted to be experiencing corrosion. This can lead to a leak which can cause damage to the surrounding areas. Have a licensed Plumber fully review the plumbing supply lines and repair or replace as needed.

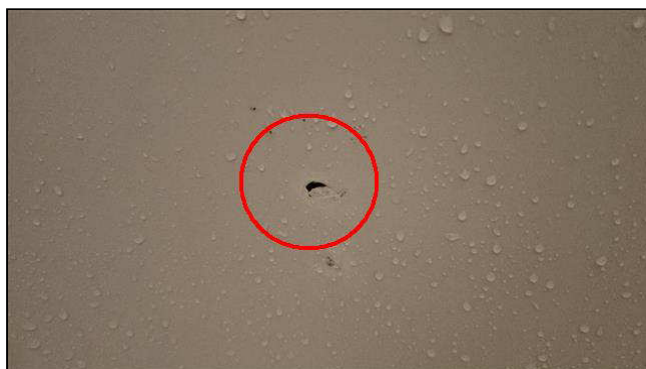
B. Item 2(Picture) upstairs hall bathroom tub

(2) Chips were noted in the tubs in baths listed below. This can allow water to penetrate the bath tub which can lead to further damage. Have a licensed Plumber further review and repair/replace as needed.

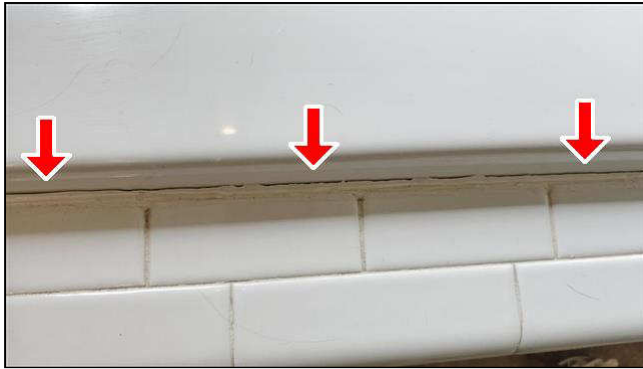
B. Item 3(Picture) primary bathroom tub

(3) The bath tub/shower has a few areas of cracked grout. This can allow water to penetrate areas outside the interior tub/shower area. Have a licensed Contractor further review and repair/replace as needed.

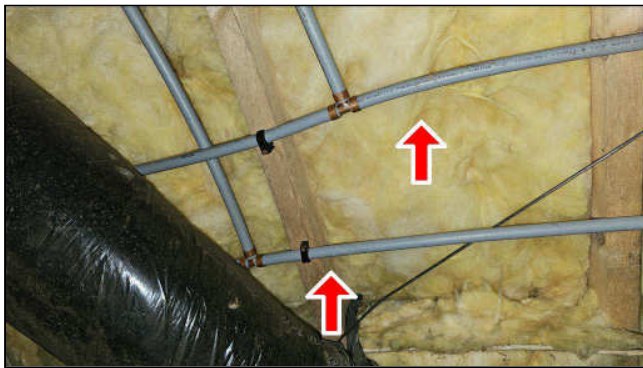
B. Item 4(Picture) crawlspace

(4) Polybutylene plastic plumbing supply lines (PB) are installed in the subject house. Polybutylene has been used in this area for many years, but has had a higher than normal failure rate, and is no longer being widely used. Copper and Brass fittings used in later years have apparently reduced the failure rate. This subject house has copper fittings. For further details contact the Consumer Plumbing Recovery center at 1-800-392-7591 or the web at <http://www.pbpipe.com>

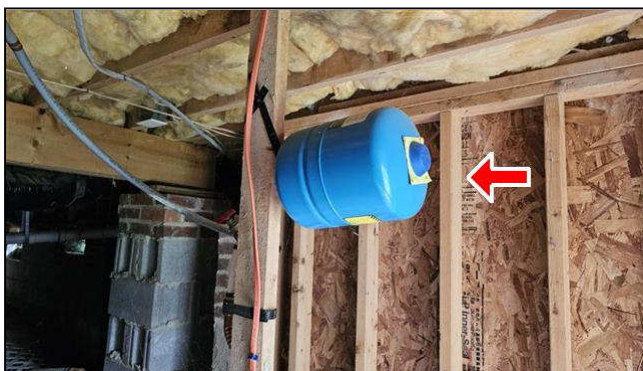
C. Item 1(Picture) water heater in crawlspace

(1) The expansion tank for the water heater was not properly supported. This can place added pressure on the plumbing lines which can lead to a leak. Have a licensed Contractor further review and repair/replace as needed.

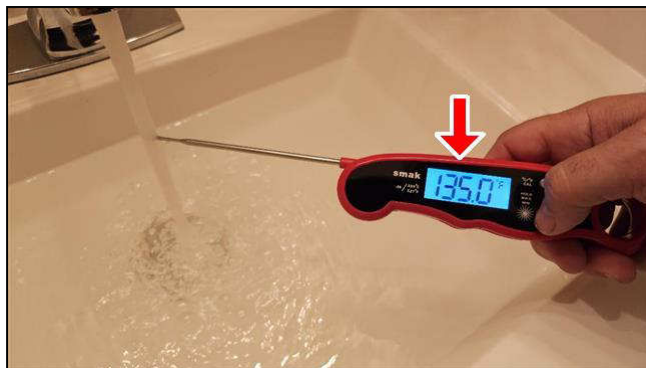
(2) The hot water temperature was noted to be too hot. This is considered to be a scald/burn hazard. Have the water temperature reduced to a safer level around 113 degrees but not to exceed 120 degrees.

C. Item 2(Picture) downstairs bathroom sink  
(135.0 °F)

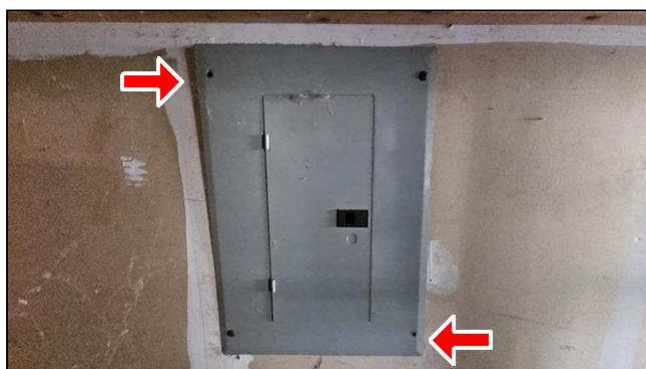
B. Item 1(Picture) garage panel

The electrical panel cover was noted to be missing some mounting screws. This prevents the cover from being fully secured. Have a licensed Electrician further review and install as needed.

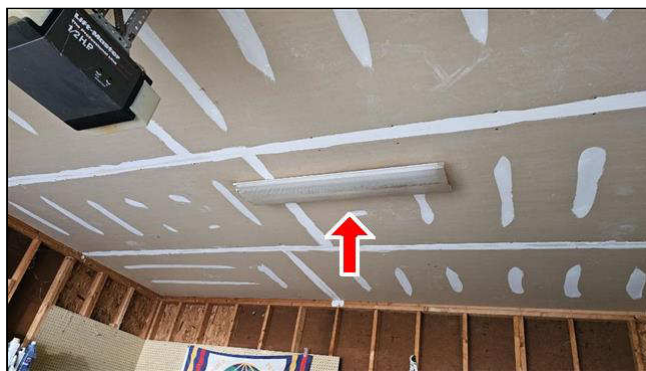
D. Item 1(Picture) garage

(1) Lights were noted to be out in the areas listed below. This is most likely burned out bulbs. Have a licensed Electrician further review and repair/replace as needed.

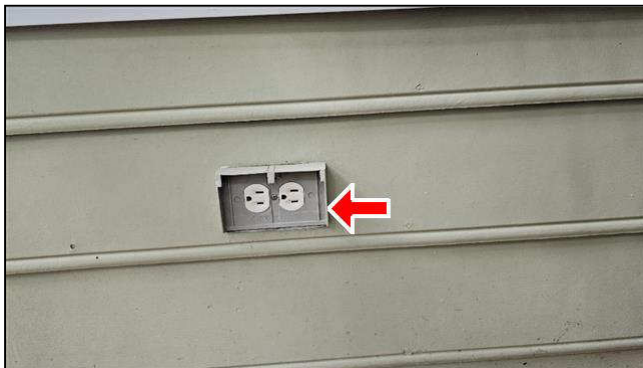
D. Item 6(Picture) rear deck

(2) The exterior outlet cover was noted to be missing. This is considered to be an electrical hazard as water can come into contact with the electrical outlet. Have a licensed Electrician further review and repair or replace as needed.

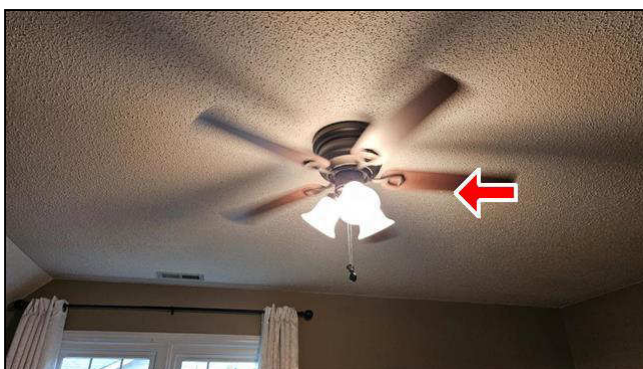
D. Item 7(Picture) left side bedroom

(3) The ceiling fan "wobbles" in the area listed below. The fan appears to be out of balance. Have a licensed Electrician further review and repair or replace as needed.

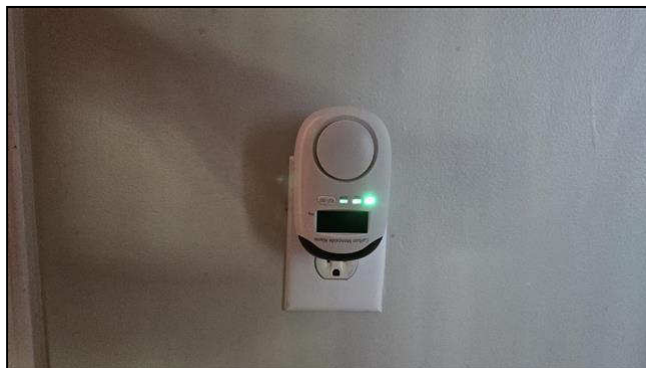
I. Item 1(Picture) upstairs hall

A removable carbon monoxide detector was found in the home. These detectors should be left or replaced in the event the current owner removes them.

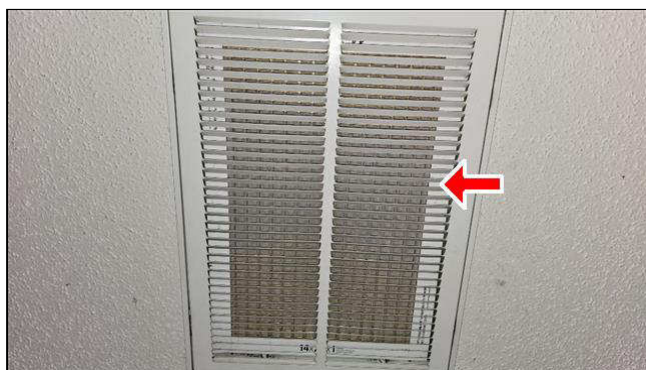
D. Item 1(Picture) upstairs hall

The disposable filter is clogged and is dirty. The filter needs to be replaced. I recommend repair or replace as needed using a qualified person

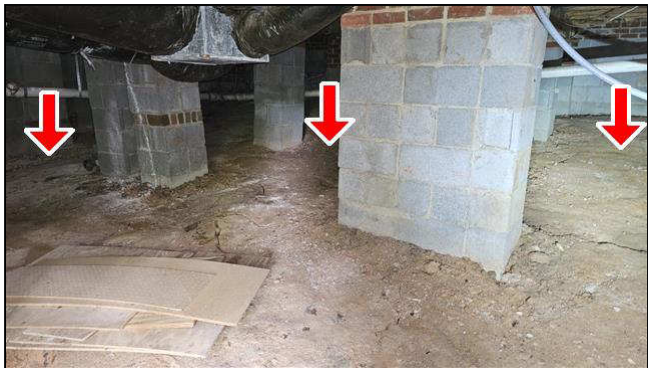
C. Item 1(Picture) throughout crawlspace

The vapor barrier (plastic) on the crawlspace ground is missing. A vapor barrier provides added protection to the floor system from moisture or dampness that can enter from ground. A licensed contractor should inspect and repair as needed.

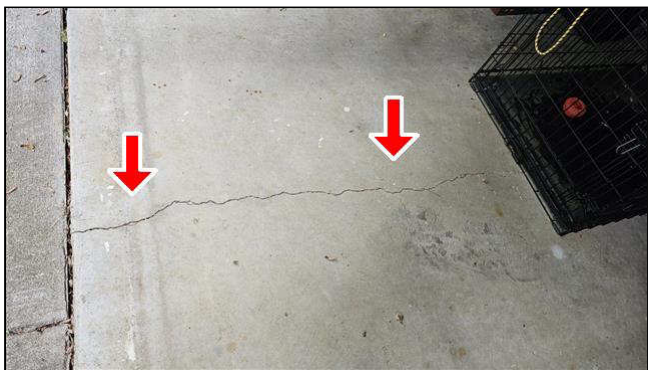
C. Item 1(Picture) garage

(1) The concrete floor of garage is cracked in areas. No displacement was noted. The area should be sealed to prevent water entry which can lead to further damage in colder months. Have a licensed Contractor further review and repair/replace as needed.

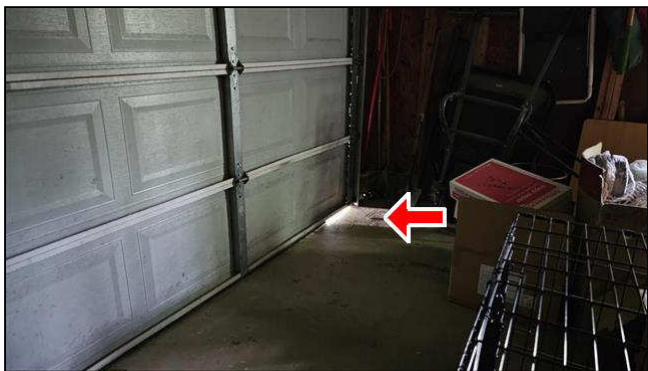
D. Item 1(Picture) garage

The garage door has damaged weather stripping and the door is not fully sealed. This can allow water, insects and rodents an entry point. Have a licensed Contractor further review and repair/replace as needed.

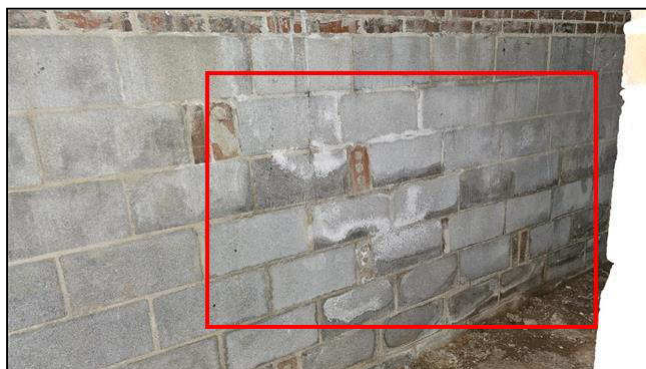
A. Item 1(Picture) front wall under porch

White efflorescence (powder substance) on block wall indicates moisture is in contact with the masonry. This does not necessarily indicate that intrusion will occur. Efflorescence is found on many homes without water intrusion occurring inside the home. But, it should alert you to the possibility that steps may be needed. Have a licensed Contractor with water intrusion experience further review and repair as needed.

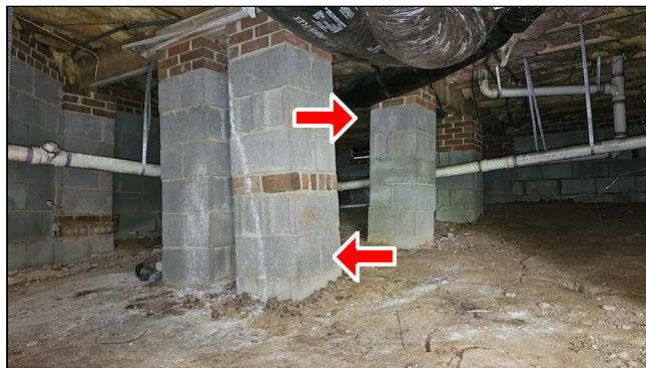
C. Item 1(Picture) under front entry

(1) Support piers were noted to have experienced slight movement and are leaning in the areas of the crawlspace listed below. This reduces the integrity of the piers. Further movement or damage to the piers can cause damage to the floor and walls structures above. Have a Structural Engineer fully review the support piers in the crawlspace and a General Contractor repair or replace as needed.

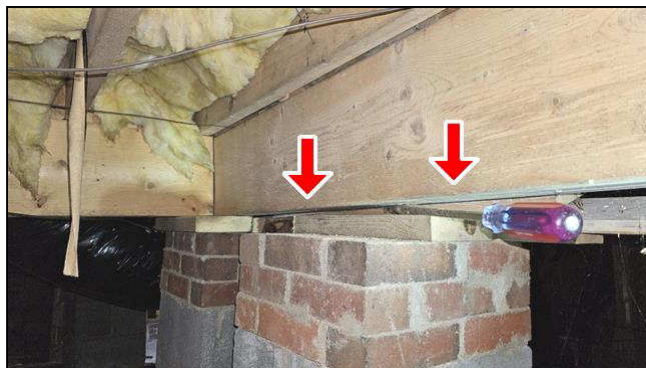
C. Item 2(Picture) under front entry

(2) A gap was noted between the pier and the support girder in the area of the crawlspace listed below. This can allow for movement of the floor structure to occur which can lead to damage to the surrounding areas. Have a Structural Engineer fully review all support piers in the crawlspace and a licensed General Contractor perform all repairs or replacements as needed.

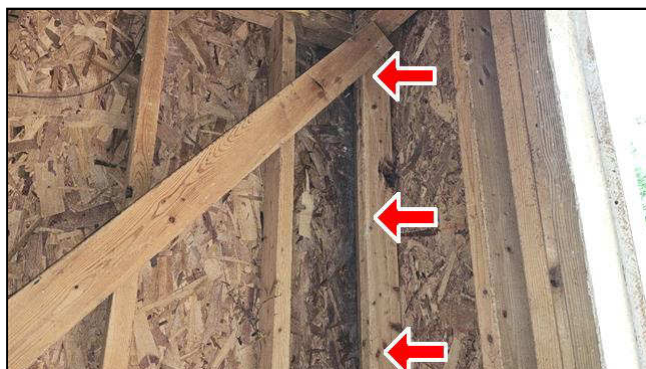
D. Item 1(Picture) rear right corner of crawlspace

(1) Staining/floor damage was noted on the floor structure in the crawlspace in the areas listed below. This is an indication water has leaked in this area. Leaking water can lead to damage to the floor structure. Have a licensed Contractor further review and repair/replace as needed.

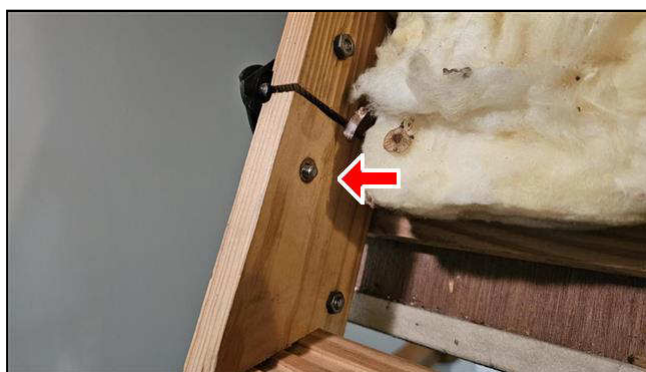
F. Item 1(Picture) pull down attic stairs

(1) The pull down attic stairs were noted to be missing fastening hardware. This reduces the support strength of the stairs and is considered a safety hazard. Have a licensed Contractor review and repair or replace as needed.

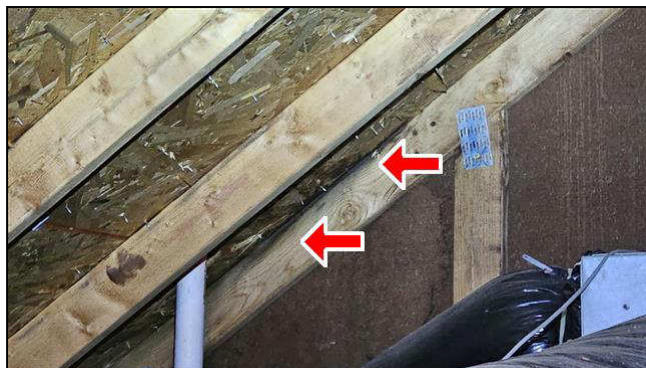
F. Item 3(Picture) rear right roof

(2) The roof sheathing in the areas listed below showed signs of water stain/damage. I could not determine if a leak was active or not. Have a licensed Contractor fully review the roof sheathing and repair/replace as needed.

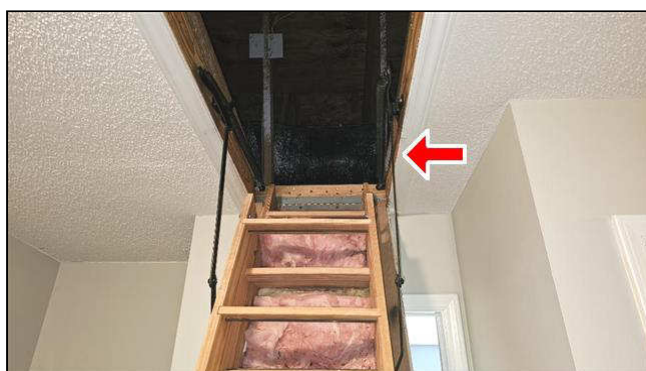
F. Item 4(Picture) pull down attic stairs

(3) The pull down attic stairs control arm was noted to be damaged in the area listed below. This reduces the integrity of the arm and can lead to damage or failure of the attic stairs. This is considered a safety hazard that could result in injury. Have a licensed Contractor further review and repair or replace as needed

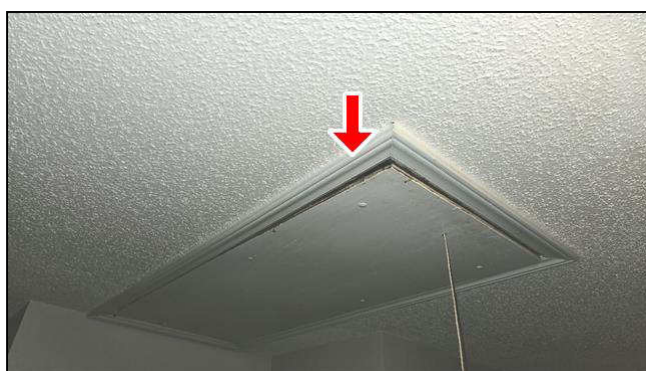
F. Item 5(Picture) pull down attic stairs

(4) The pull down attic stairs did not fully seal when closed. This allow conditioned air to escape into the attic space and reduces the energy efficiency of the home. Have a licensed Contractor review and repair or replace as needed.
