Fox Den Home Inspections  
204 Aspen Avenue  
Elon NC 27244

## Confidential Inspection Report

3649 Guess Road  
Durham NC 27705

**Inspected by:  
Michael Fields  
NC License #3674**

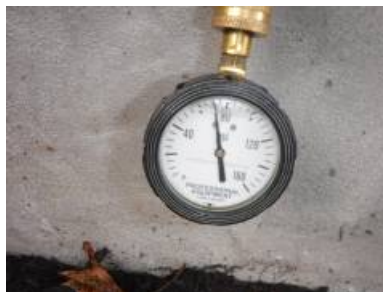
7.1 Pressure:

Water pressure around 40 to 80 pounds per square inch is considered normal. The pressure was noted at 71 PSI.
