# Inspection Report

938 N Gayoso St  
New Orleans, LA 70119

**Inspection Date:**  
Monday, December 1, 2025

RE: Report No. 19955  
938 N Gayoso St  
New Orleans, LA  
70119

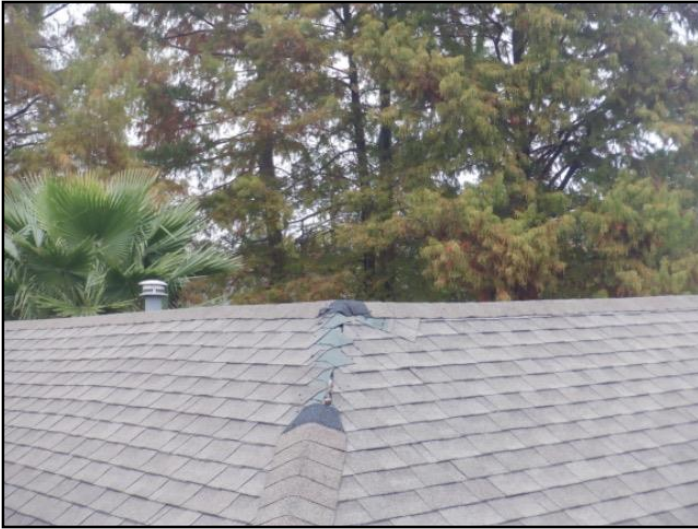
**Condition:** • [Missing, loose or torn](#)

*Missing, loose or torn*

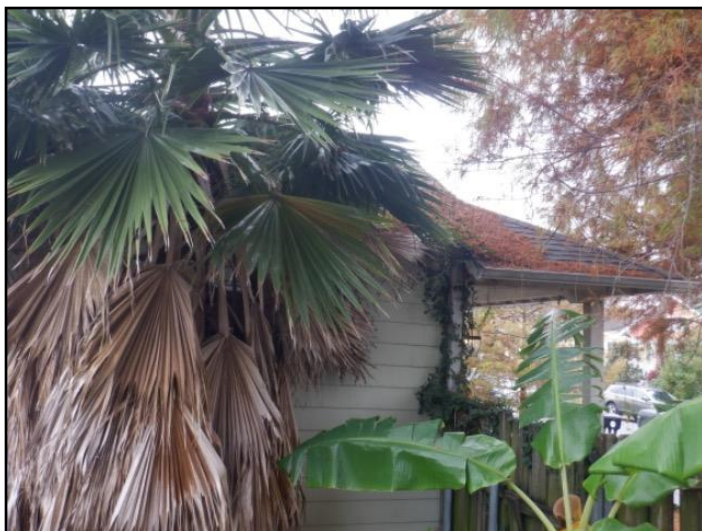
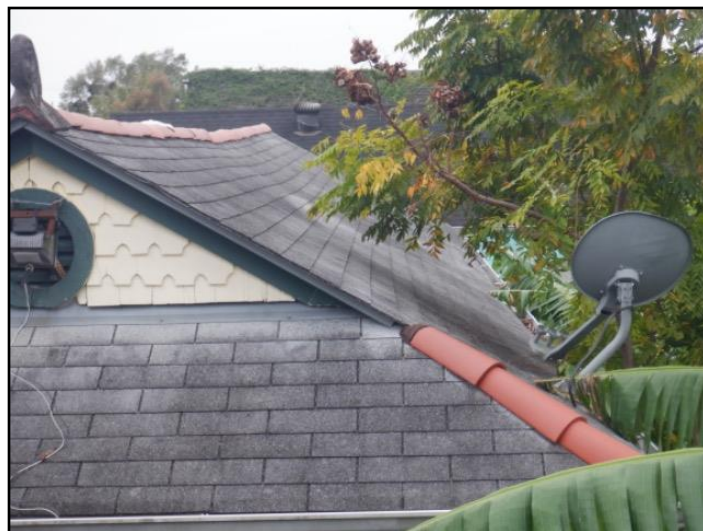
*Tree branches touching roof*

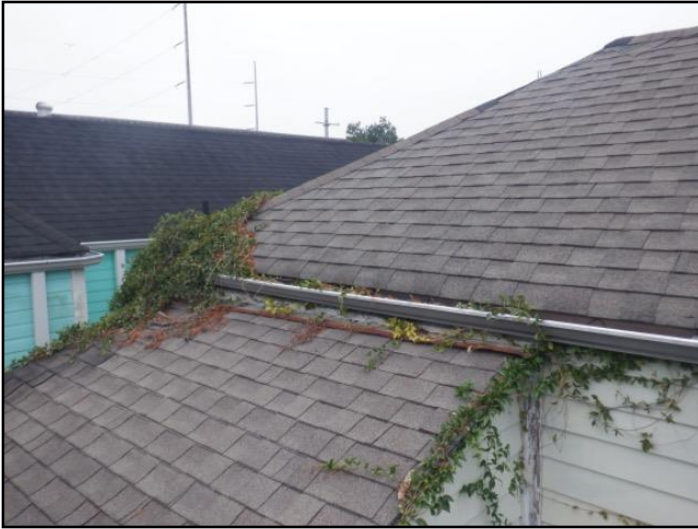
**Condition:** • Vines on roof covering

*Vines on roof covering*

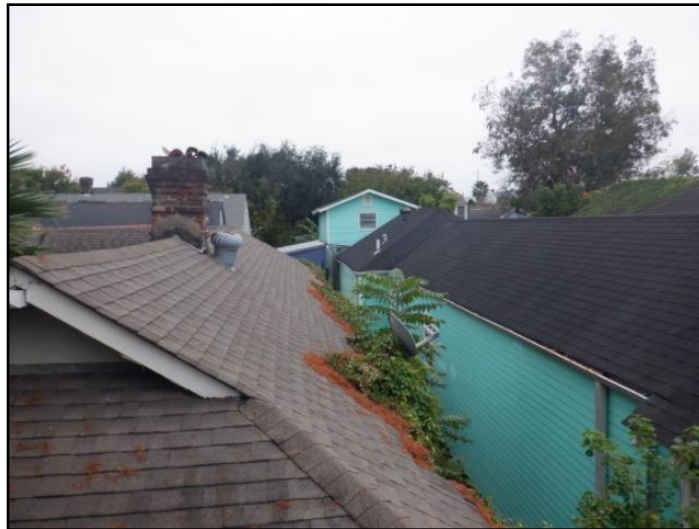
*Satellite TV dish attached to the roof...*

**Task:** Remove if not in use. Improve location if possible. Monitor for leakage or damage.

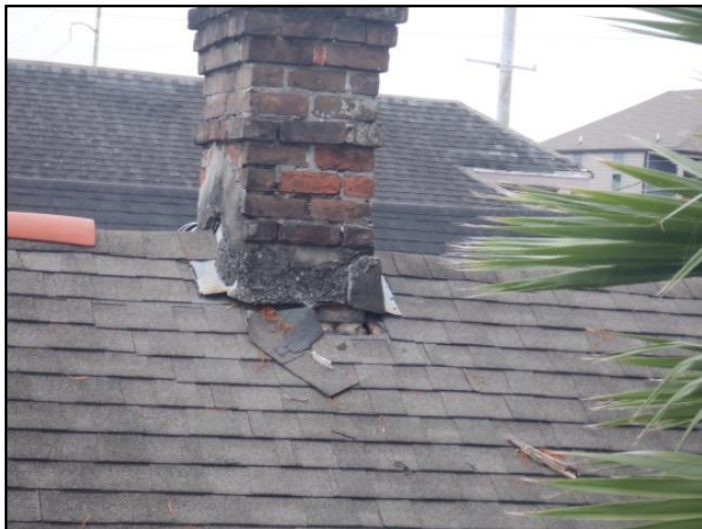
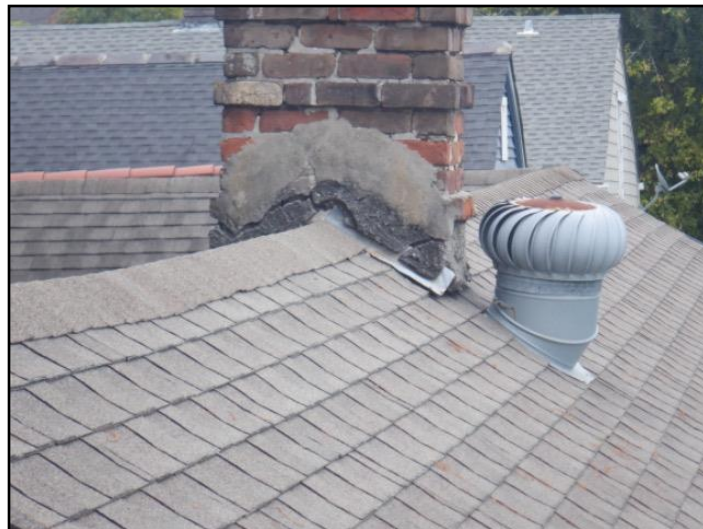
*Not let into mortar joints*

**Task:** Correct.

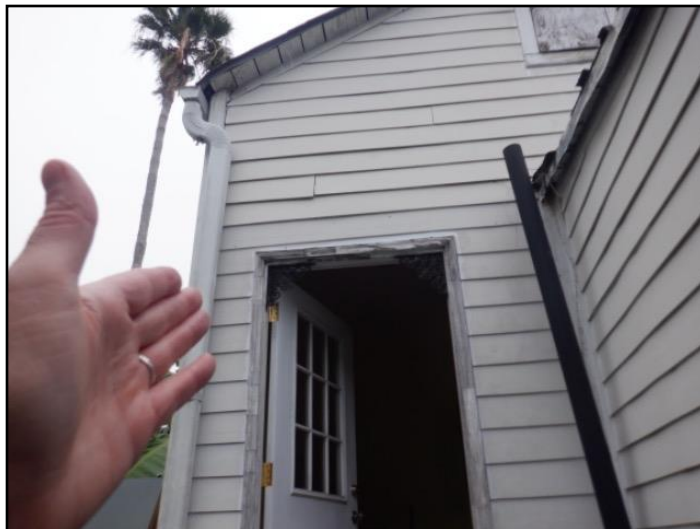
**Condition:** • Doors are susceptible to water intrusion when no roof overhang or awning is present. One is recommended wherever missing for improved water control and weatherproofing.

*Doors are susceptible to water intrusion...*

**Task:** Repair.

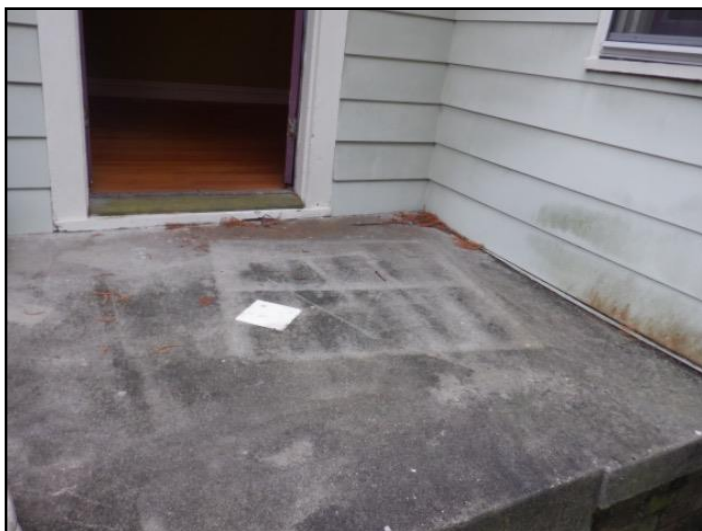
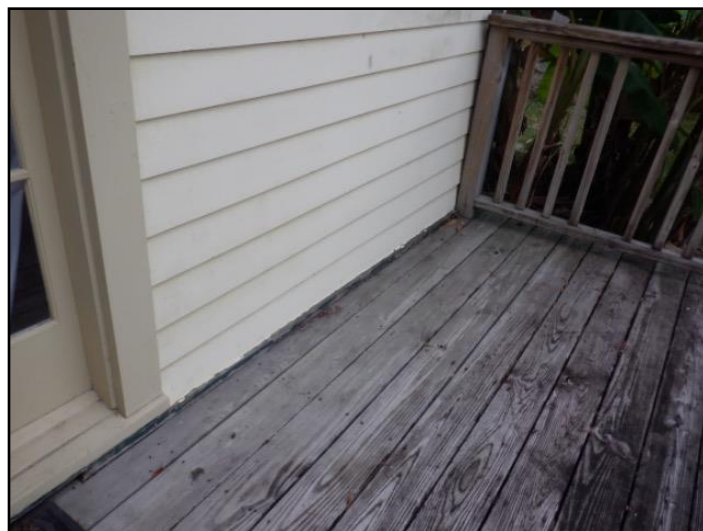
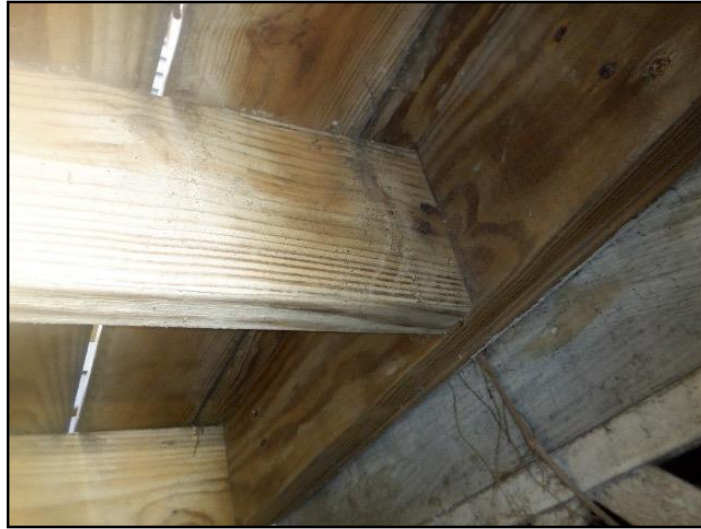
**Condition:** • Missing flashing at deck/porch connection

There should be flashing that tucks up under and behind the siding, and comes down over the auxiliary structures that connect to the exterior walls. This prevents water from entering behind this connection, which can cause water intrusion to the interior and damage to the structure. See illustration for further clarification. A trim piece or improving seals at this area are a similar remedy if flashing installation is not feasible.

Missing flashing at deck/porch connection

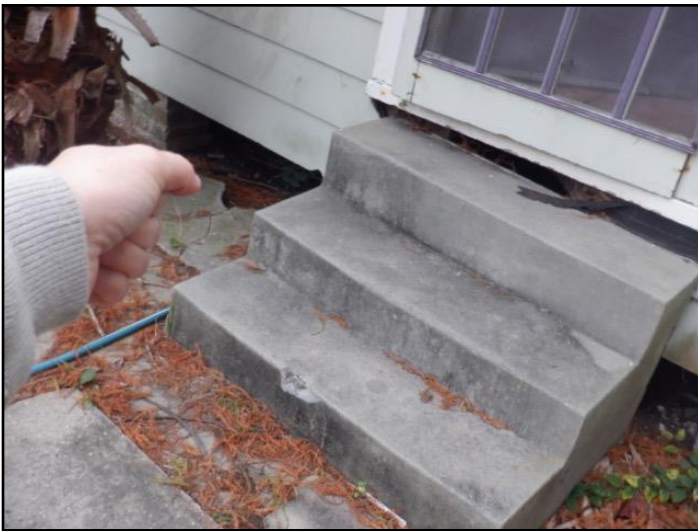
**Condition:** • Missing stair handrail

Steps with four or more risers or rising more than 30 inches in height should have a handrail installed along one side for safety. Railings should be sturdy enough to resist a person's weight and balusters spaced no more than 4". Railings should not be loose or climbable, and should be high enough to provide adequate protection; 36 inches is common. Stair hand railings should be graspable; a 2x4 is not adequate.

Missing stair handrail

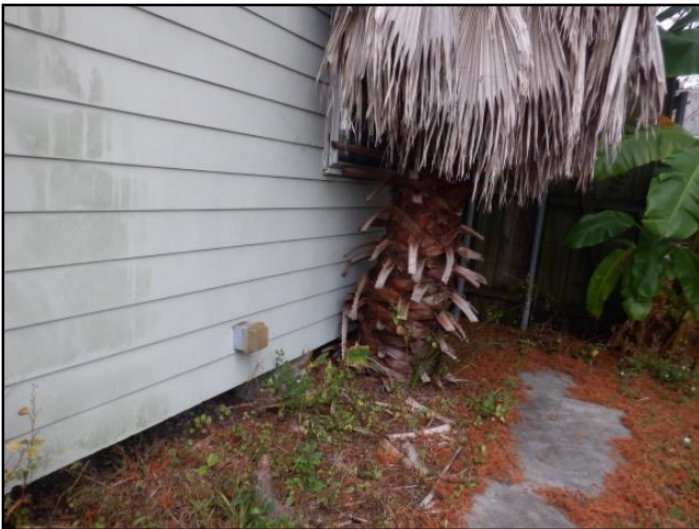
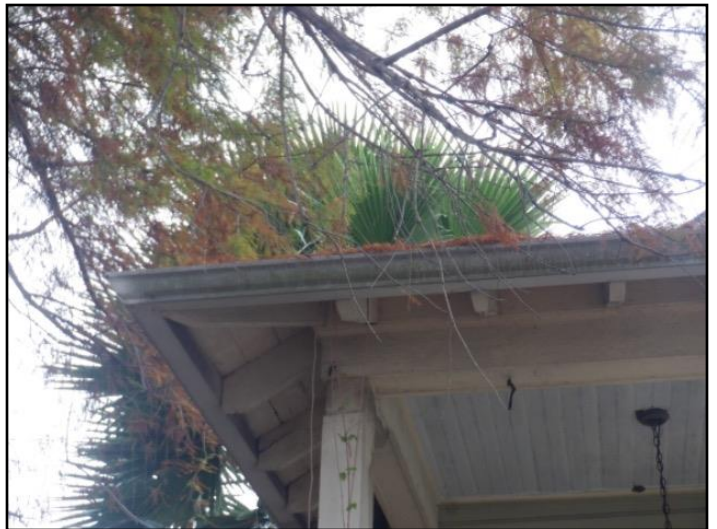
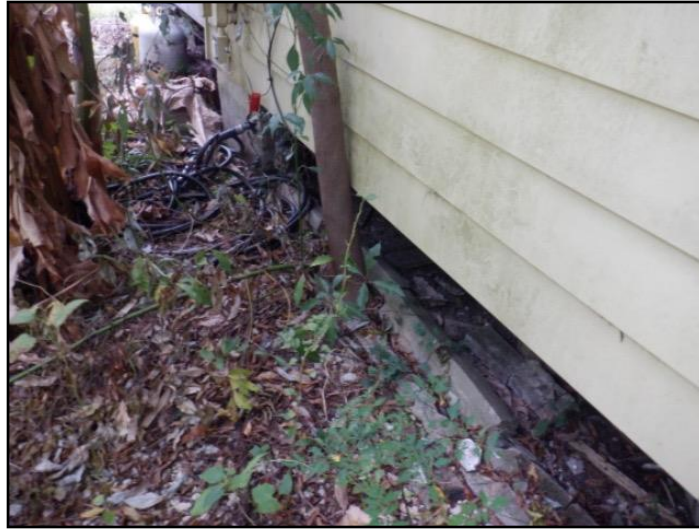
Trees and branches overhang or touch roof and prevent proper drying, increases the chance of moisture damage. Branches can also damage siding and provide an access point for pests.

*Trees or shrubs too close to building*

**Task:** Trim back trees from over roof and walls.

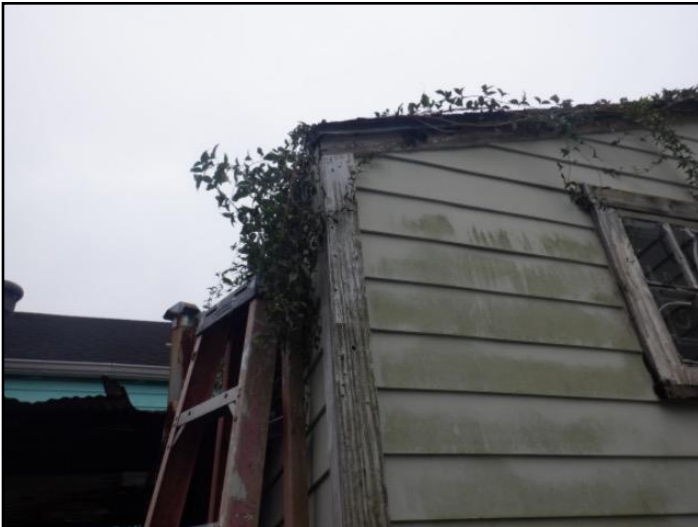
**Condition:** • Vines can damage siding by trapping moisture and reduce drying potential. Excess moisture leads to material deterioration . Vine roots can also damage paint and create a path for insect and water penetration. Vines should be kept away from all trim, including doors, windows, soffits, and fascia. They should also be kept off of gutters, roofs and masonry.

Extensive vine growth noted.

*Vines can damage siding by trapping moistur...*

**Task:** Remove.

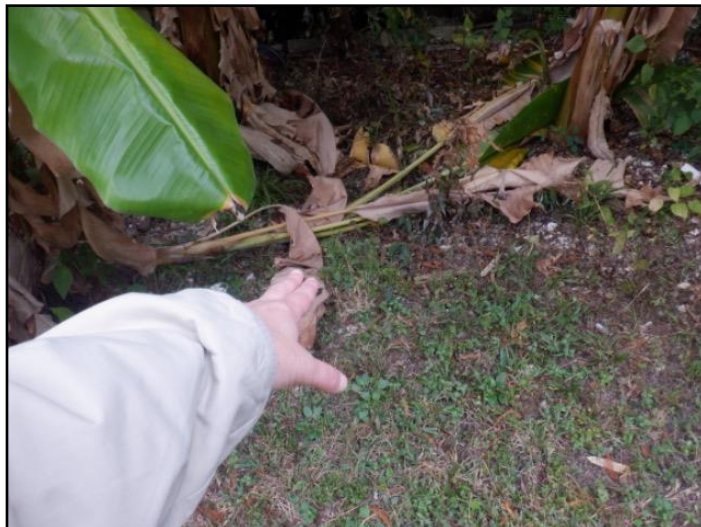
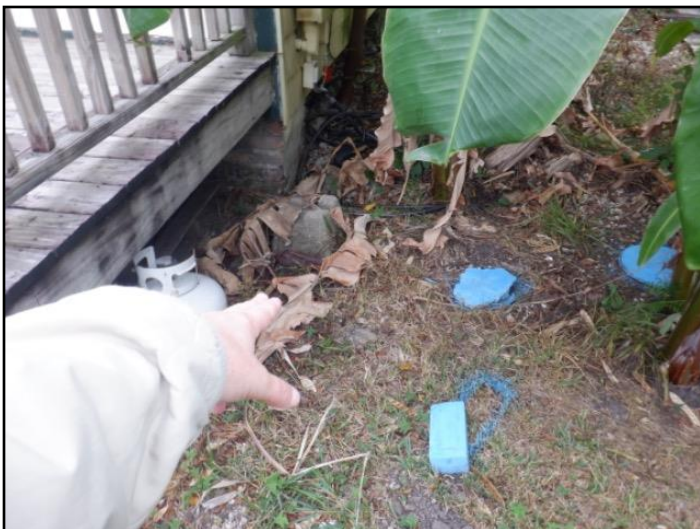
**Condition:** • Improper slope or drainage

Ground that slopes toward the house can funnel surface water from rain against the foundation slab or piers. This can lead to undermining of the foundation, sinkholes and/or standing water. The ground should slope down away from the building.

*Improper slope or drainage*

**Task:** Improve.

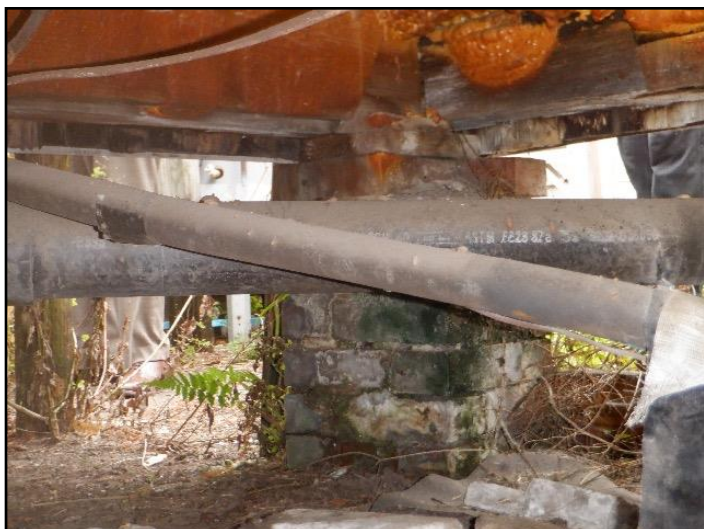
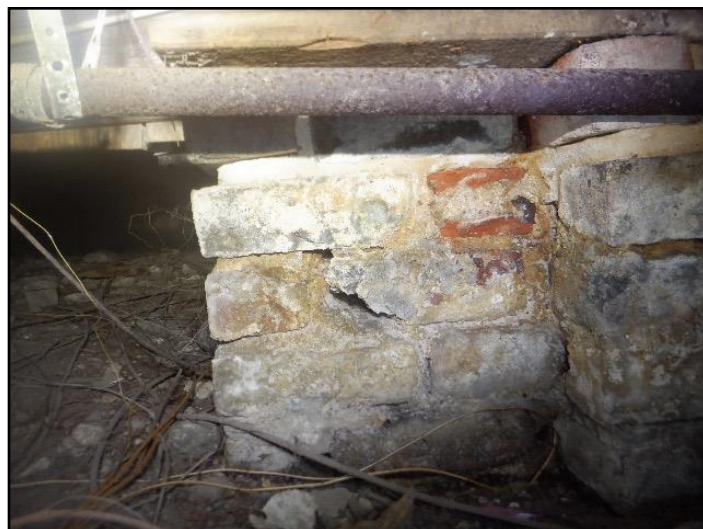
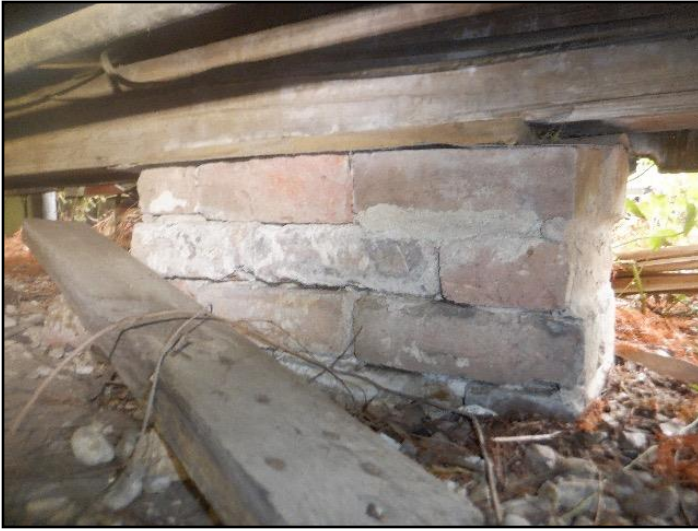
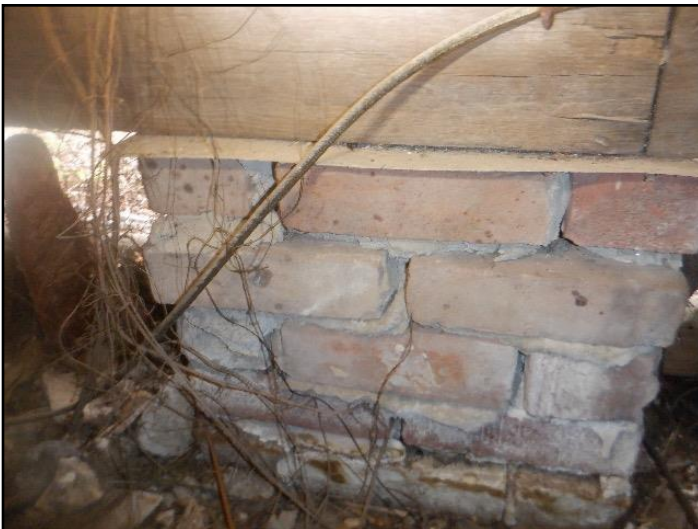
**Condition:** • Mortar and/or brick deterioration

*Mortar and/or brick deterioration*

**Task:** Repair

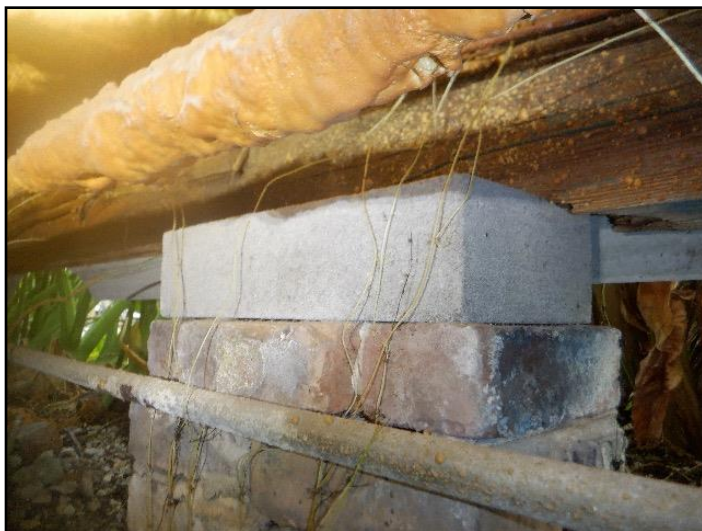
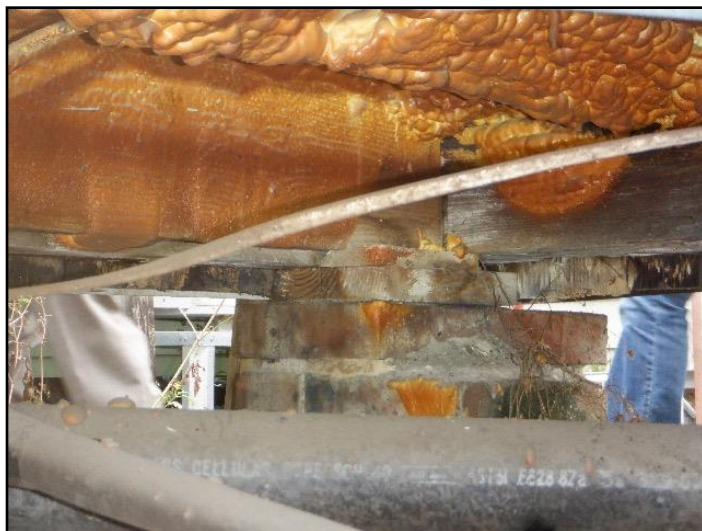
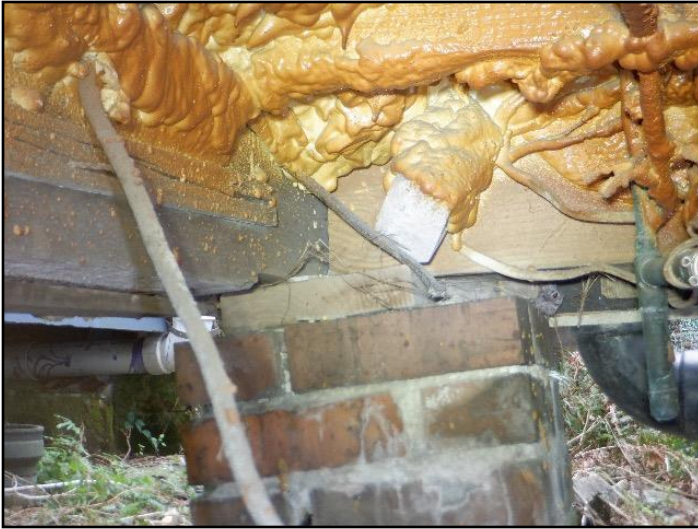
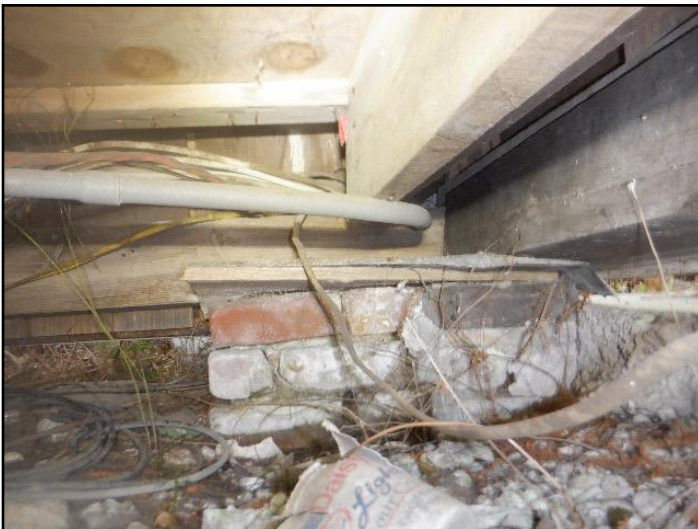
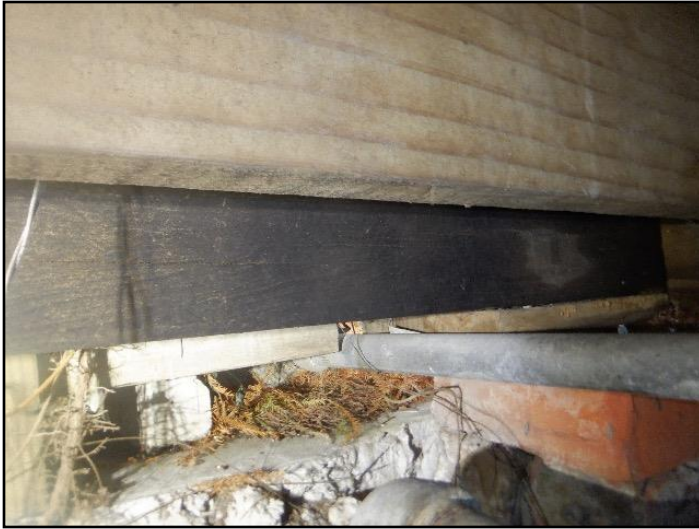
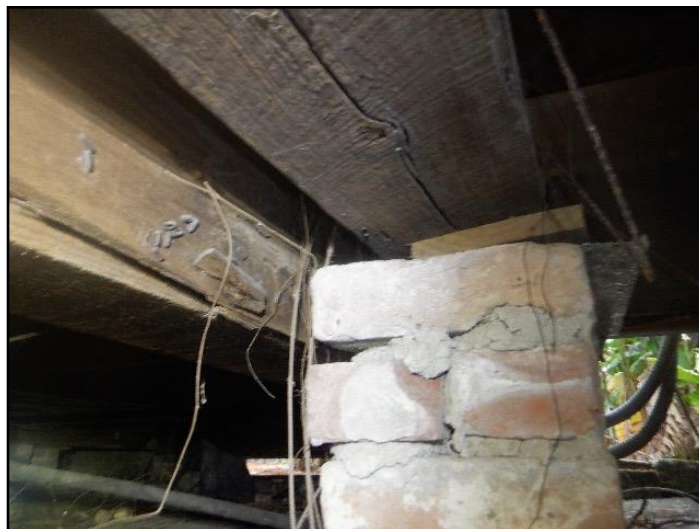
**Condition:** • Excessive, or improper shims

Shims should have full bearing on both the sill and pier. Inadequately sized shims will cause concentrated loads on structural members and may cause damage or movement. Shims should be made of a non-compressible material such as metal, masonry, hard plastics, slate, or fiber cement. No more than one to two shims should be used with a maximum total depth of two inches.

Excessive, or improper shims

*Excessive, or improper shims*

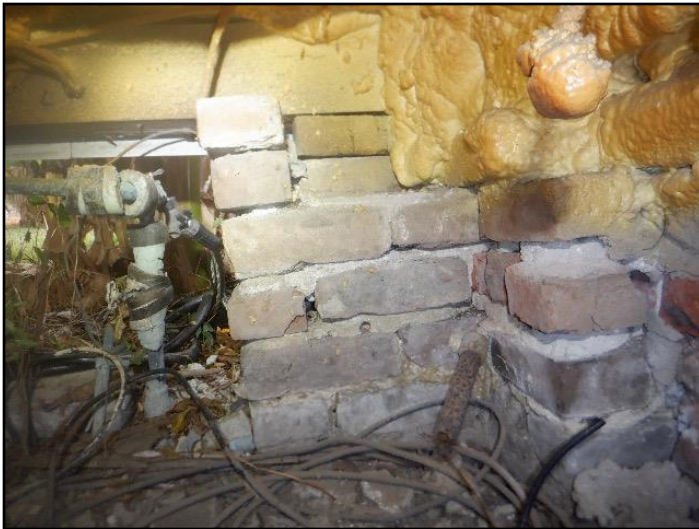
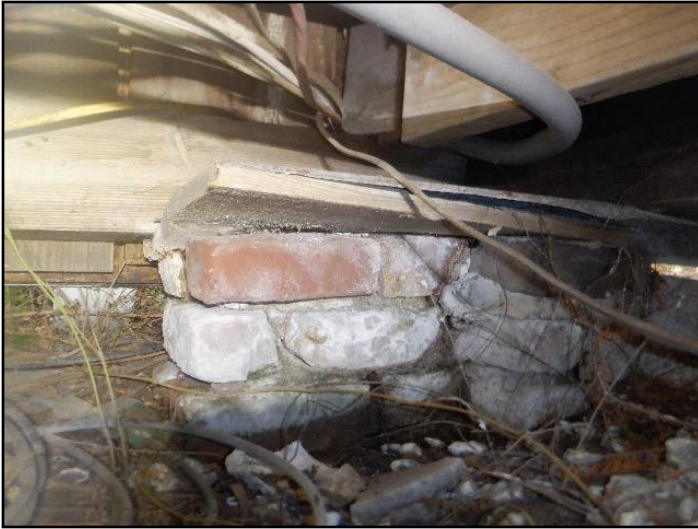
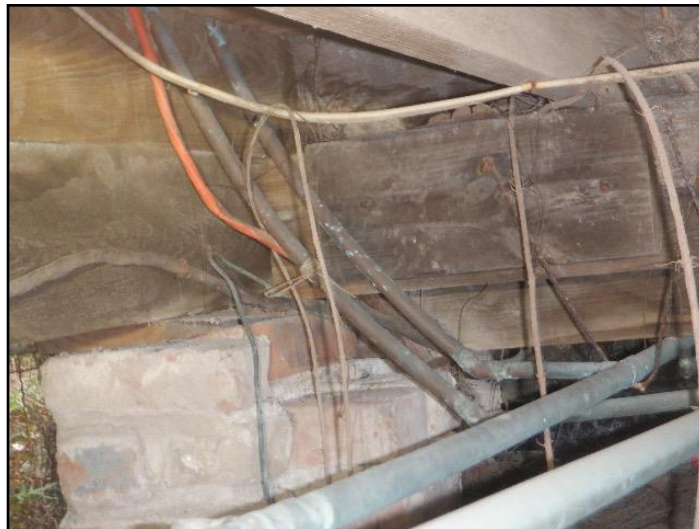
**Condition:** • Loose or missing brick or block

Loose or missing brick or block

*Loose or missing brick or block*

**Task:** Repair or replace.

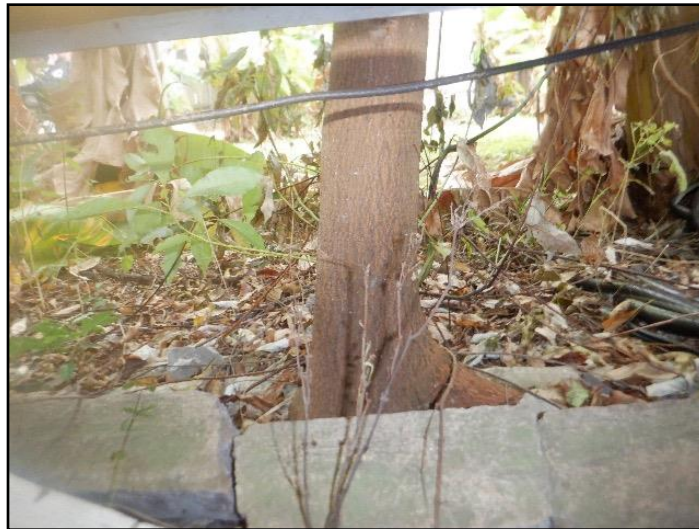
**Condition:** • [Large trees close to building](#)

*Large trees close to building*

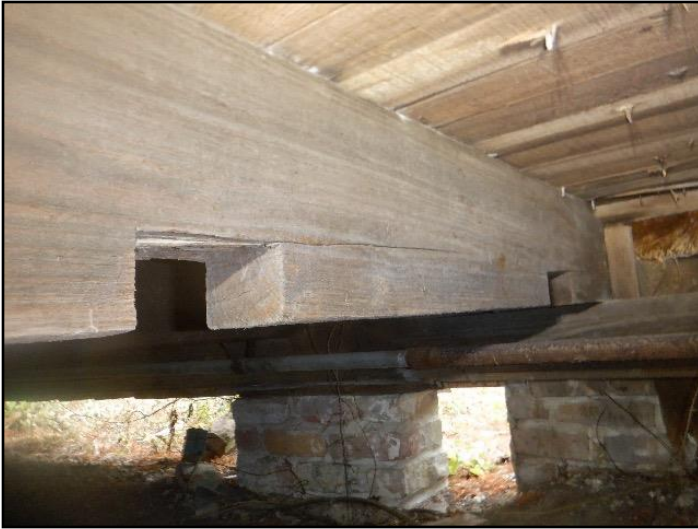
**Condition:** • [Split or damaged](#)

*Split or damaged*

**Task:** Repair.

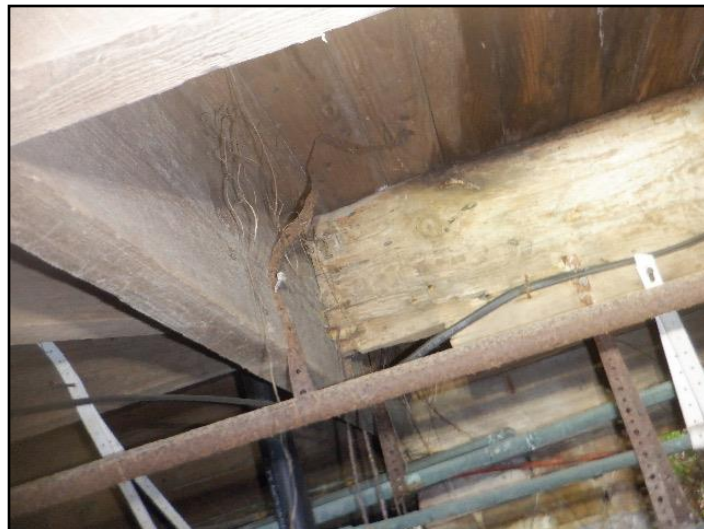
**Condition:** • Missing joist hangers

Joist hangers recommended at all box out connections, when joists are installed flush to adjacent framing without end bearing, or excessive notches.

*Missing joist hangers*

**Task:** Install.

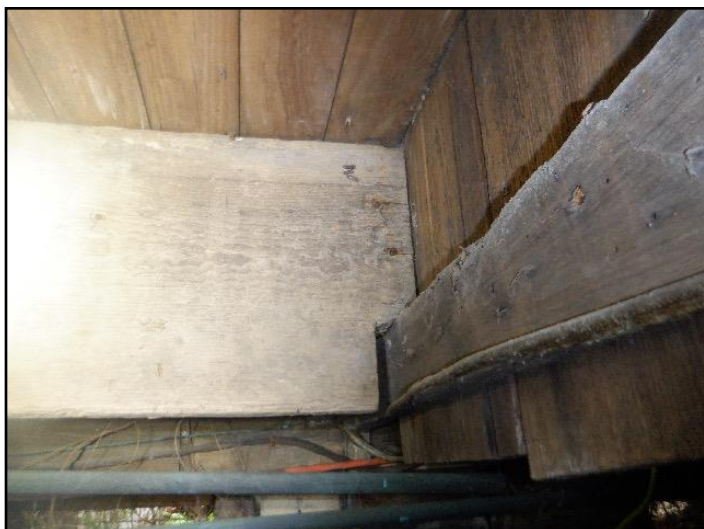
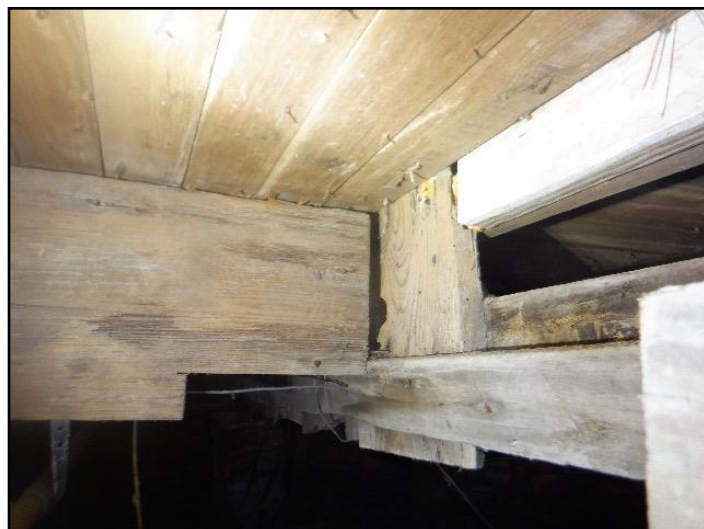
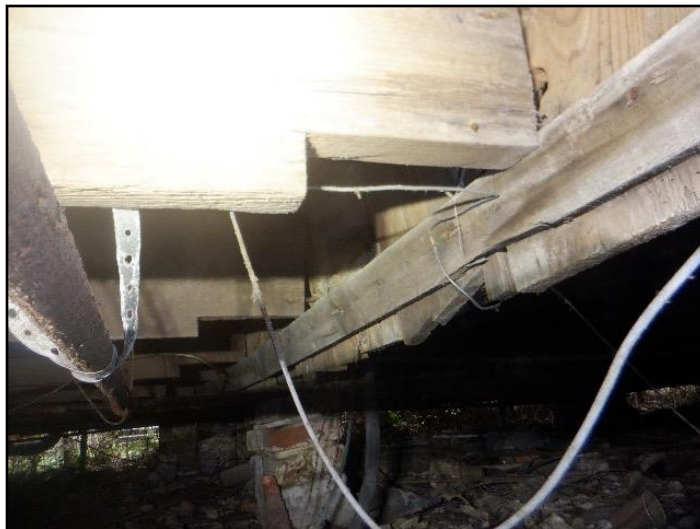
**Condition:** • Inadequate end bearing

Joists are resting on ledger that is loosely nailed to barge boards that are loose and not securely connected to framing.

**Location:** Middle Main building Crawl Space

*Inadequate end bearing*

**Task:** Correct.

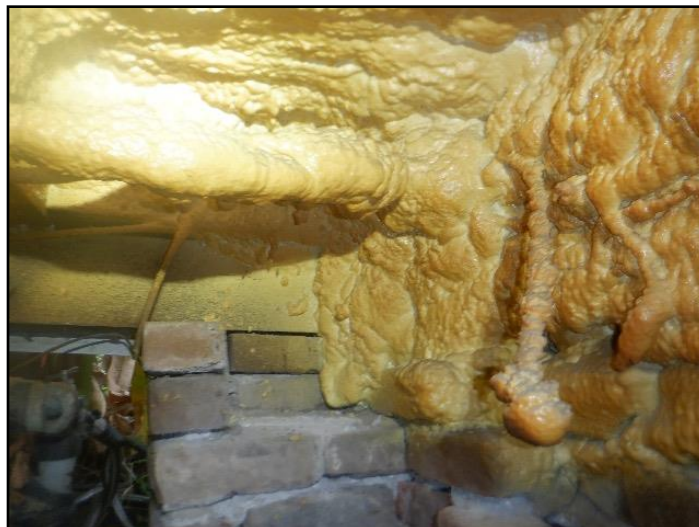
- Entered but access was limited
- Crawlspace insulation severely limited inspection of the foundation support and floor structure.

*Crawlspace insulation severely limited...*

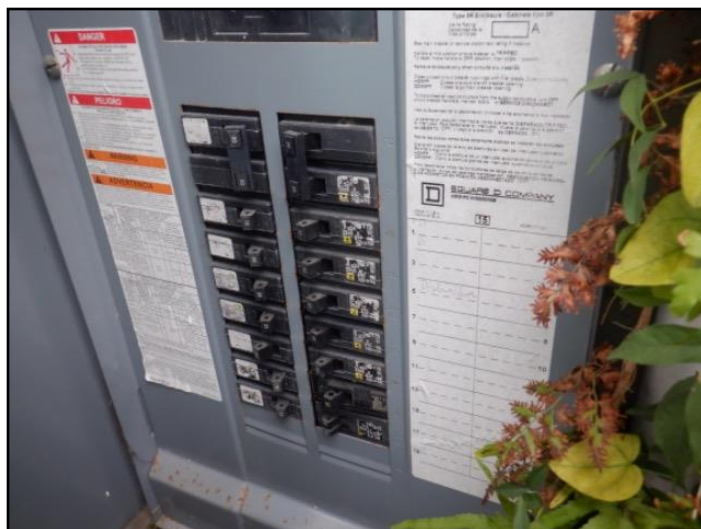
**Condition:** • [Circuits not labeled](#)

Circuits not labeled

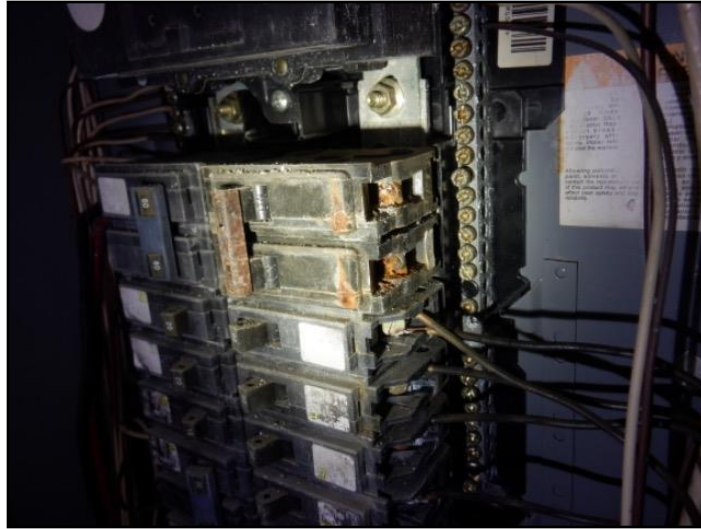
**Condition:** • [Rust or water in panel](#)

**Location:** rear building

*Rust or water in panel*

**Task:** Correct.

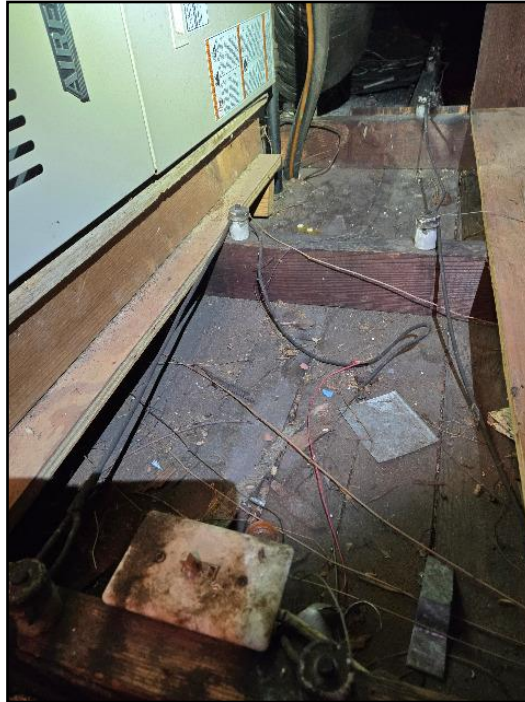
**Condition:** • Inactive knob and tube wires found

Inactive knob and tube wires found. Though disconnected, all abandoned wires should be completely removed to ensure the wiring is never put back into service.

*Inactive knob and tube wires found*

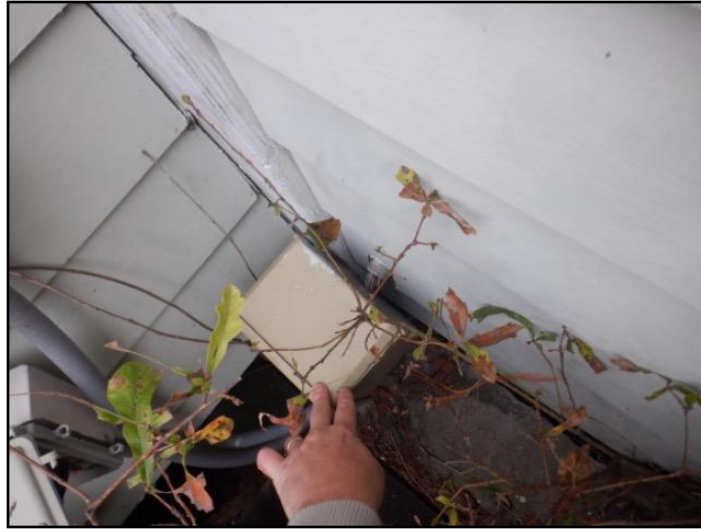
**Condition:** • Loose conduit, exposed wire

*Loose conduit, exposed wire*

**Task:** repair

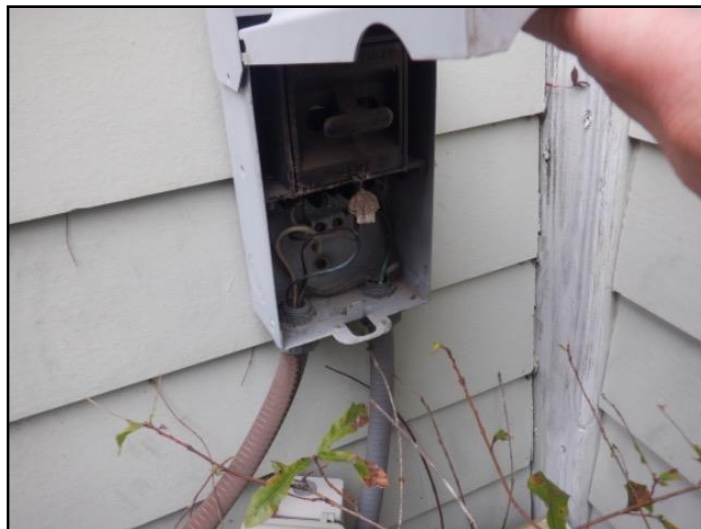
**Condition:** • Cover loose or missing

Cover missing on junction box(s), exposed, live wiring. Electrical connections should be in closed junction boxes.

**Location:** ac shutoff

*Cover loose or missing*

**Task:** Correct.

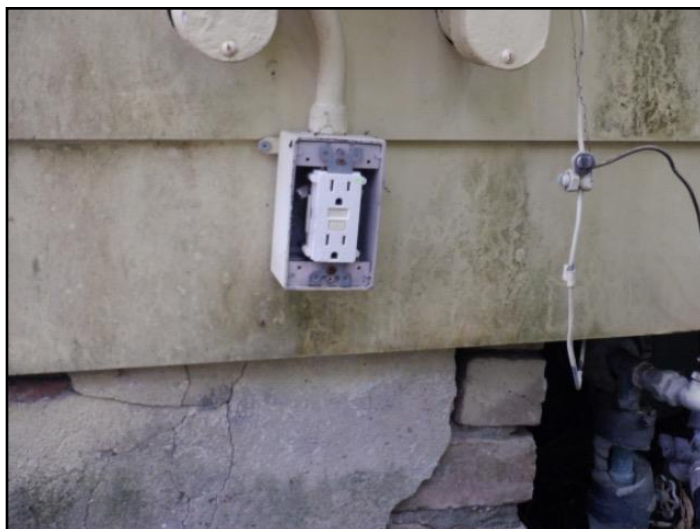
**Condition:** • Exterior outlet missing weather cover

**Location:** Rear building

*Exterior outlet missing weather cover*

**Task:** Repair.

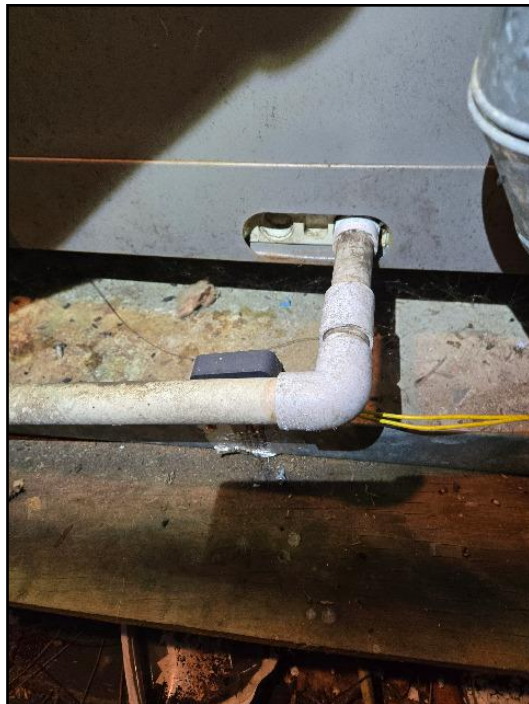
**Condition:** • There is a float switch installed on the drain pan, which will shut the system off if the secondary drain line is clogged and/or the drain pan fills with water. However, there is no safety switch installed on the primary drain line. This is will shut the system off if the primary drain line becomes clogged.

*No safety switch*

**Task:** Install

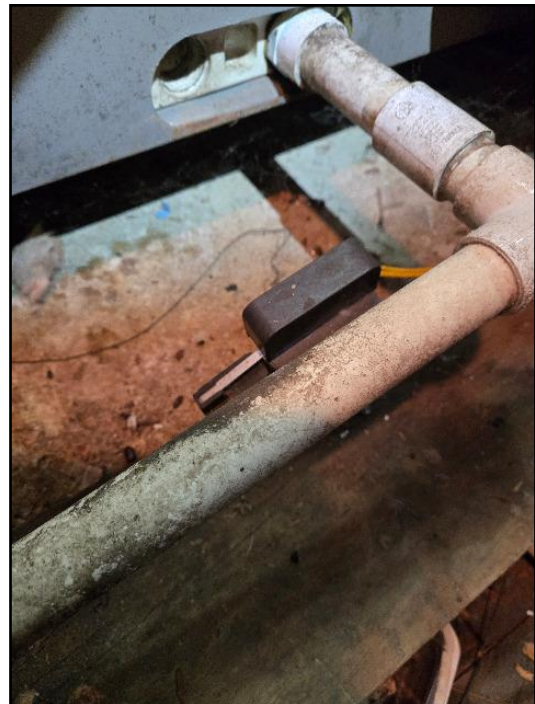
*There is a float switch installed on the...*

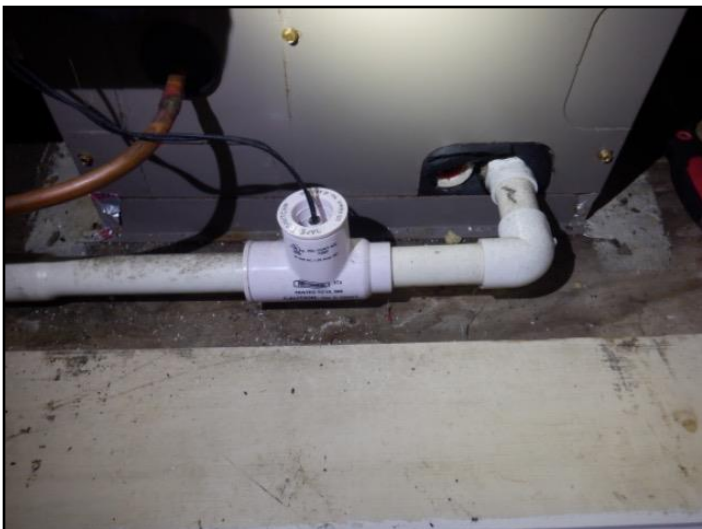
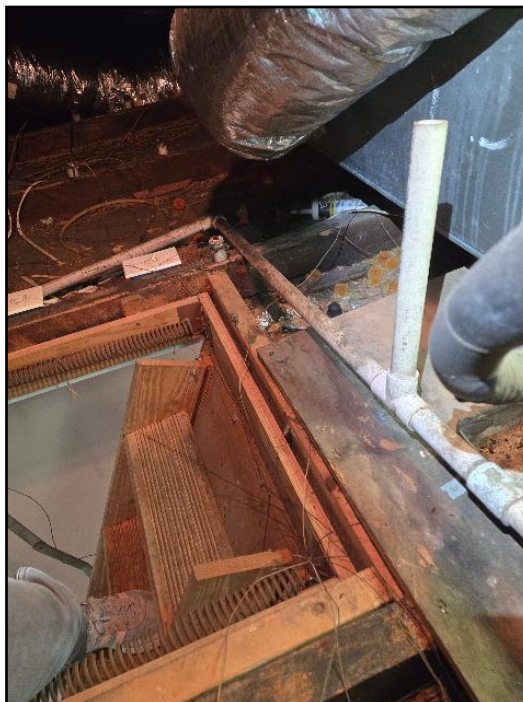
**Condition:** • Line not insulated

*Line not insulated*

**Task:** Correct

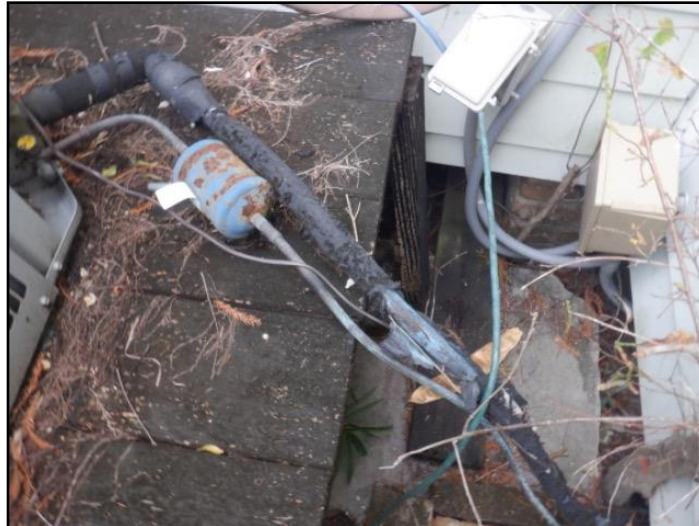
Condition: • Old and/or damaged insulation

*Old and/or damaged insulation*

**Task:** Repair.

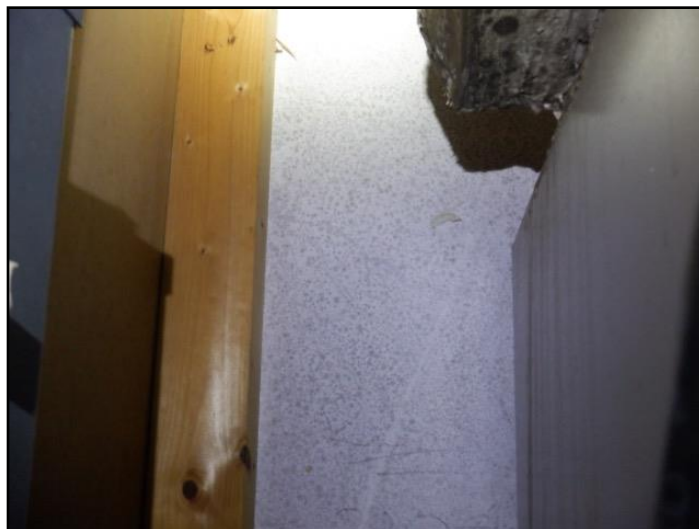
Elevated moisture/possible mold in the furnace closet or air return. Furnace closets and air returns are highly conducive to condensation and possible mold growth. The closets are typically enclosed spaces that are not well ventilated, where warm unconditioned air inside the closet interacts with cold air conditioning components, such as the evaporator coil, ductwork, condensate drains, and refrigerant lines. Air leaks, missing insulation around condensate/refrigerant lines, or a leak at the evaporator coil or condensate drain line can also cause elevated moisture, water intrusion, and possible mold.

*Moisture/mold in closet or air return*

**Task:** Improve. Clean or remediate as needed. Possibility of hidden mold growth - See Appendix.

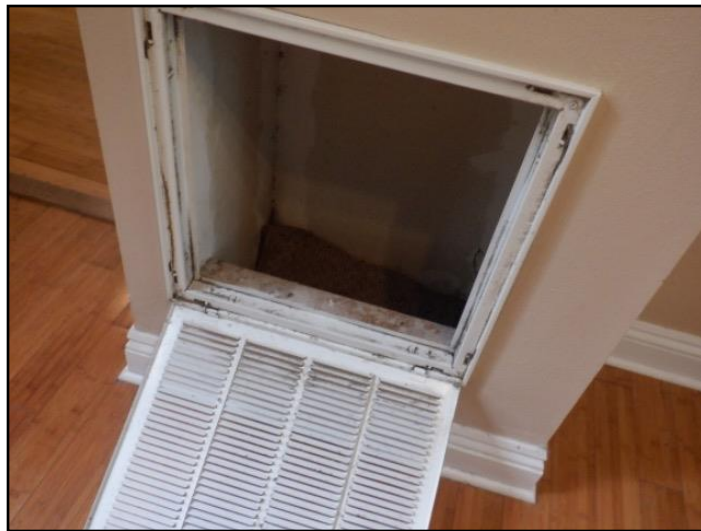
**Condition:** • Filter missing, wrong size or collapsed

*Filter missing, wrong size or collapsed*

**Task:** Install.

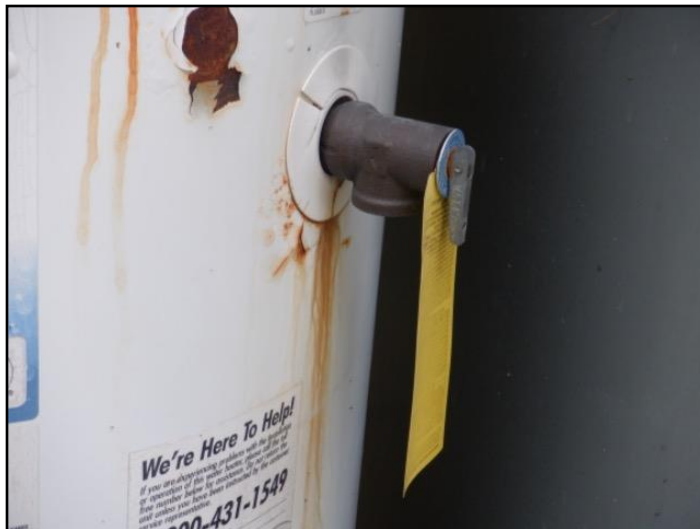
**Condition:** • [Discharge tube missing](#)

TPR valve releases hot water if there is too much pressure in the tank or the water is too hot. The discharge tube provides a safe place for water to discharge from the tank without causing a possible scalding injury or damage to the structure. The discharge tube should not discharge more than 6 inches away from the ground directed downward.

**Location:** rear building

*Discharge tube missing*

**Task:** Install.

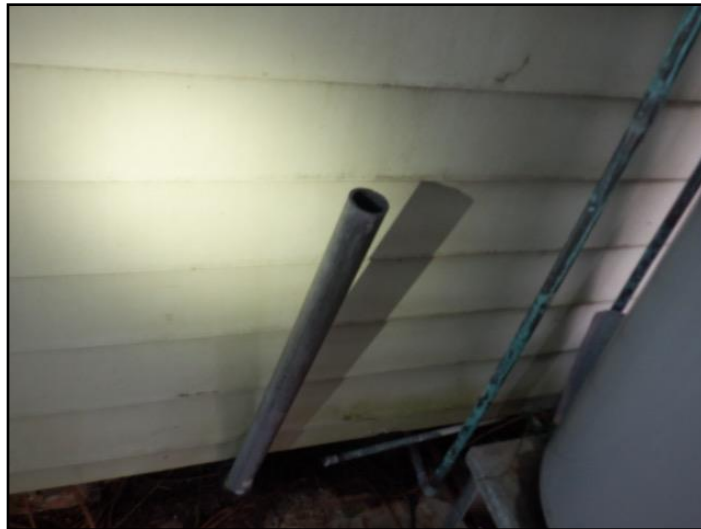
**Condition:** • The vent terminates too low

**Location:** rear exterior

*The vent terminates too low*

It is recommended that plumbing vents terminate above the roofline.

**Task:** Correct.

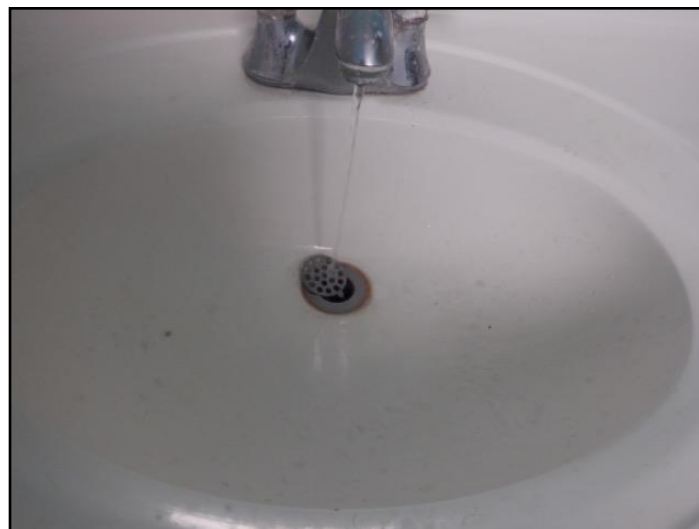
**Condition:** • Drain stop missing/ineffective

**Location:** main house bathroom

*Drain stop missing/ineffective*

**Task:** Remedy.

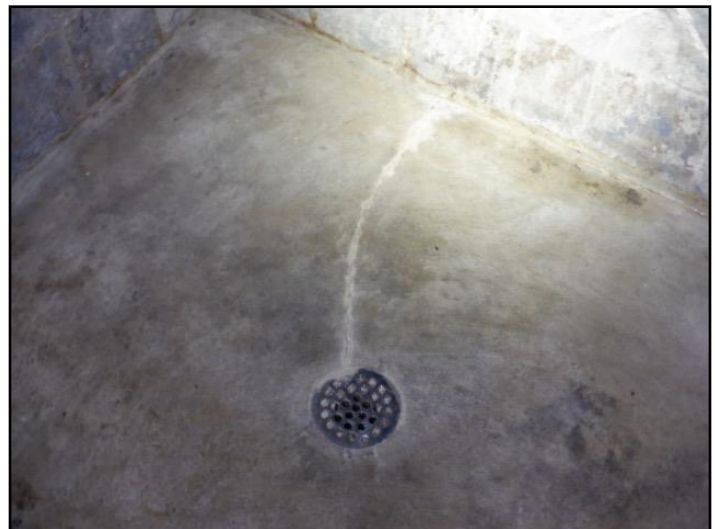
**Condition:** • Grout/caulk loose, missing or deteriorated

*Grout/caulk loose, missing or deteriorated*

**Task:** Repair. Seal.

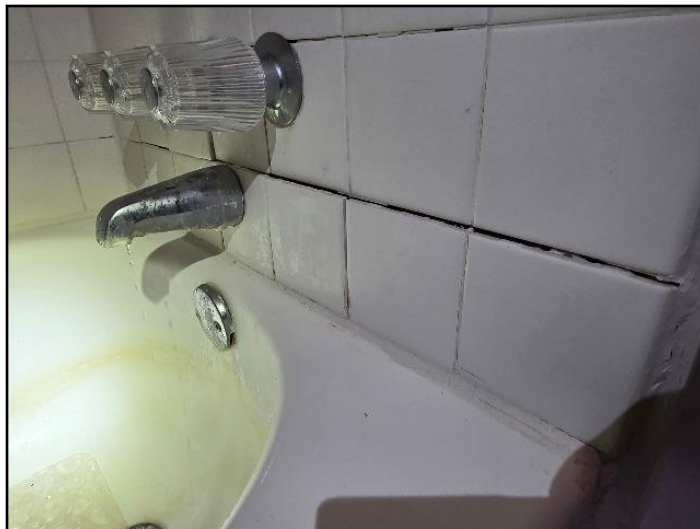
**Condition:** • Tile loose, cracked or missing

*Tile loose, cracked or missing*

**Task:** Repair or replace.
