# Inspection Report

938 N Gayoso St  
New Orleans, LA 70119

**Inspection Date:**  
Monday, December 1, 2025

RE: Report No. 19955  
938 N Gayoso St  
New Orleans, LA  
70119

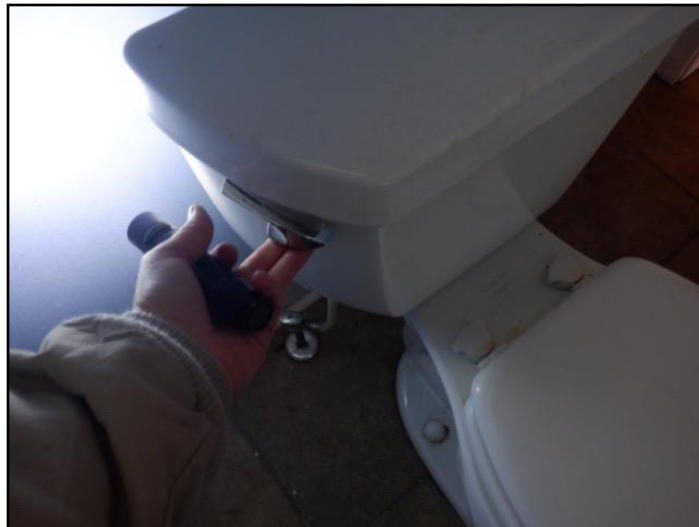
**Condition:** • Flush handle loose

**Location:** Main Building Bathroom

*Flush handle loose*

**Task:** Repair.

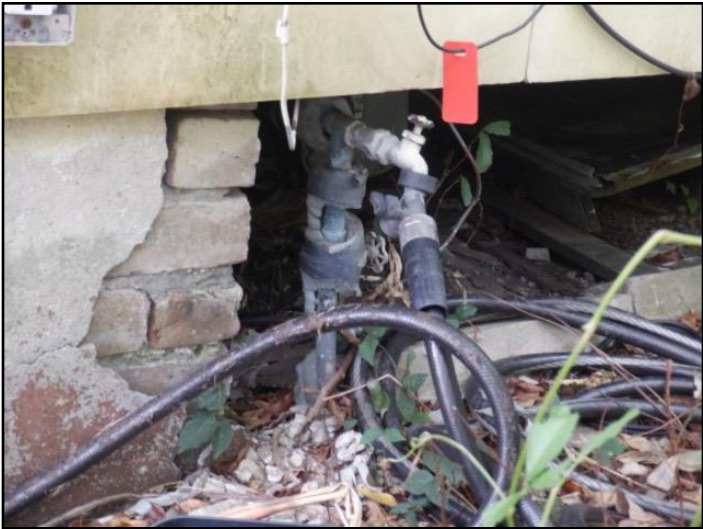
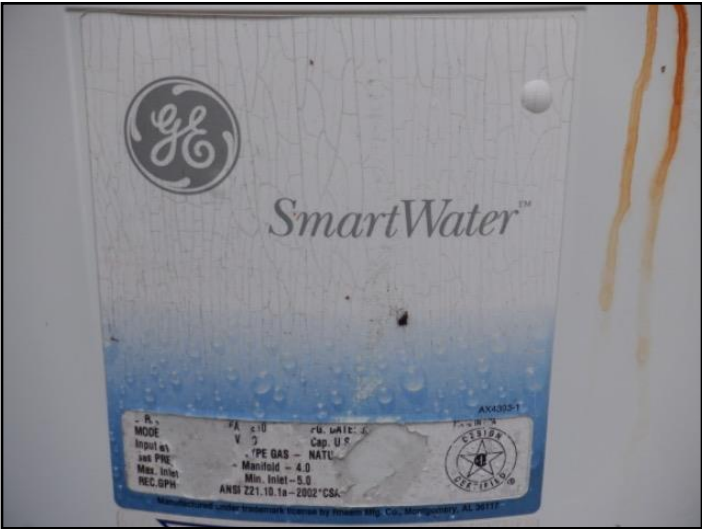
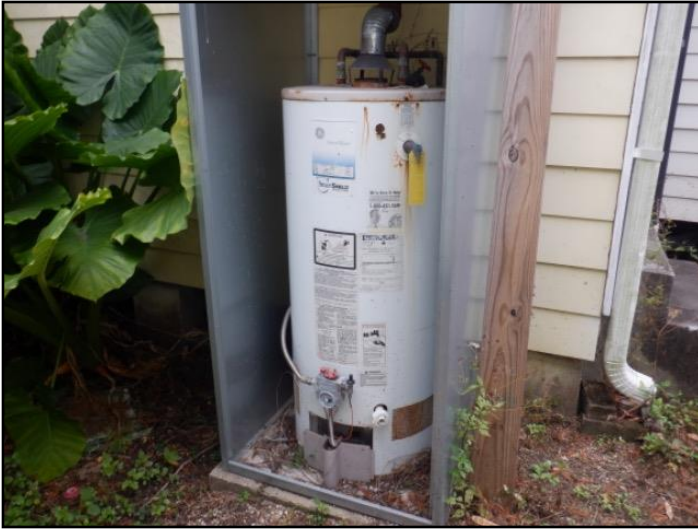
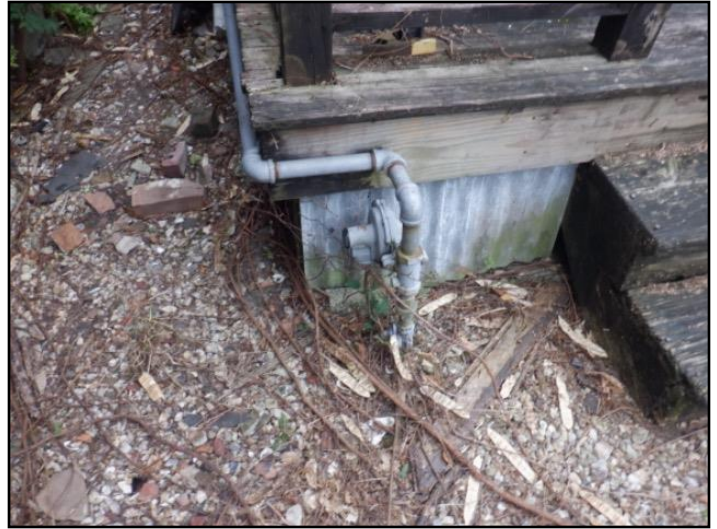
General View of Plumbing System

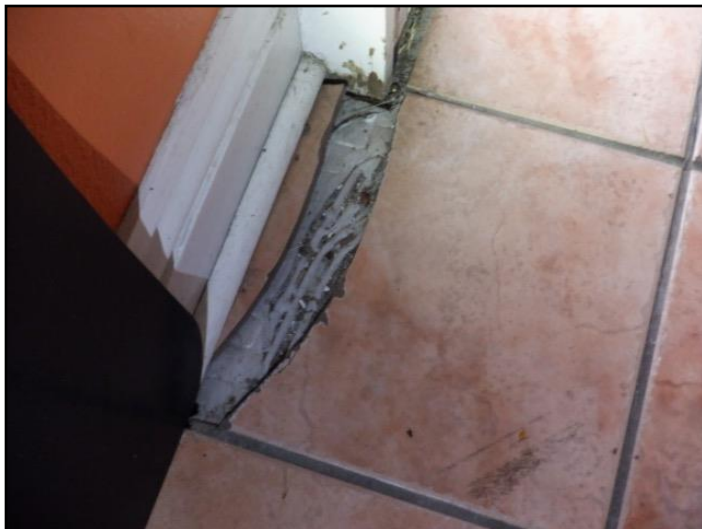
**Condition:** • Tiles/grout loose cracked, broken, or missing

*Tiles/grout loose cracked, broken, or missing*

**Task:** Repair or replace.

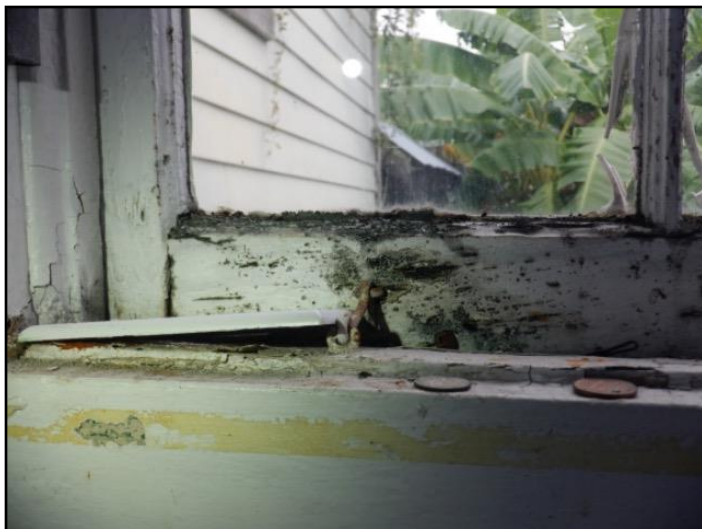
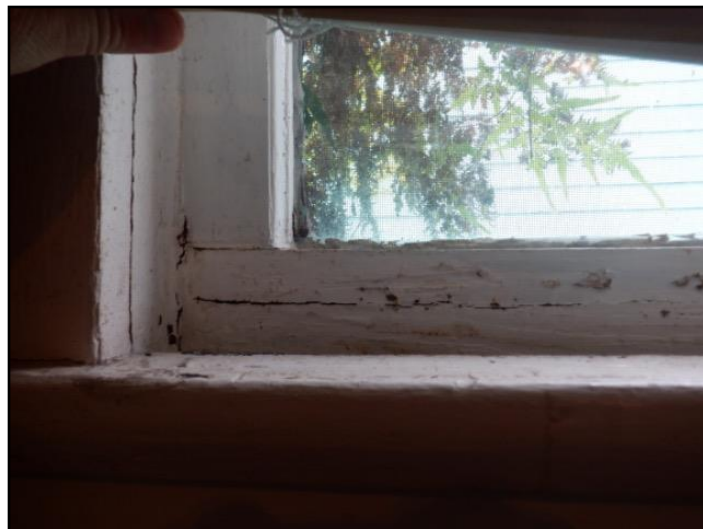
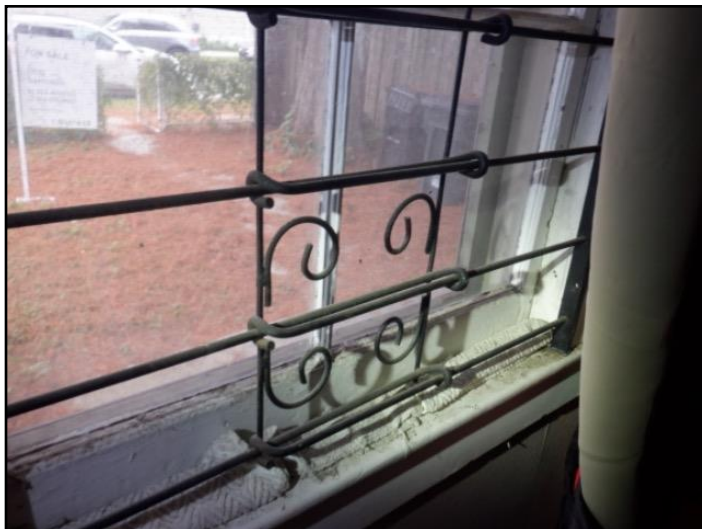
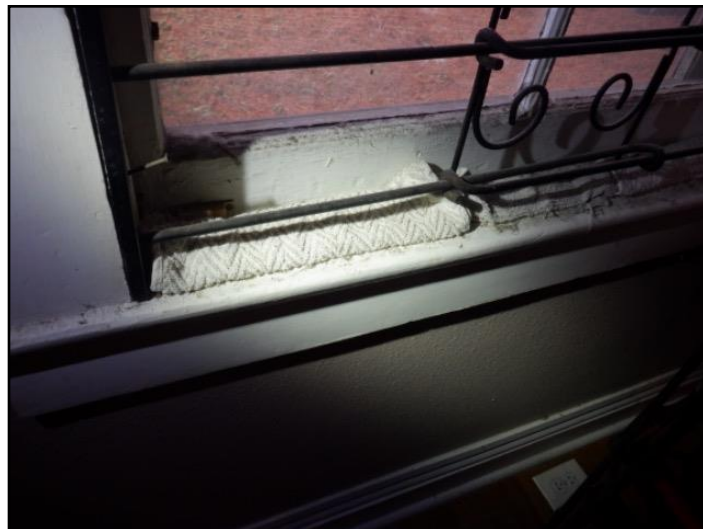
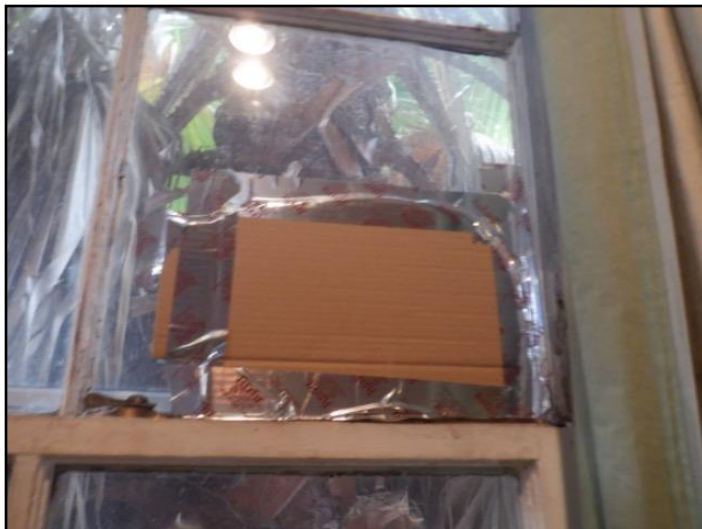
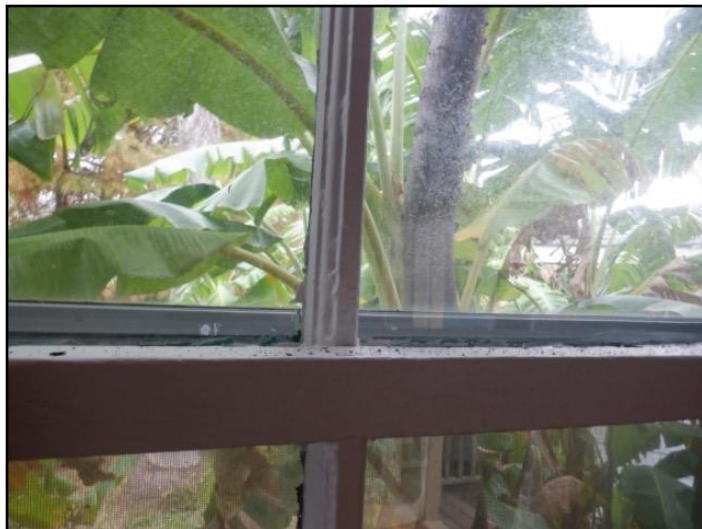
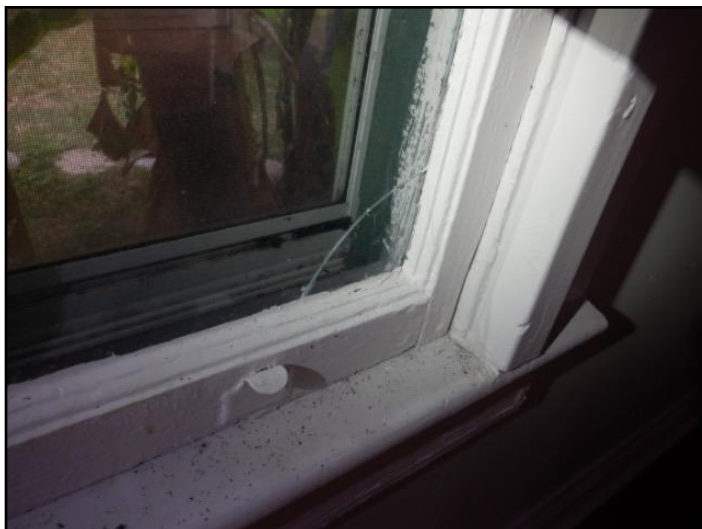
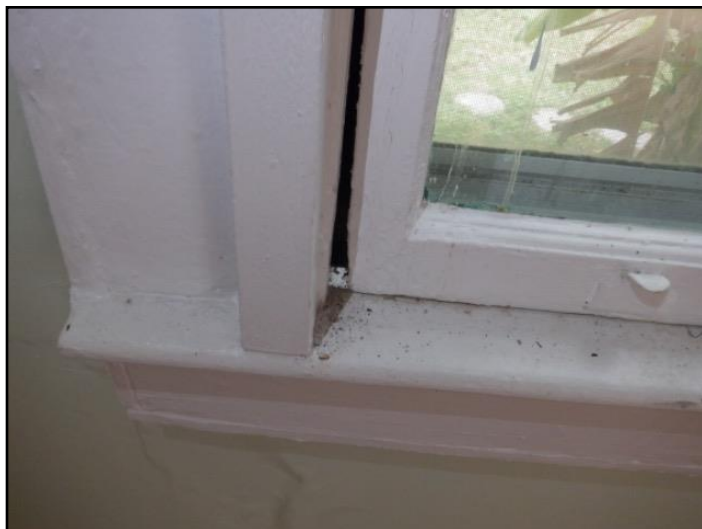
## Condition: • General window issues

Typical older window issues may include: air and water leaks, rot, missing or disconnected sash cords, peeling paint, inoperative, does not stay open, missing or ineffective hardware, painted shut, etc. At least one operable window per room is recommended for emergency egress.

General window issues

**Task:** Correct.

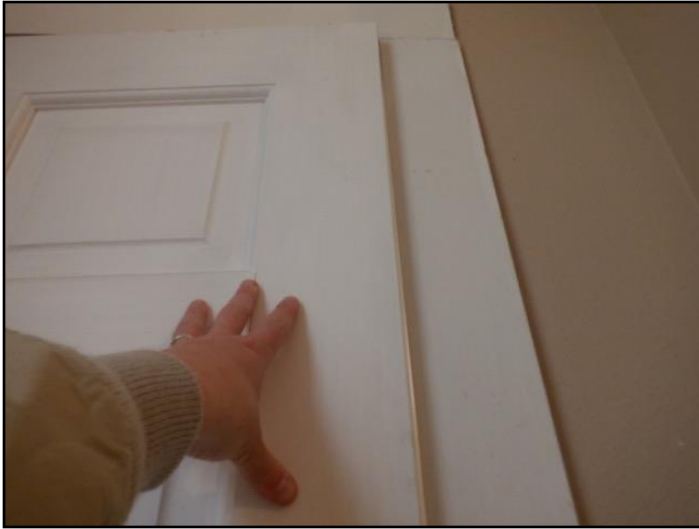
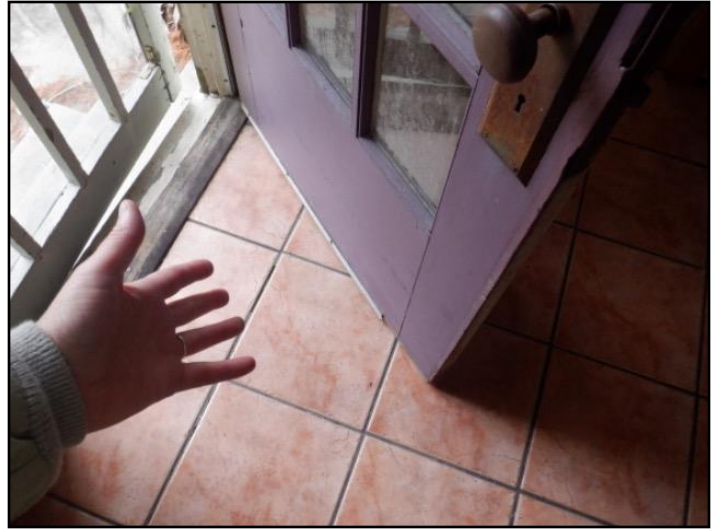
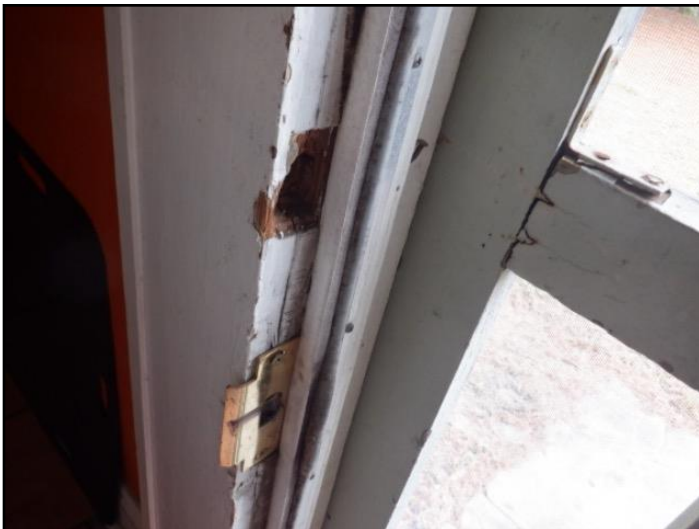
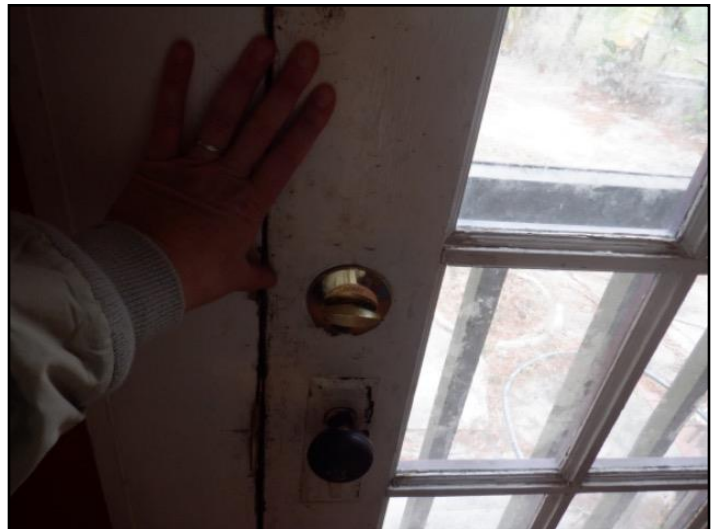
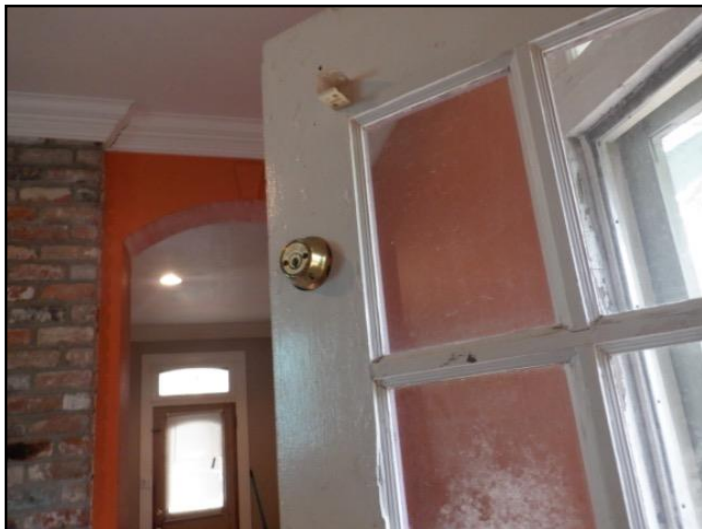
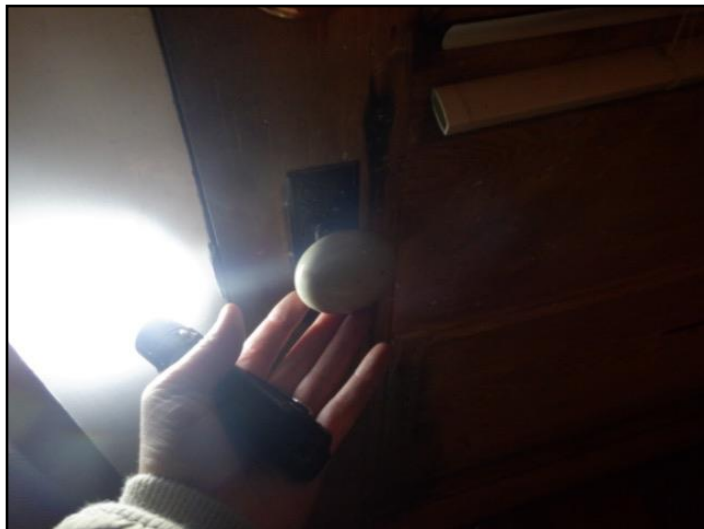
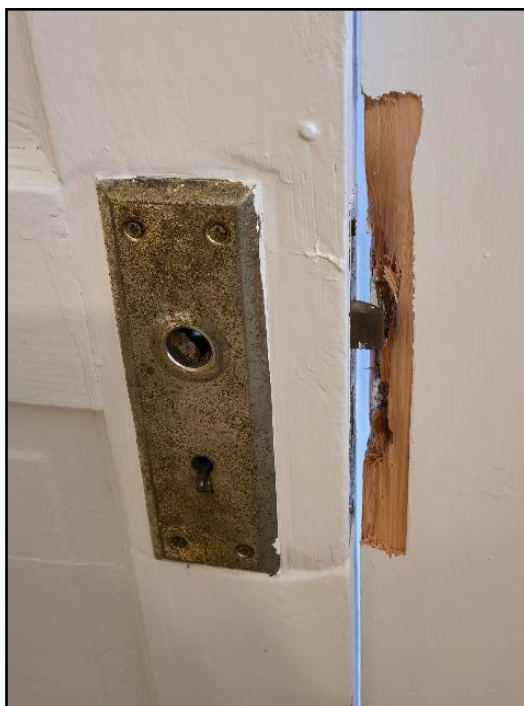
## Condition: • General door issues

Typical door issues noted. These issues include loose/missing/ineffective hardware, dragging on floor, failure to latch, swinging open or closed, tight fit, mechanical damage, and missing/ineffective weatherstripping.

General door issues

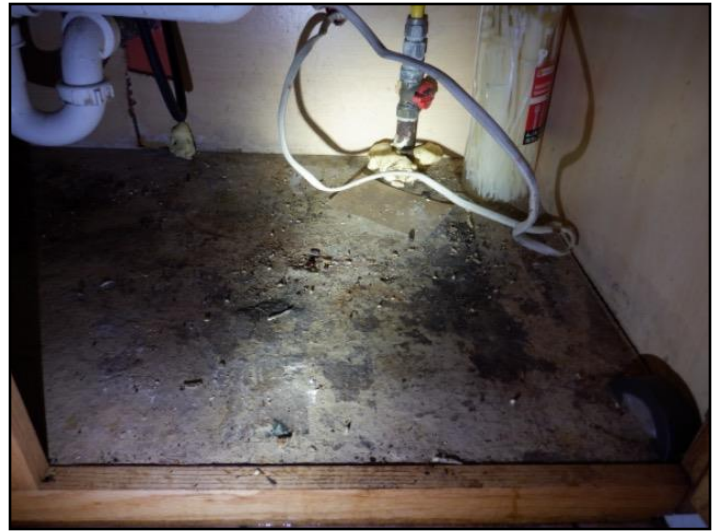
**Condition:** • General cabinets and countertop issues

General cabinets and countertop issues

**Task:** Repair. Possibility of hidden mold growth - see appendix.

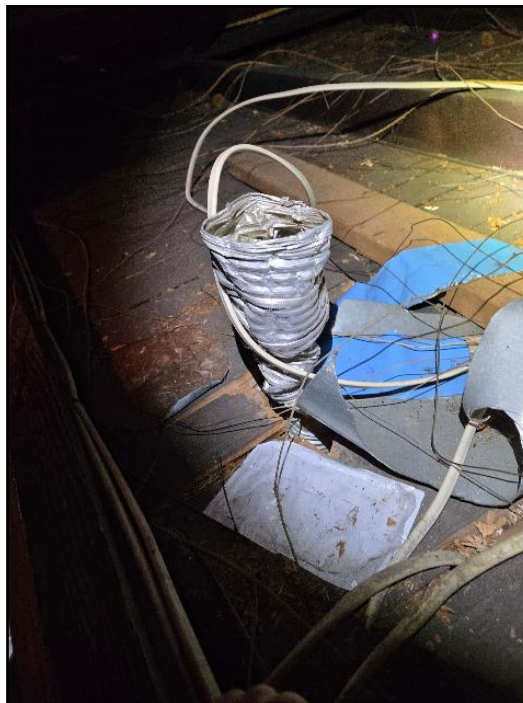
**Condition:** • Not vented to exterior

Not vented to exterior

**Task:** Correct.
