# Inspection Report

938 N Gayoso St  
New Orleans, LA 70119

**Inspection Date:**  
Monday, December 1, 2025

RE: Report No. 19955  
938 N Gayoso St  
New Orleans, LA  
70119

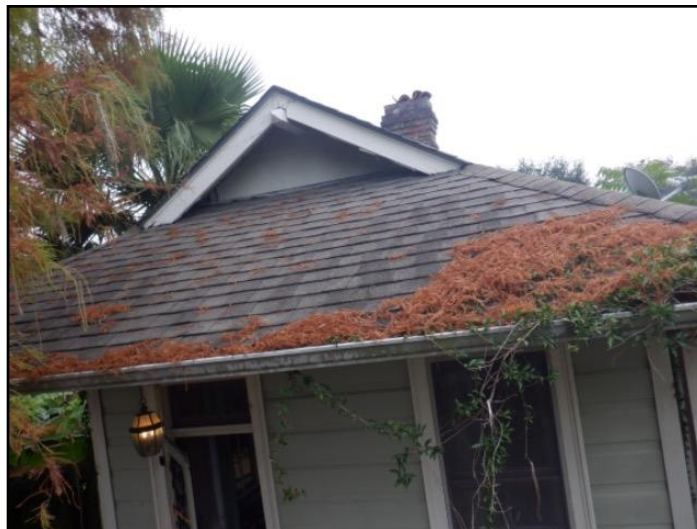
**Condition:** • Debris

*Debris*

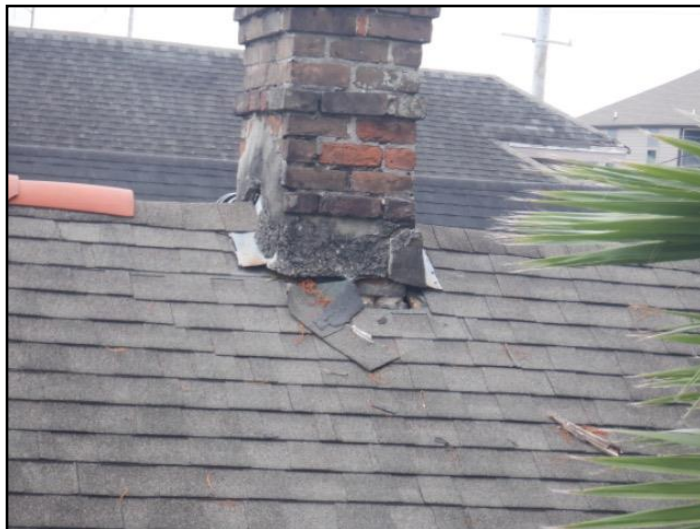
**Condition:** • Hole noted in roof.

**Task:** Repair.

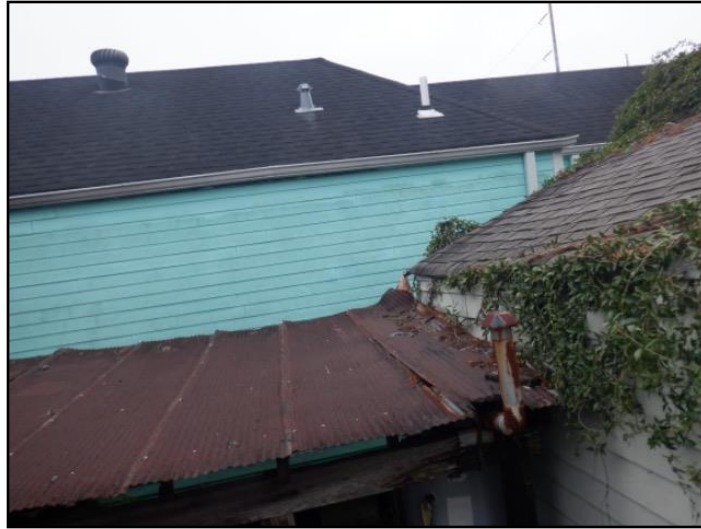
**Condition:** • Rear metal roof was extremely rusted, loose, lifted, damaged and completely failing.

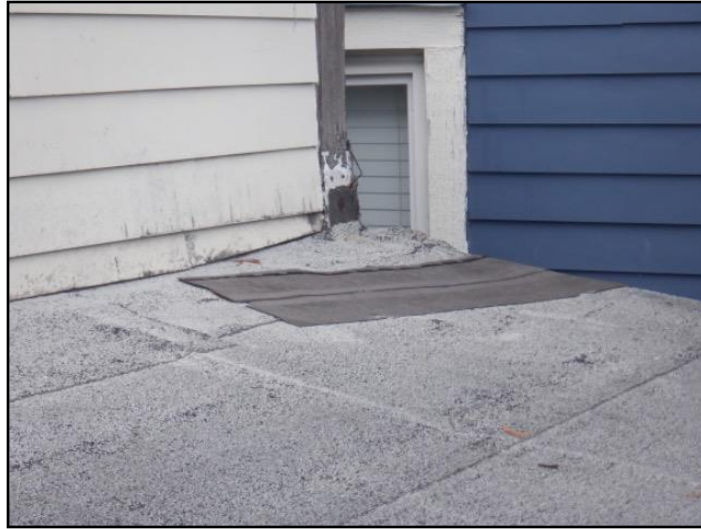
**Condition:** • Missing flashing

Missing flashing

**Task:** Verify

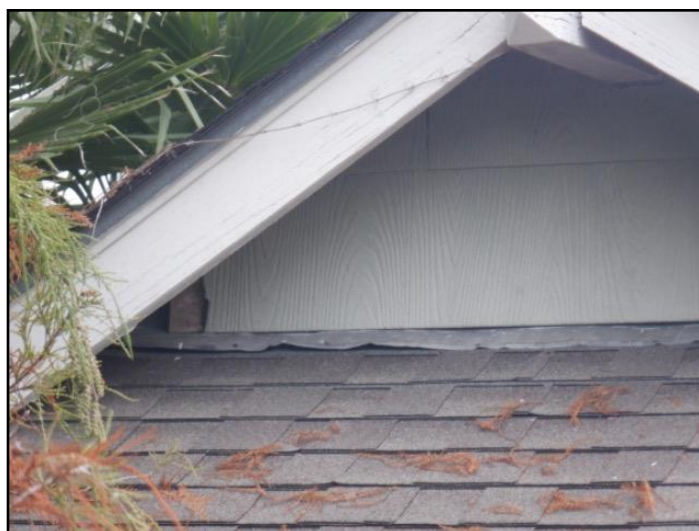
*Loose*

**Task:** Repair

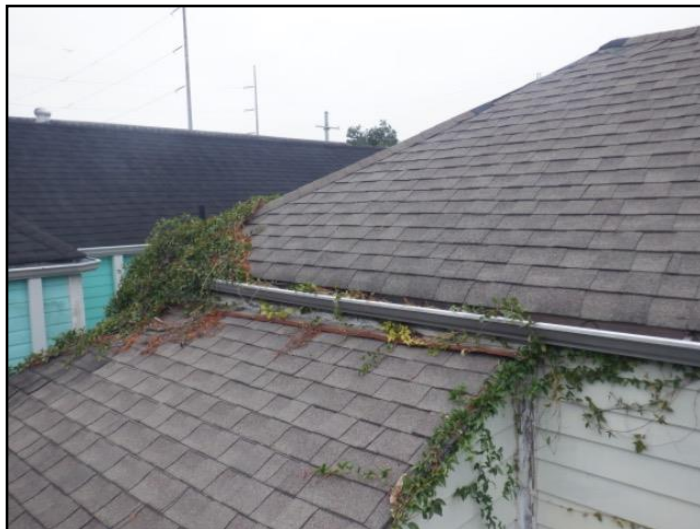
**Condition:** • Rusted and lifted.

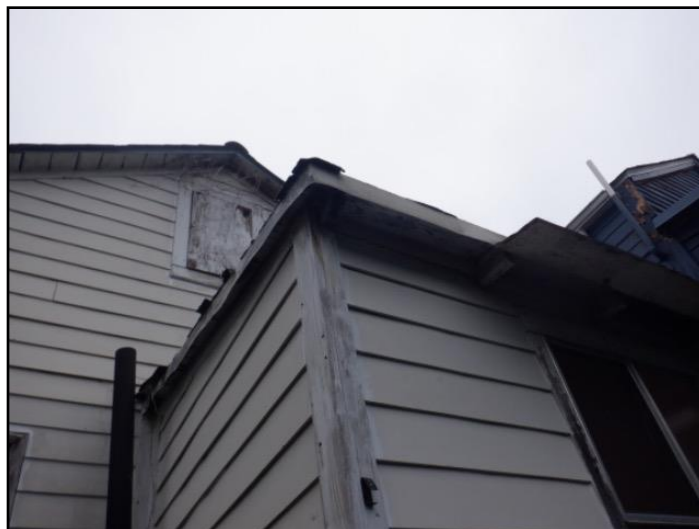
*Missing*

**Task:** Informational

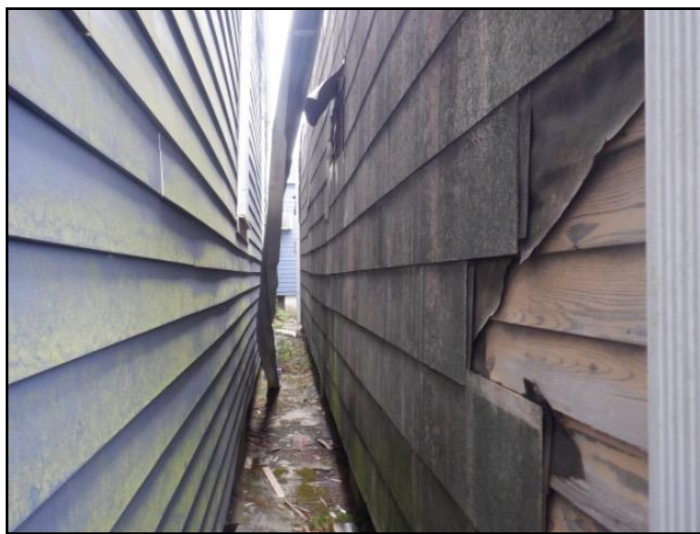
Damage

**Task:** repair

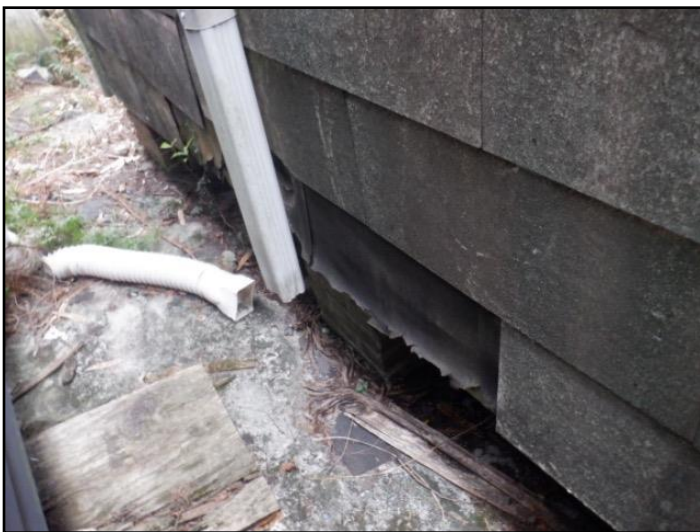
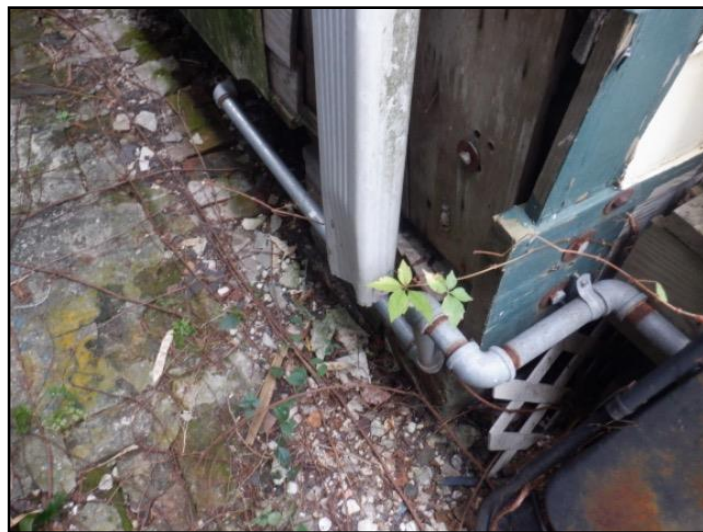
**Condition:** • No diverter

No diverter

**Task:** Repair.

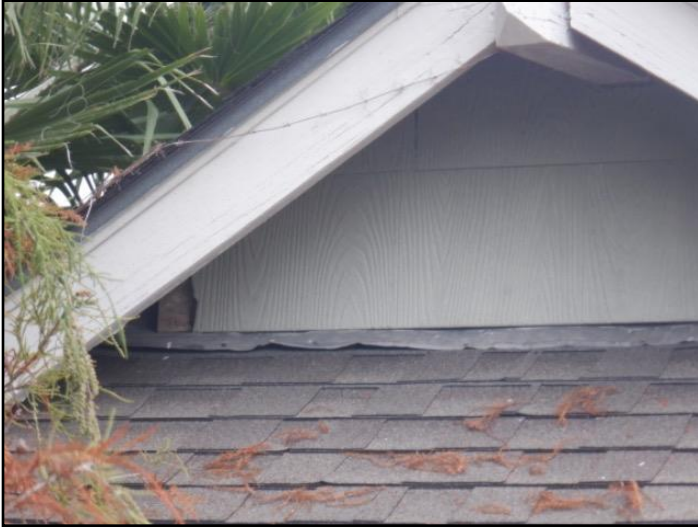
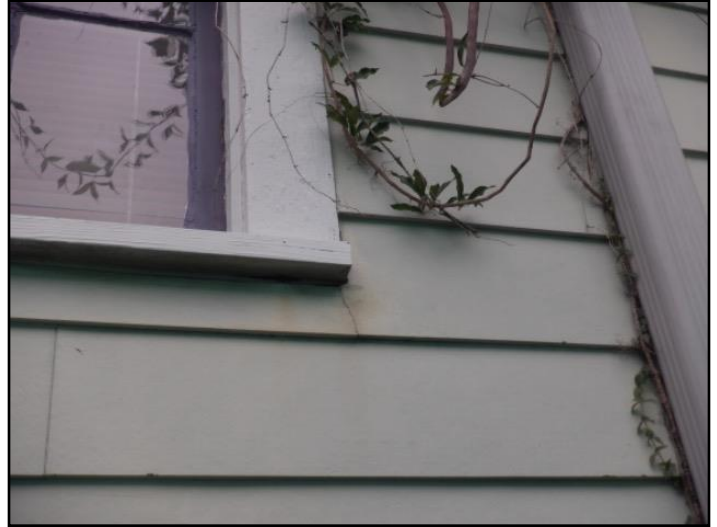
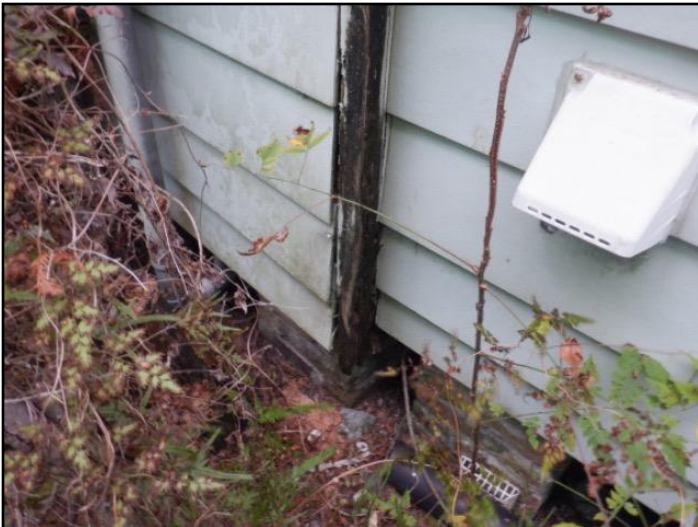
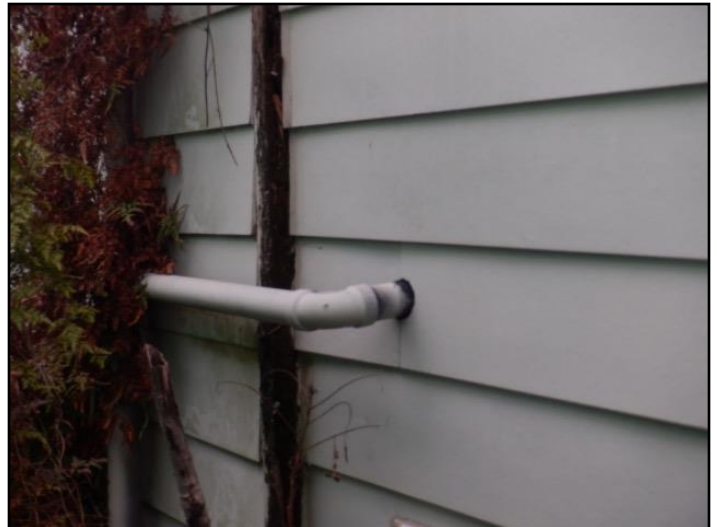
Moisture damage, cracks/openings, peeling paint, and general or isolated disrepair. Openings in exterior may also attract wood destroying insects to structure, and may cause hidden possible damage and mold growth. These issues should be addressed before further material deterioration occurs.

*Deferred maintenance*

**Task:** Repair.

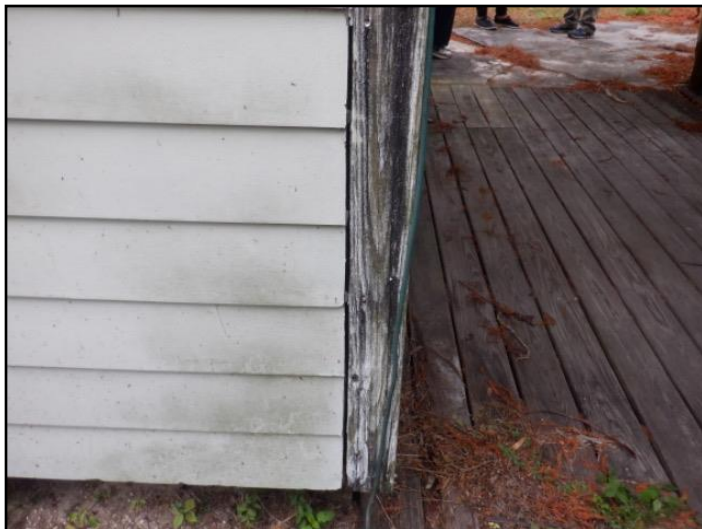
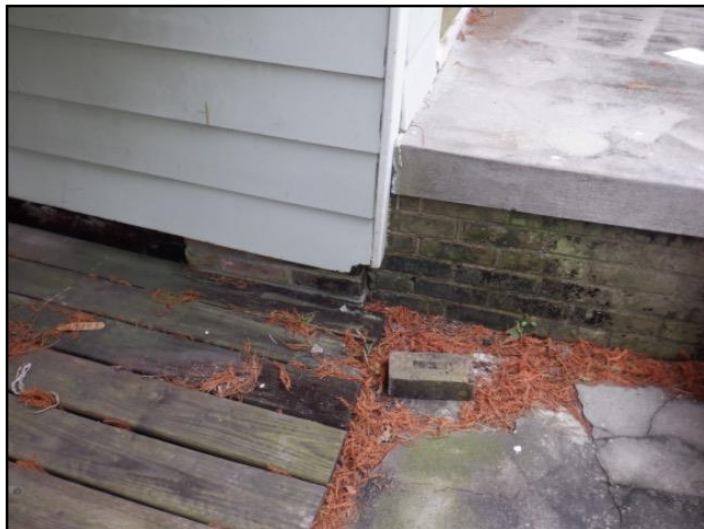
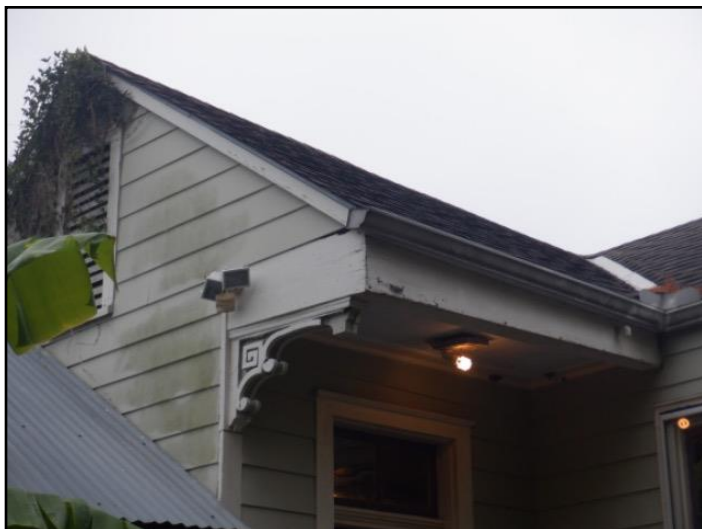
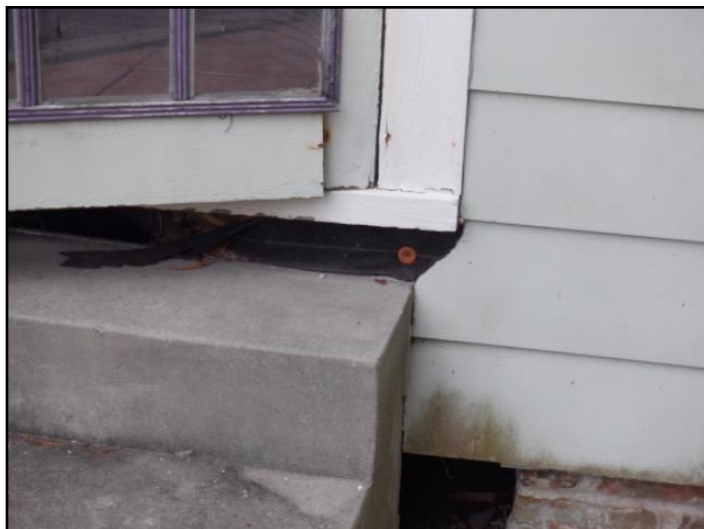
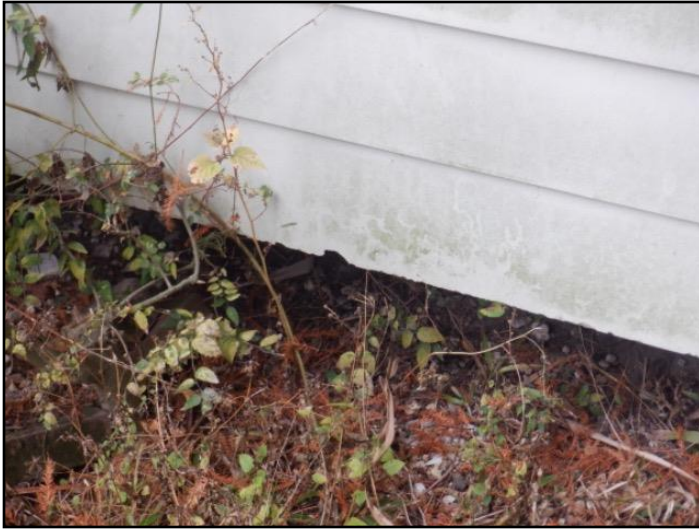
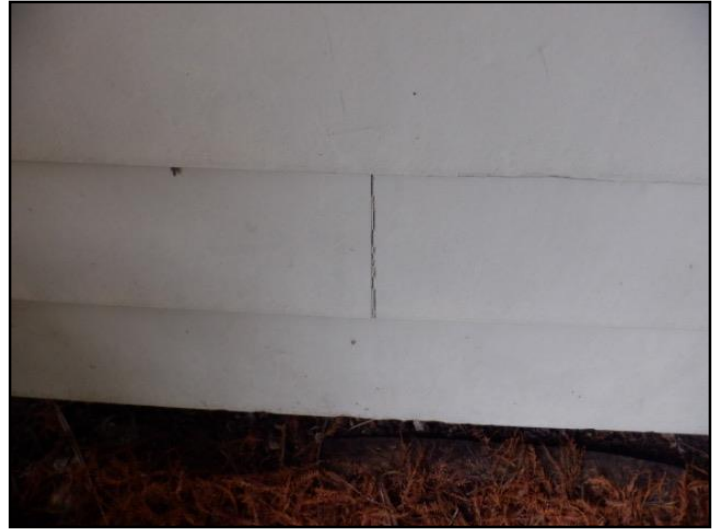
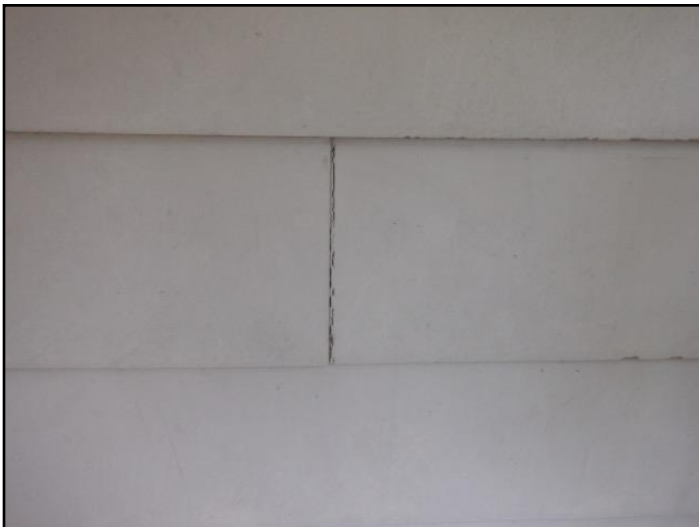
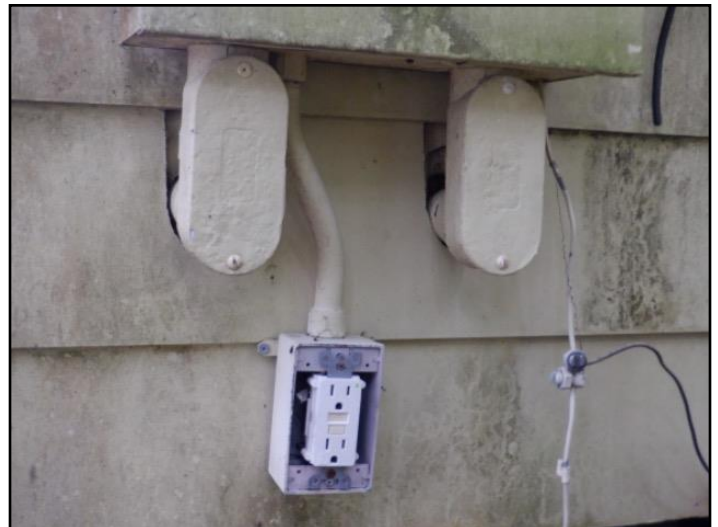
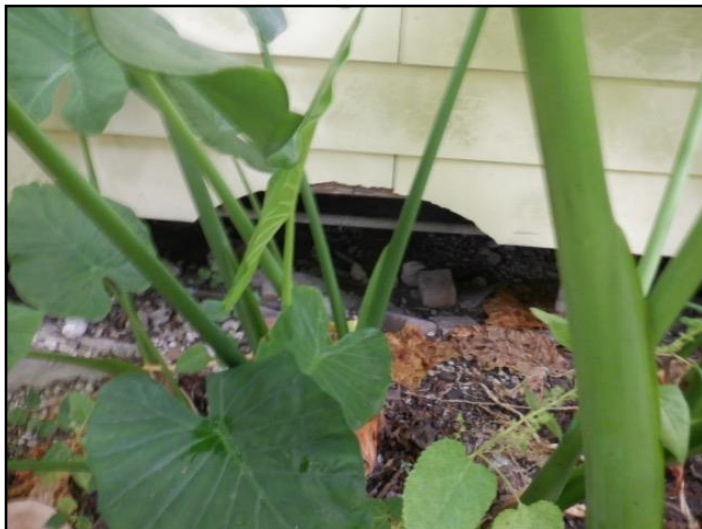
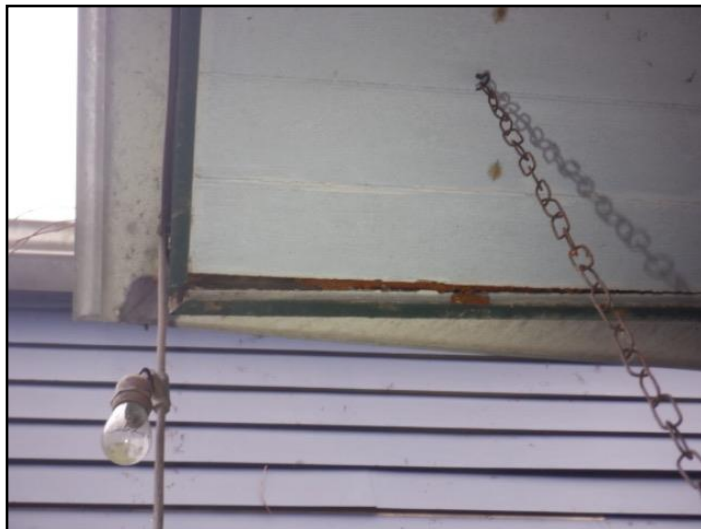
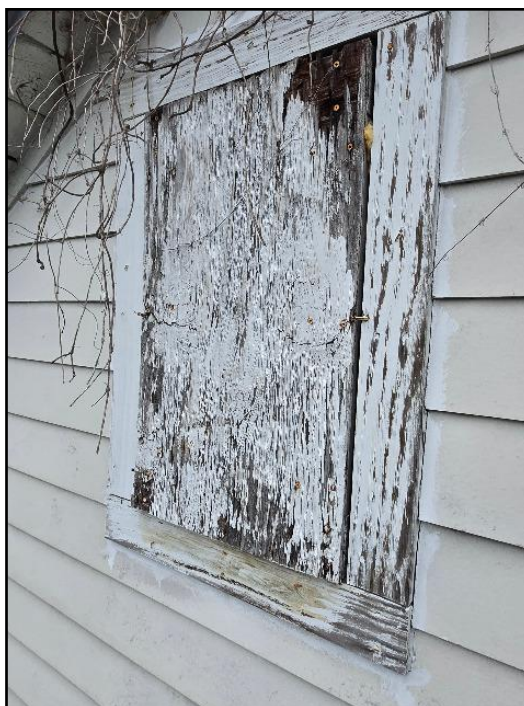
*Deferred maintenance*

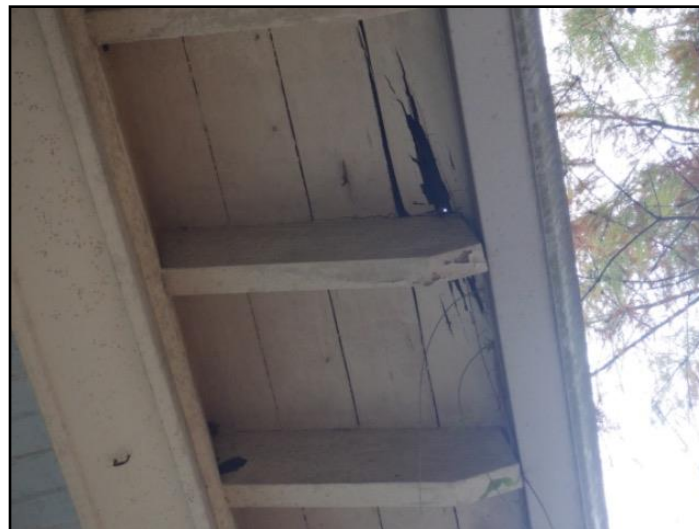
**Condition:** • [Rot or insect damage](#)

*Rot or insect damage*

**Task:** Repair or replace.

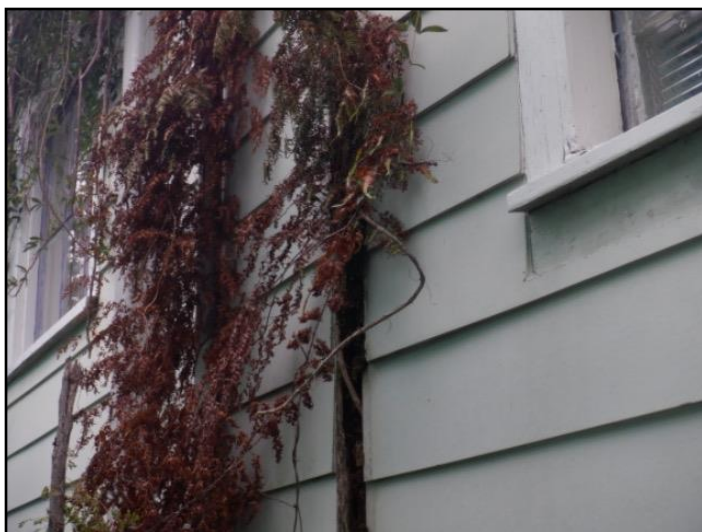
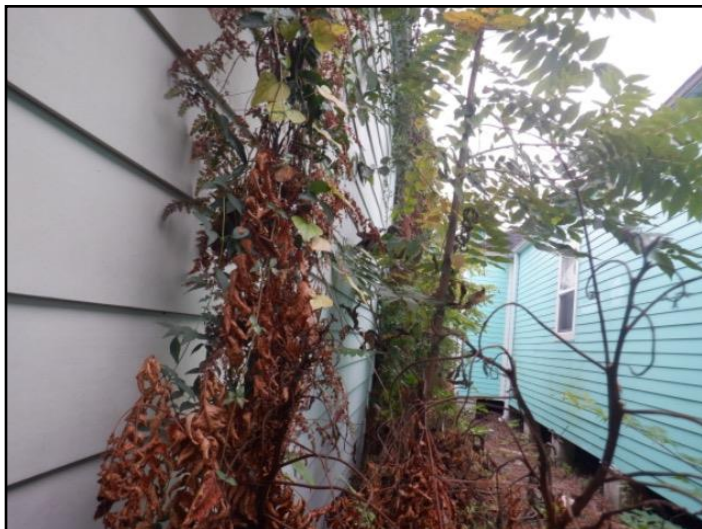
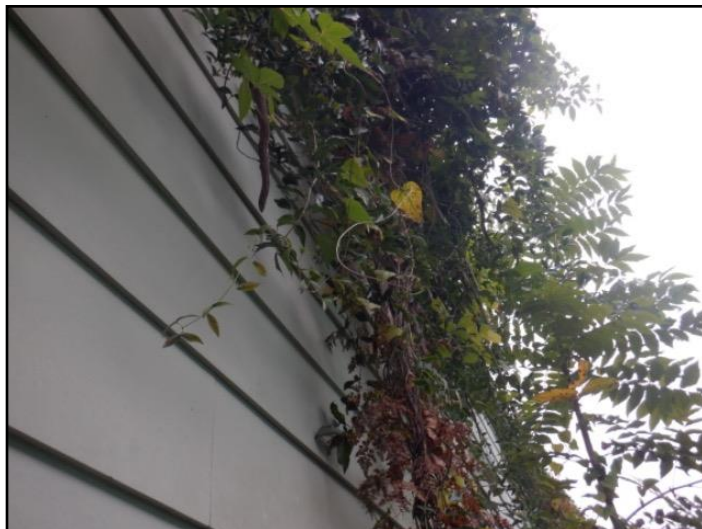
**Condition:** • Vine growth appeared to be separating the siding from the house in various areas. Water intrusion at these areas may have caused rot/deterioration/insect damage to the wall framing. Possible hidden damage when repairs begin.

**Task:** Further evaluation. Repair.

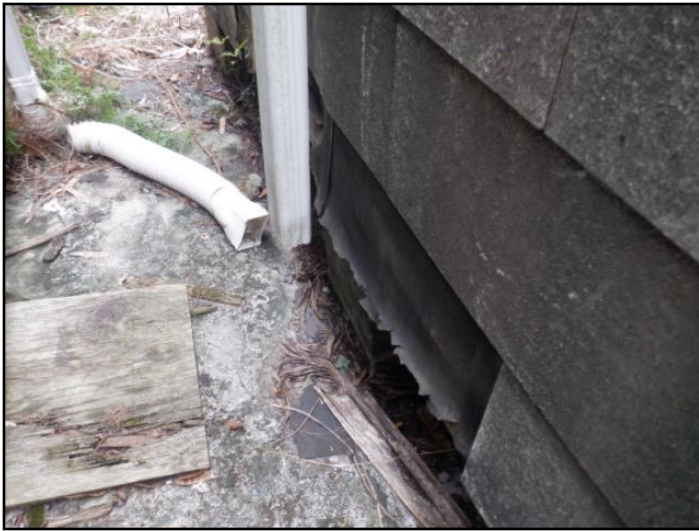
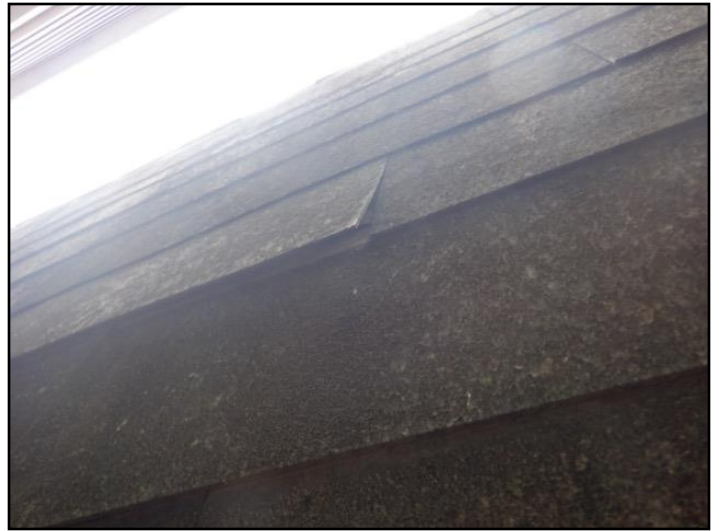
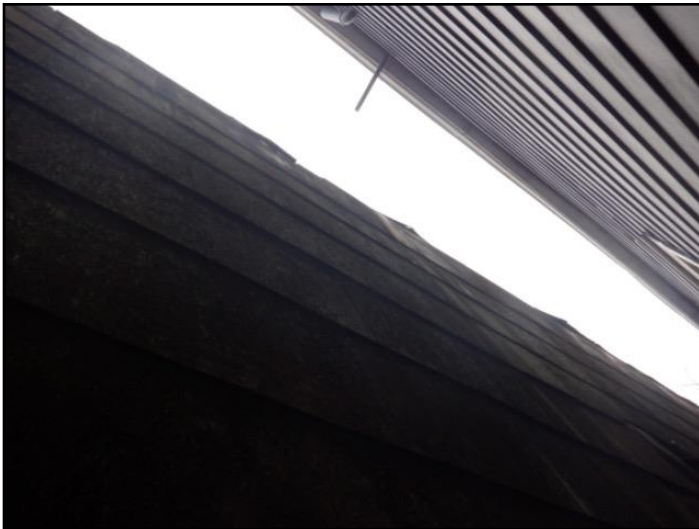
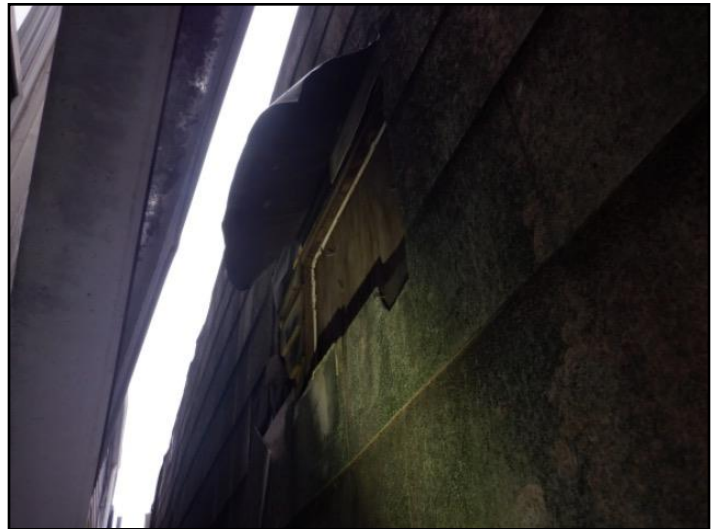
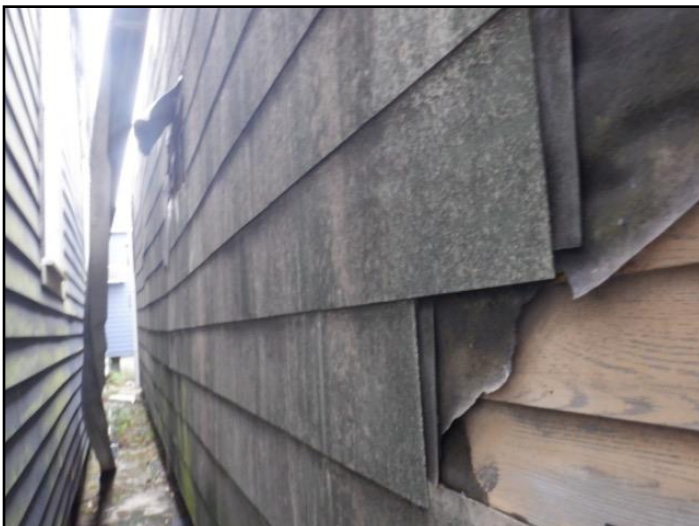
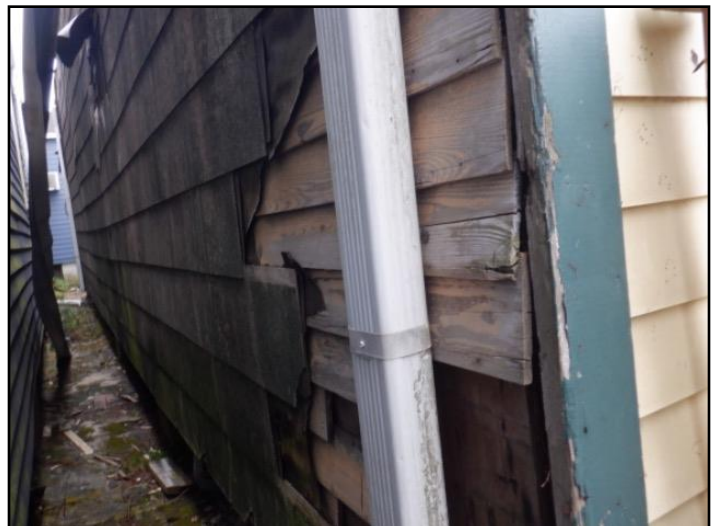
**Condition:** • Siding was in overall poor condition, particularly on the left wall. The roof did not overhang past the wall and the wall was bulged with siding in poor condition. Water may be entering behind the siding, causing rot/deterioration/insect damage to the framing. Further evaluate extent of damage and repair as needed.

**Task:** Further evaluate. Repair.

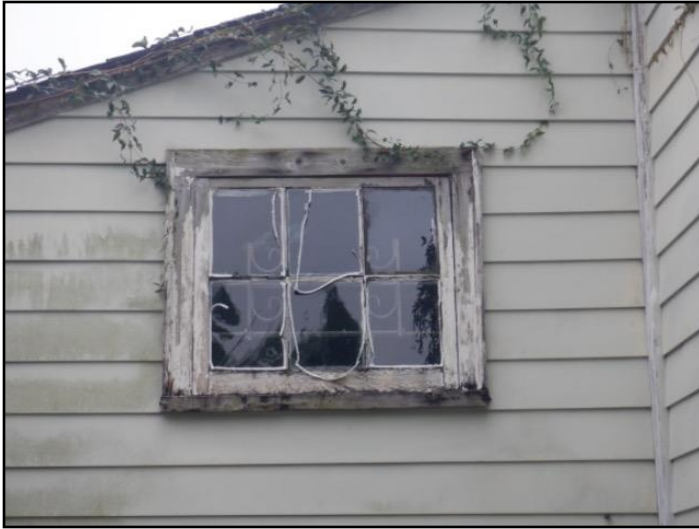
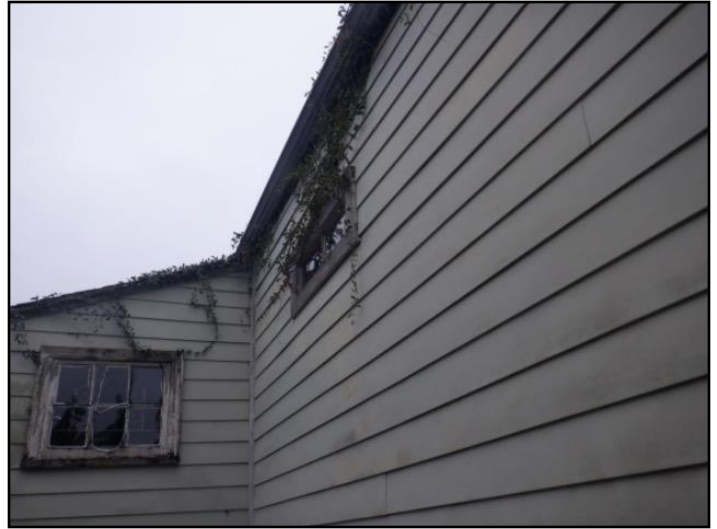
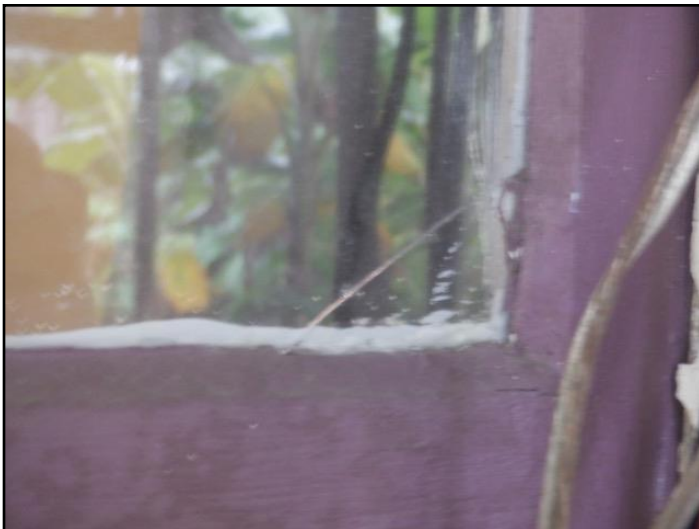
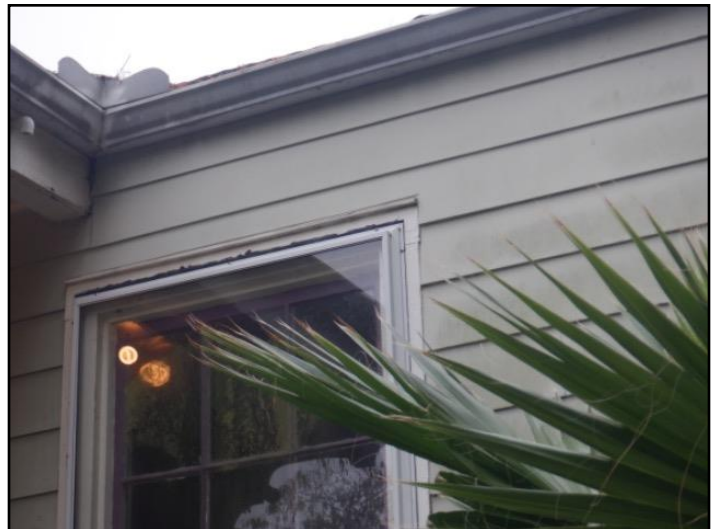
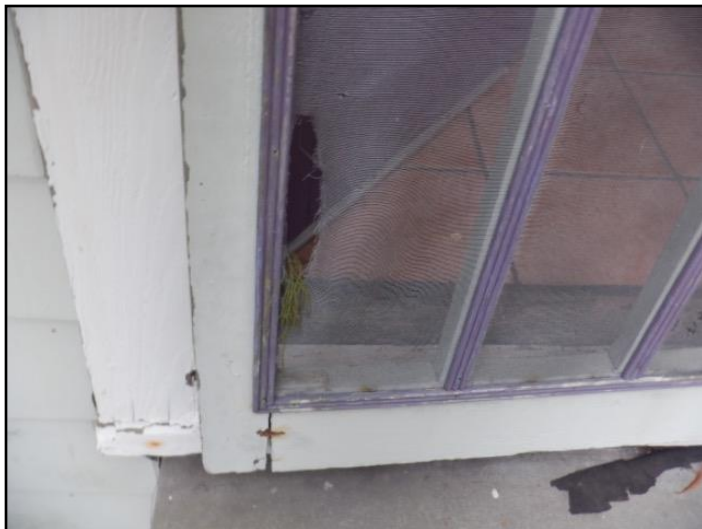
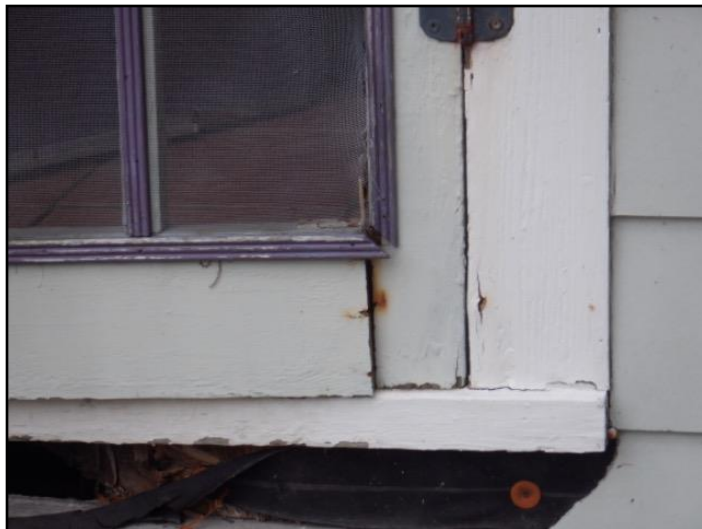
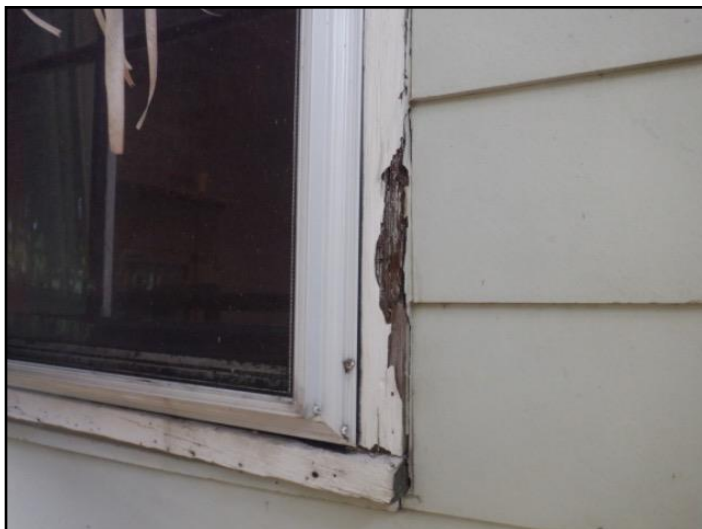
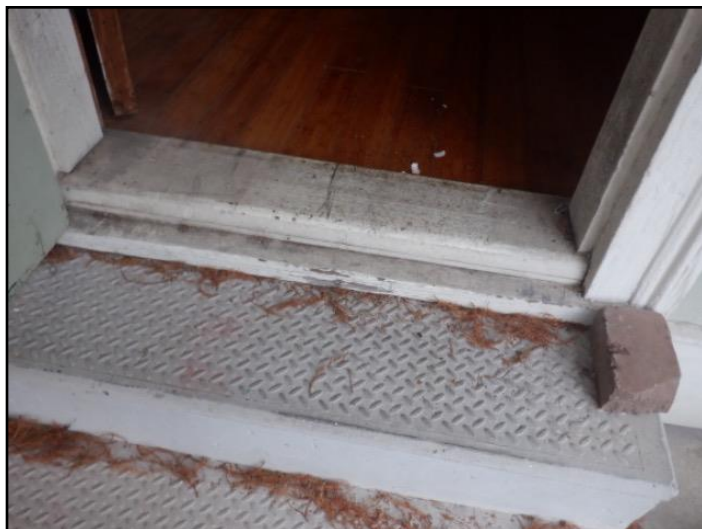
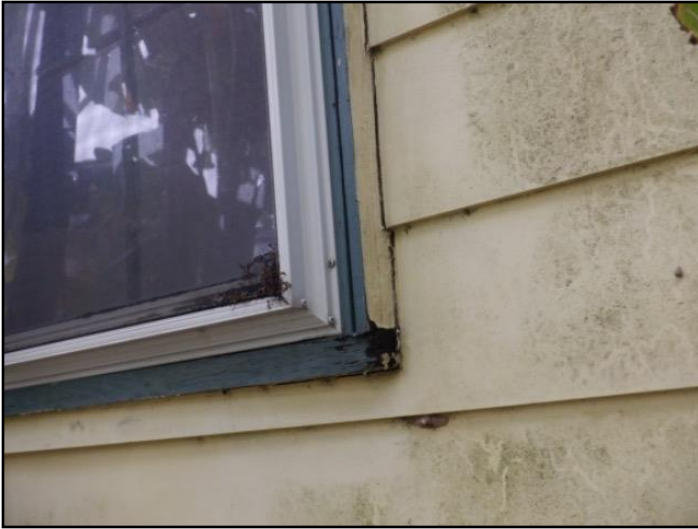
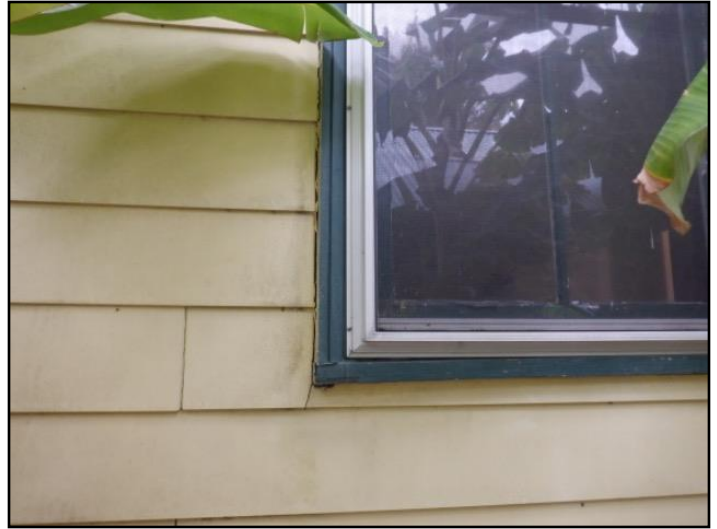
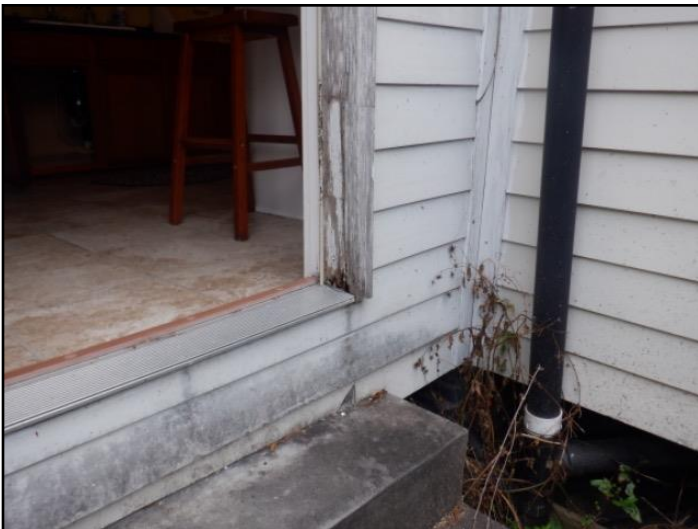
Typical deferred maintenance on exterior wood windows/doors, frames, and trim. Moisture damage, cracks/openings, leaking, peeling paint, missing putty, damaged muntins, and general disrepair. Moisture intrusion has or can cause exterior wood surfaces to rot. This should be addressed before further material deterioration occurs.

*Deferred maintenance*

Deferred maintenance

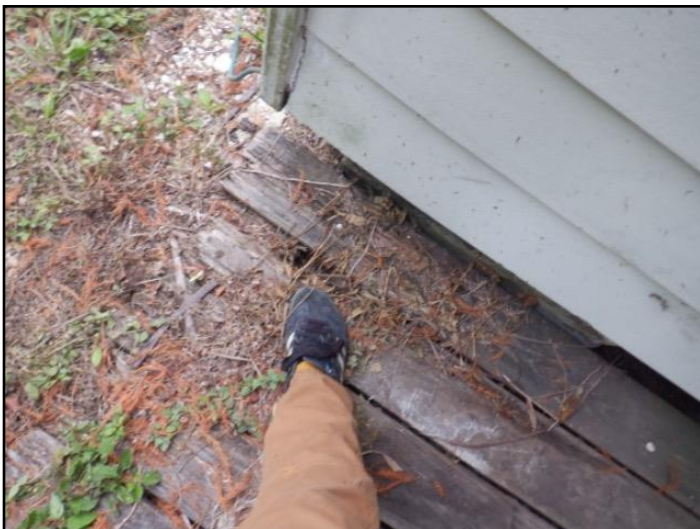
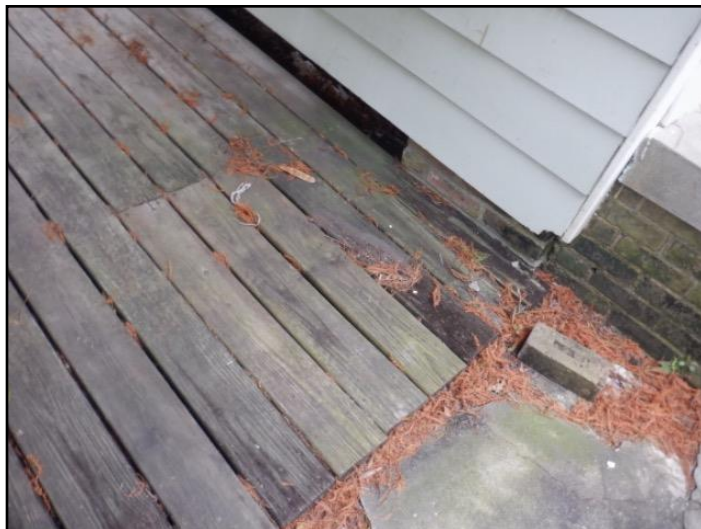
**Condition:** • Ground level deck was rotting, deteriorated and creating wood/soil contact.

**Task:** Remedy

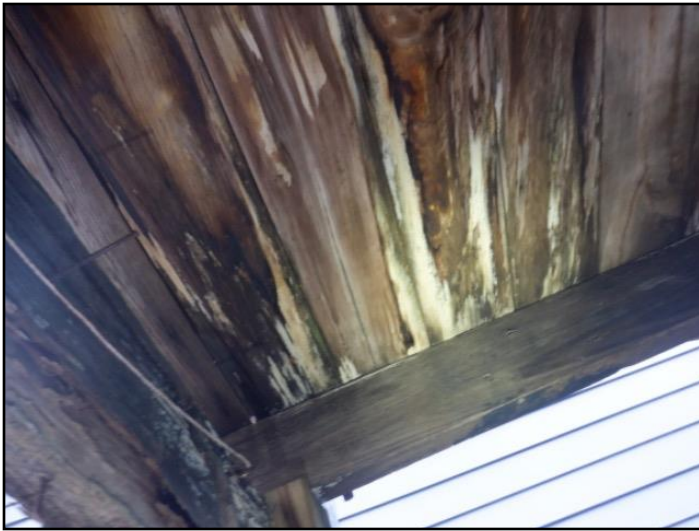
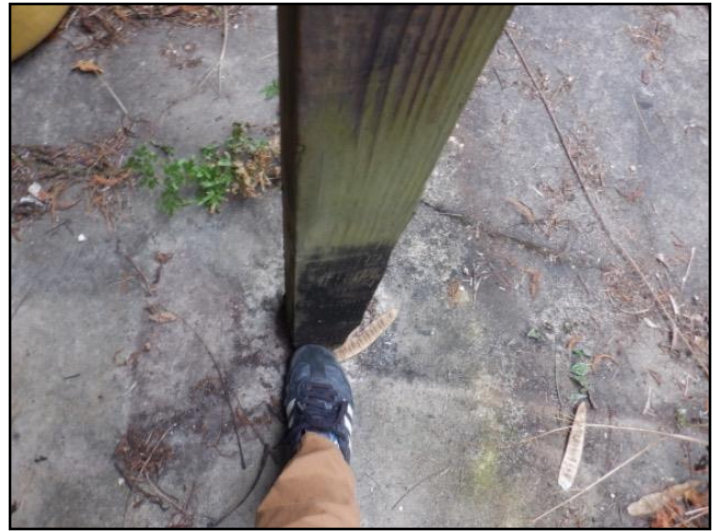
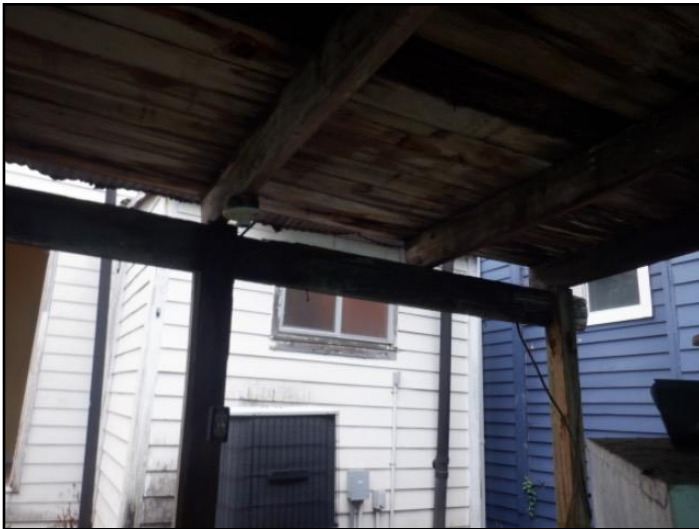
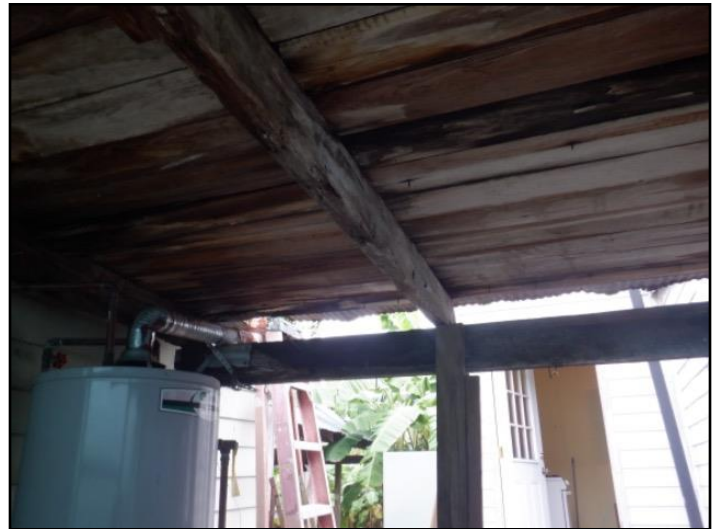
**Condition:** • Unflashed door overhang.

**Task:** Repair.

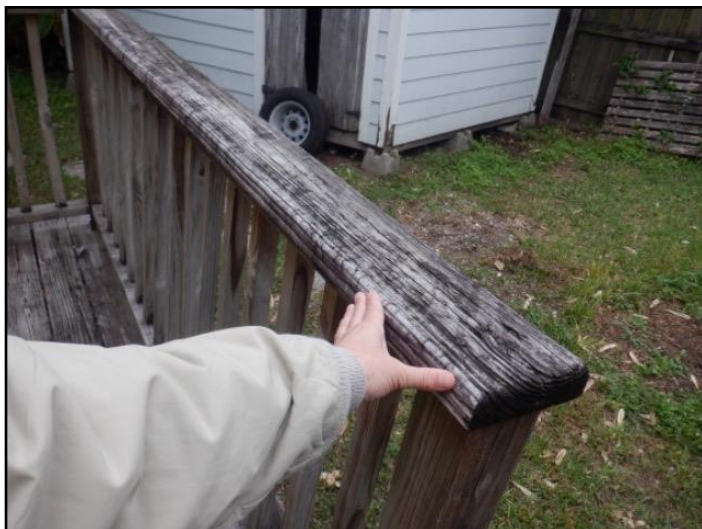
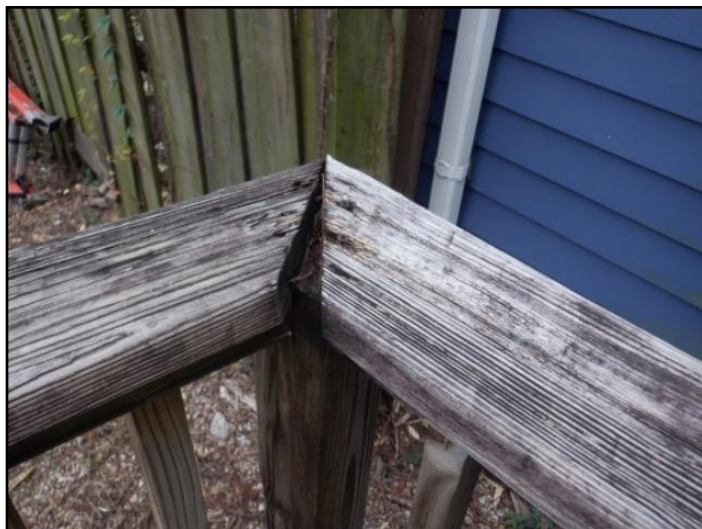
**Condition:** • Porch was deteriorated and in poor condition. Porch appeared to be sagging towards the left. Wood decking, guardrails and stairs were rotting.

**Task:** Repair

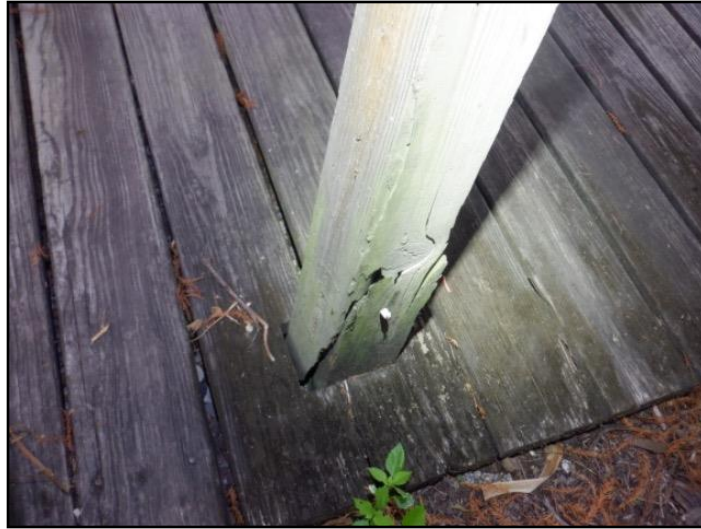
**Condition:** • Split

*Split*

**Task:** Repair.

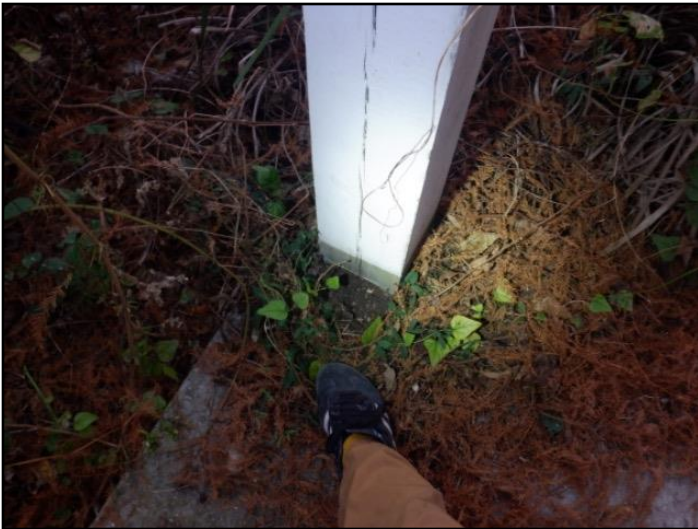
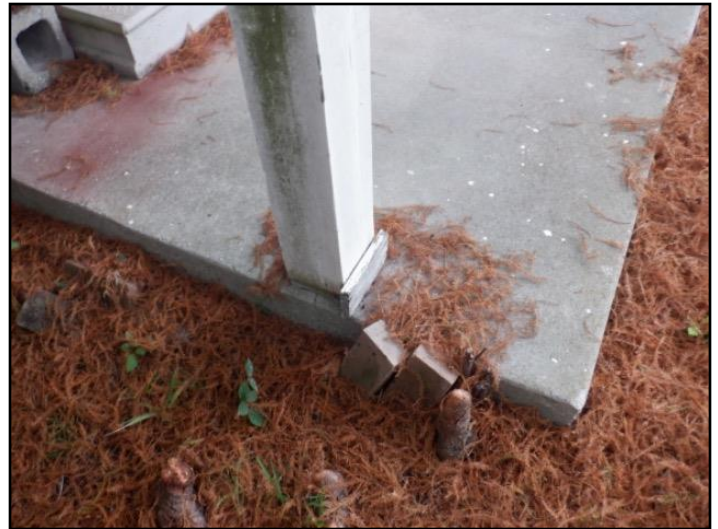
**Condition:** • Posts were damaged and not secured to the concrete.

**Task:** Repair.
