# Inspection Report

938 N Gayoso St  
New Orleans, LA 70119

**Inspection Date:**  
Monday, December 1, 2025

RE: Report No. 19955  
938 N Gayoso St  
New Orleans, LA  
70119

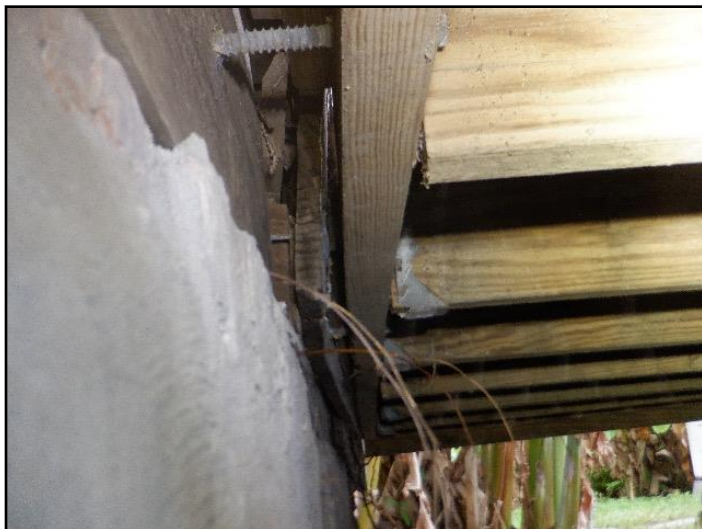
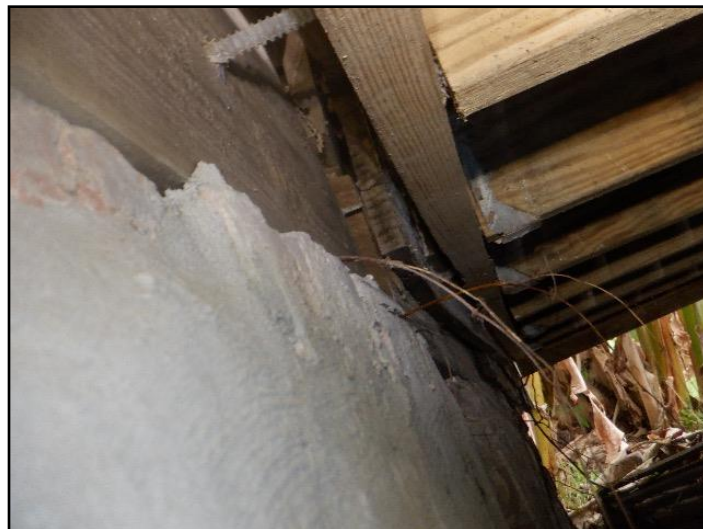
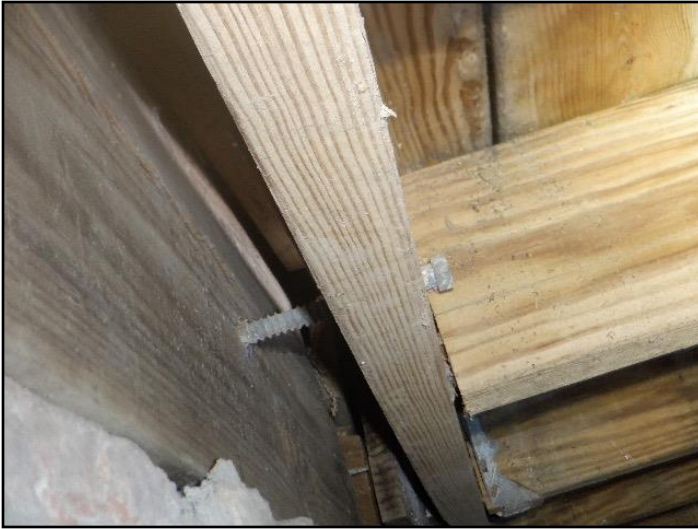
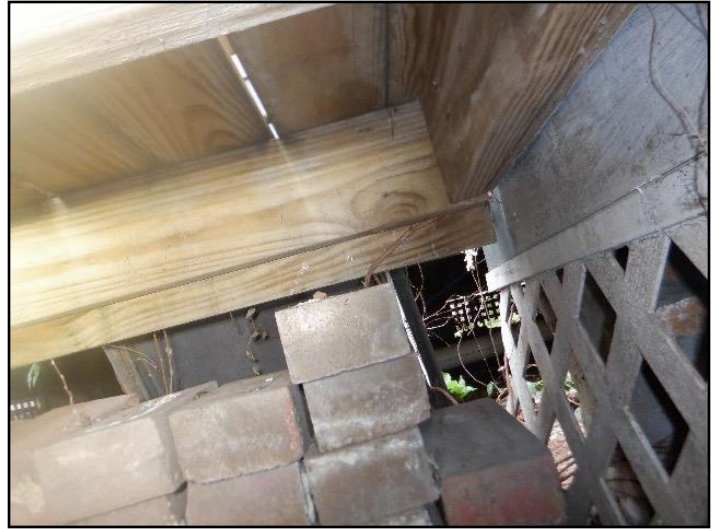
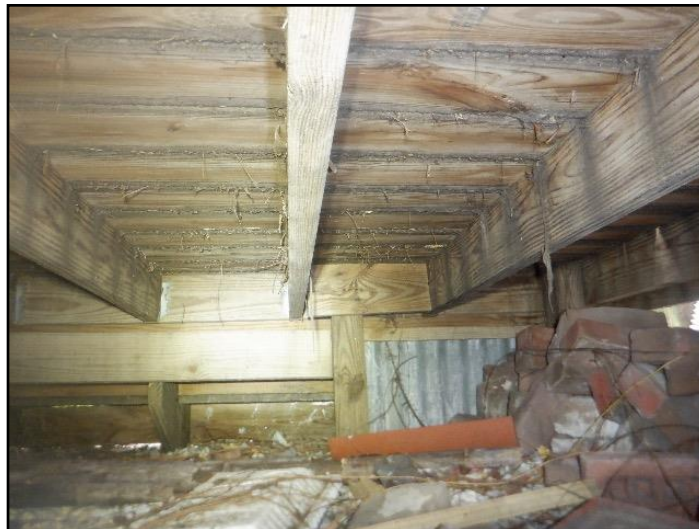
**Condition:** • Ledgerboard problems

Ledgerboard problems

secure ledgerboard every 16" to 24" with lag bolts

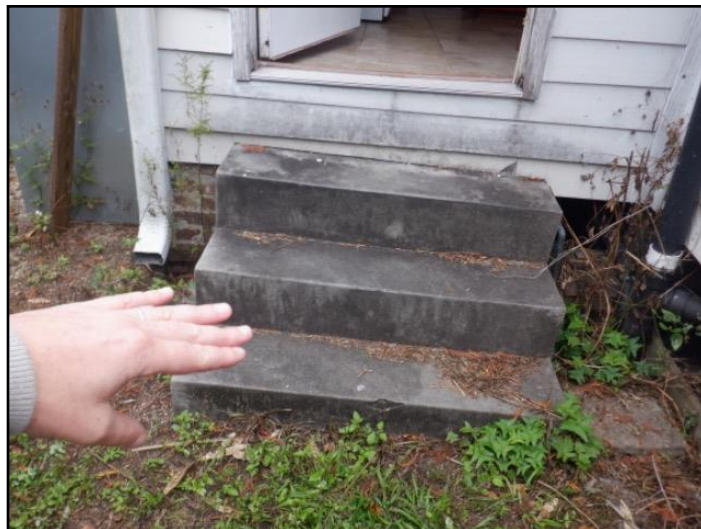
**Condition:** • Stairs were settled, sloped and had an excessive rise to the interior.

**Task:** Repair.

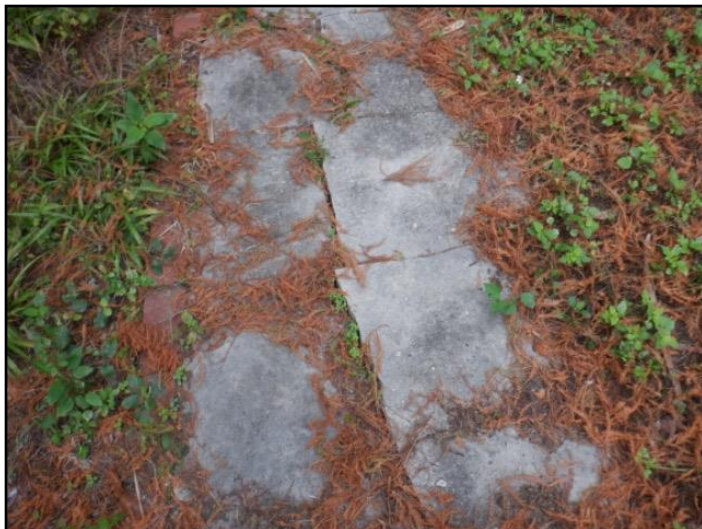
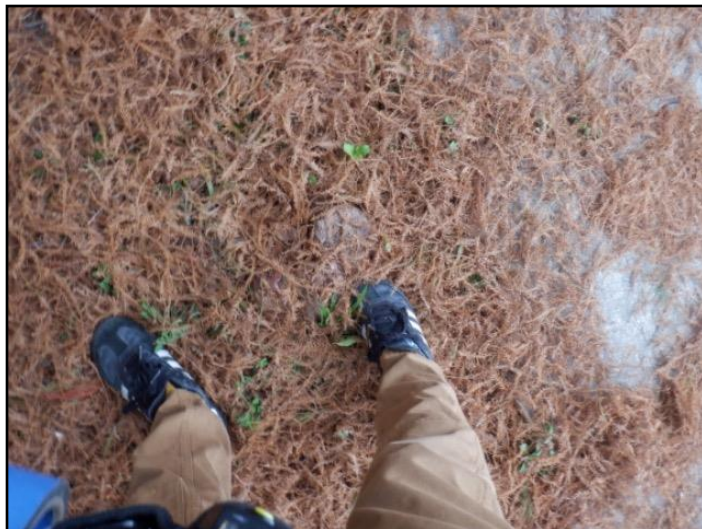
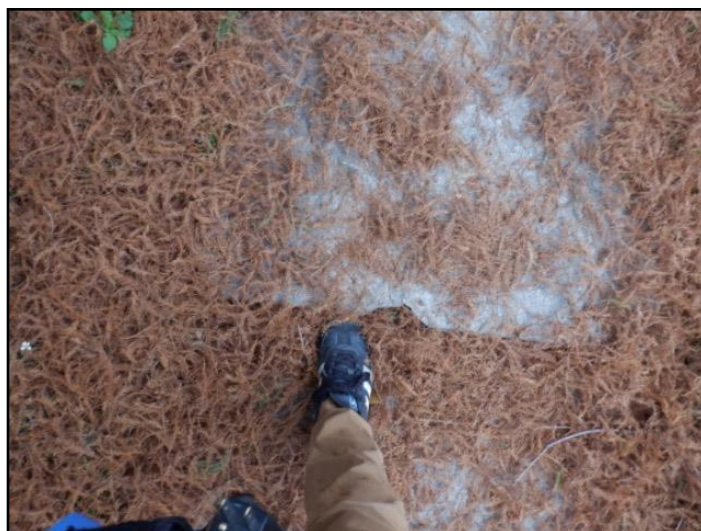
**Condition:** • Trip hazard

*Trip hazard*

**Task:** Repair.

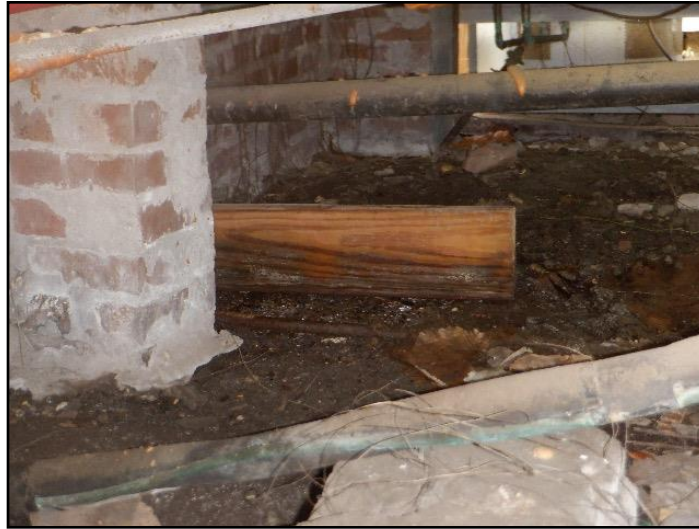
**Condition:** • Crawlspace debris

*Crawlspace debris*

**Task:** Remove.

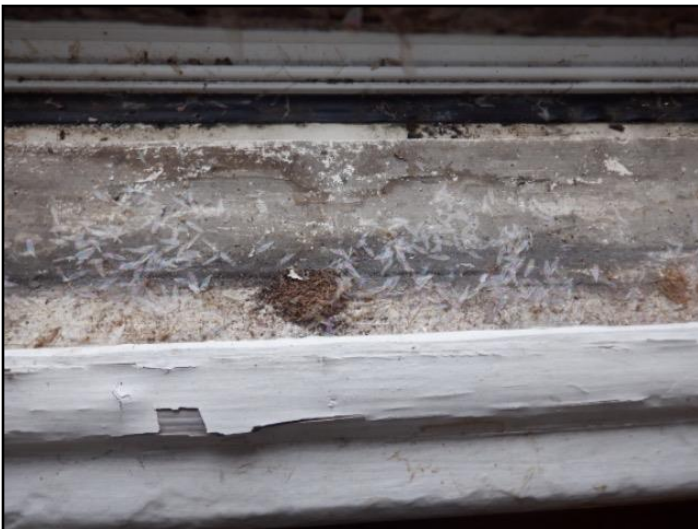
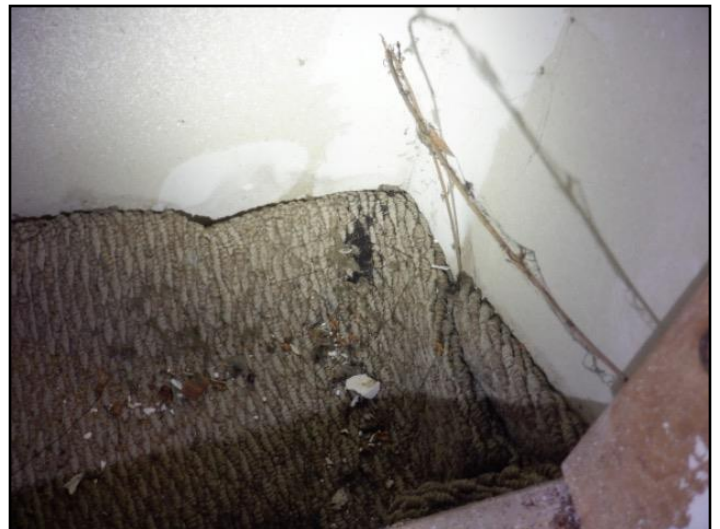
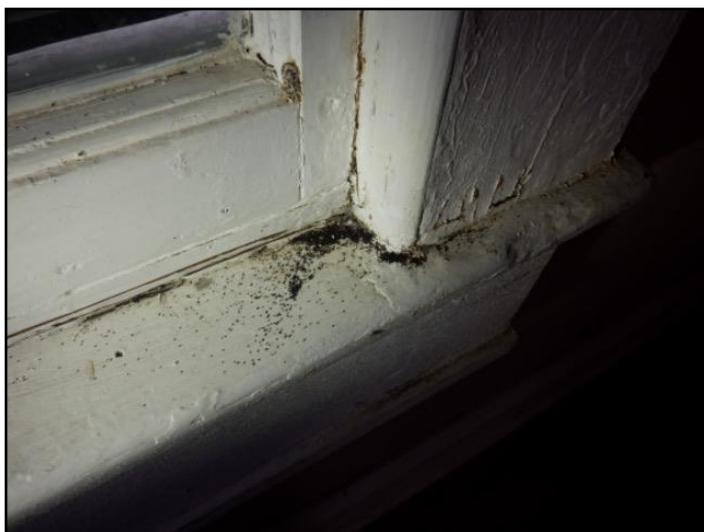
**Condition:** • Indications of insect activity.

Indications of possible wood destroying insect material. Wood destroying insect inspection recommended, or refer to completed inspection report as applicable. Obtain all treatment history documentation.

*Indications of insect activity.*

**Task:** Further evaluation. Maintain insect protection program.

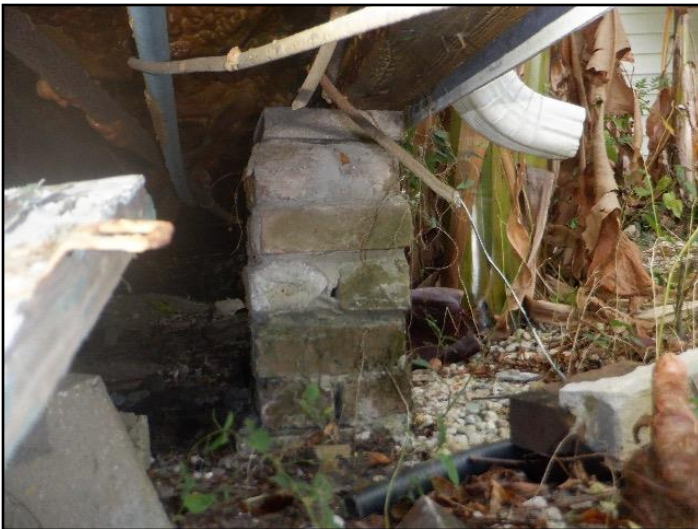
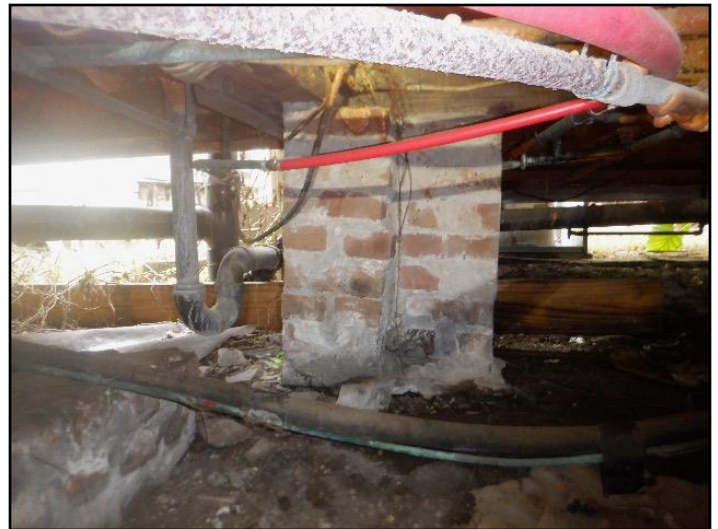
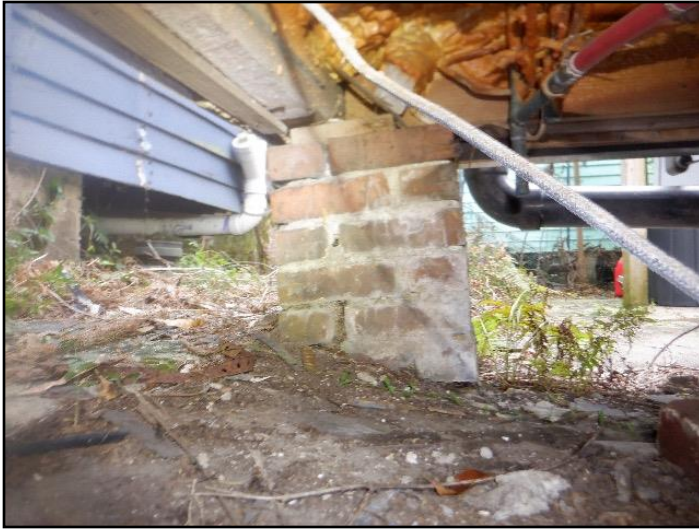
**Condition:** • [Leaning](#)

Leaning

*Leaning*

**Task:** Repair.

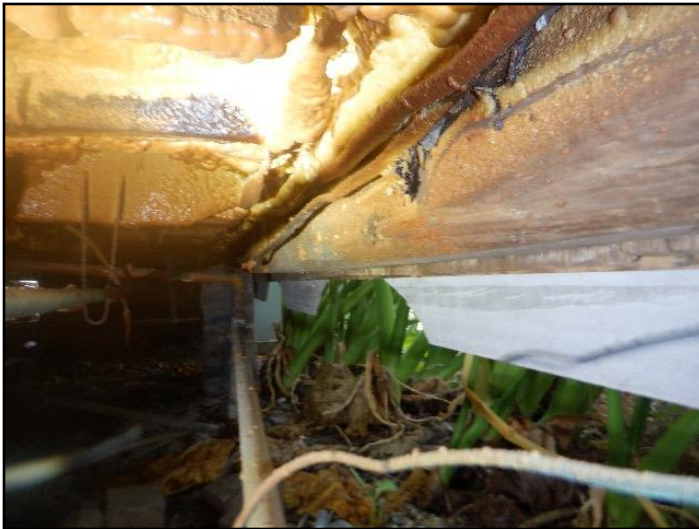
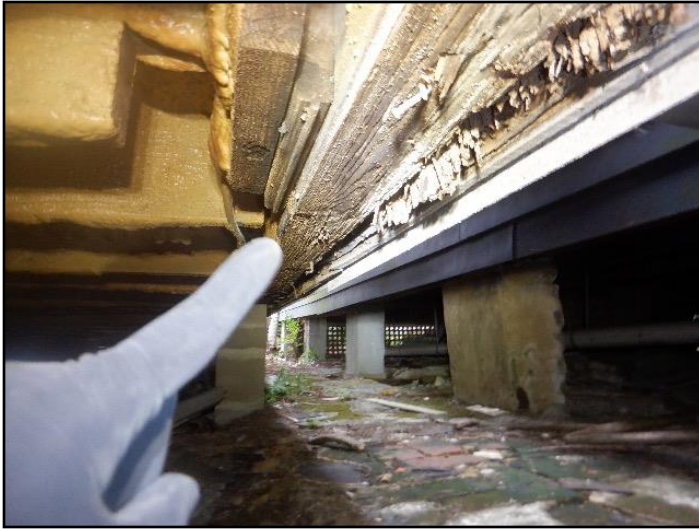
**Condition:** • [Missing](#)

*Missing*

Missing

**Task:** Install.

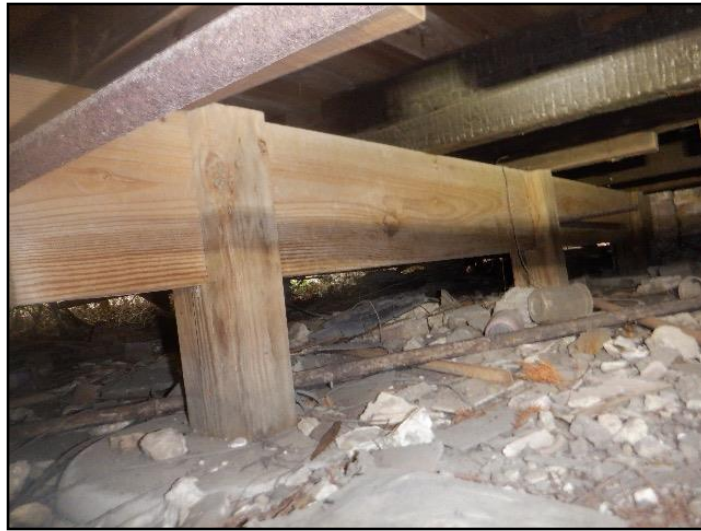
## **Condition:** • Bounce beam issues

Bounce beams are beams typically installed after the house is built to stiffen a deflection or bounce in the floor. They are typically not constructed to the same standards as a load-bearing foundation beam, and typically are missing footers or mortar, and are therefore more susceptible to movement and separation from joists.

*Bounce beam issues*

**Task:** Further evaluation. Replace.

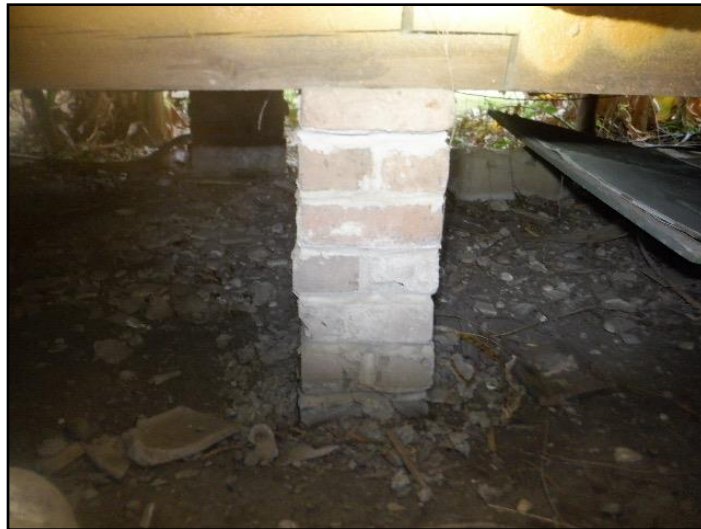
**Condition:** • Undersized

**Task:** Replace.

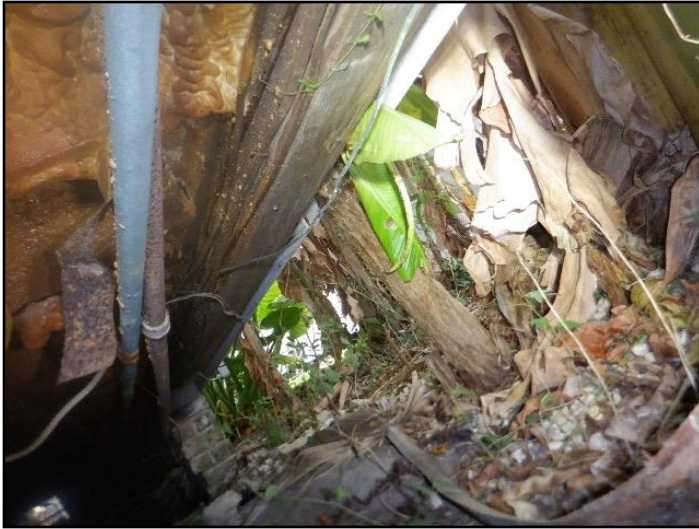
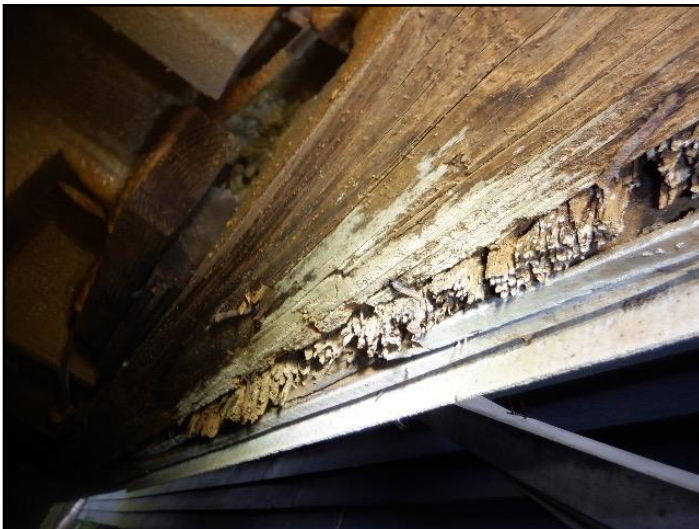
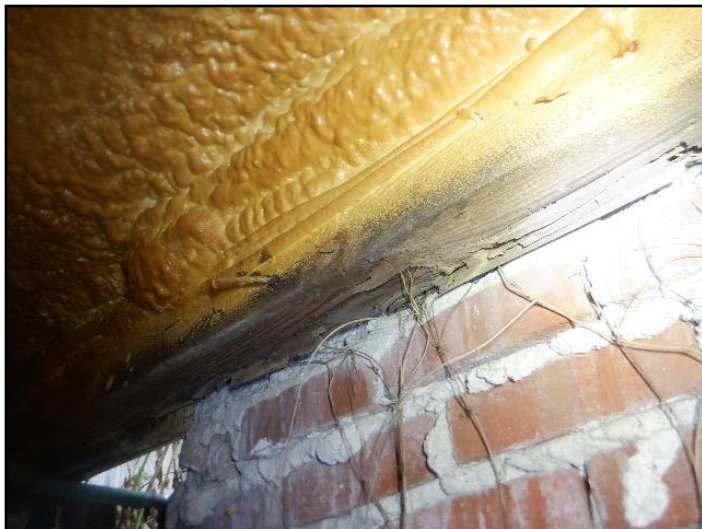
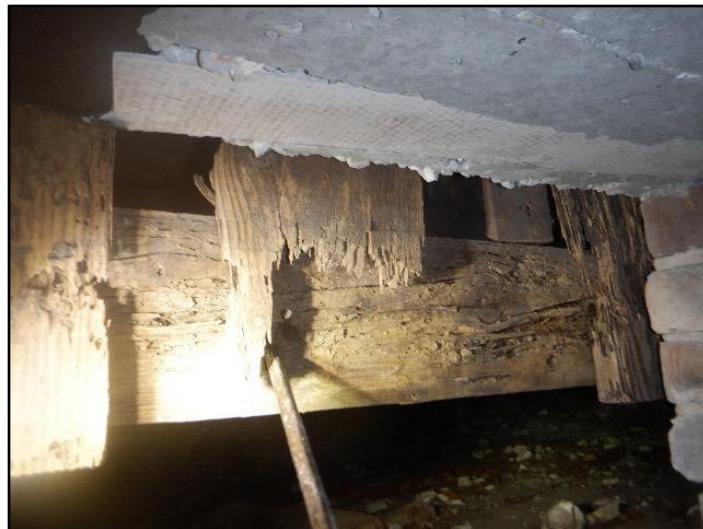
**Condition:** • [Rot or insect damage](#)

*Rot or insect damage*

It is highly recommended for termite shields to be installed when sills are replaced and piers are repaired.

**Task:** Further evaluation. Replace.

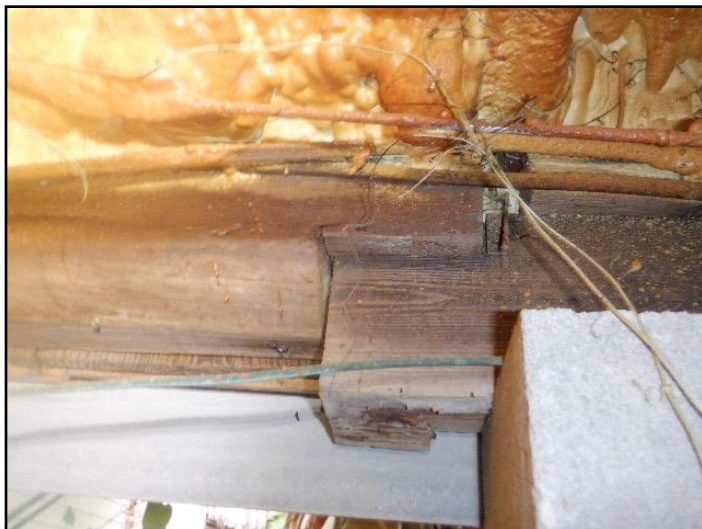
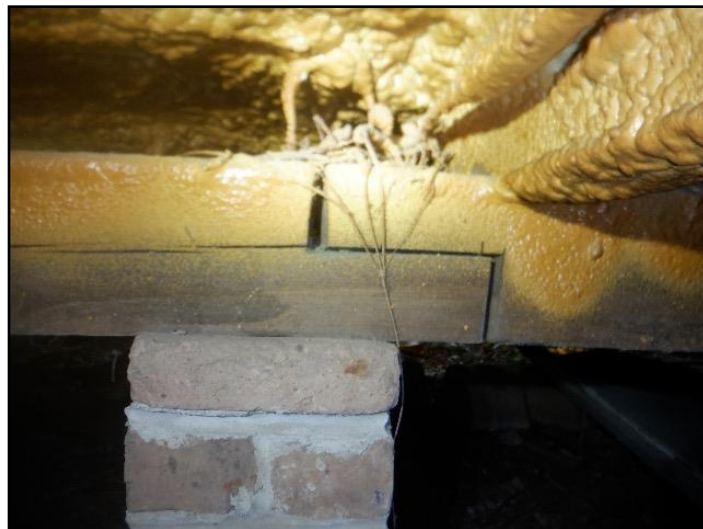
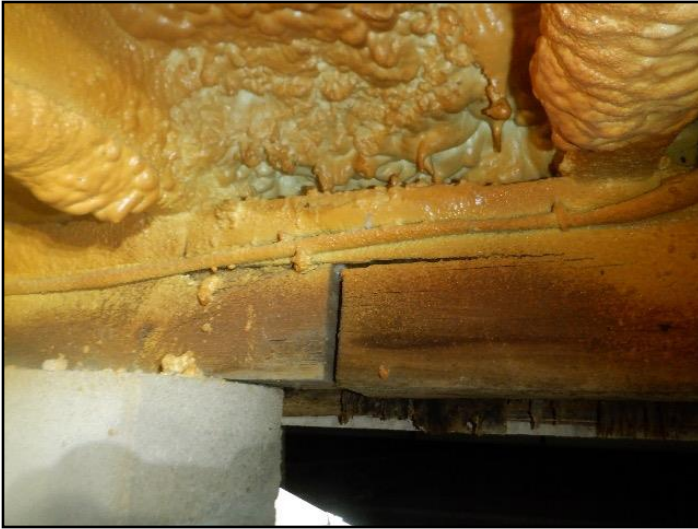
**Condition:** • Improper splicing

*Improper splicing*

**Task:** Correct.

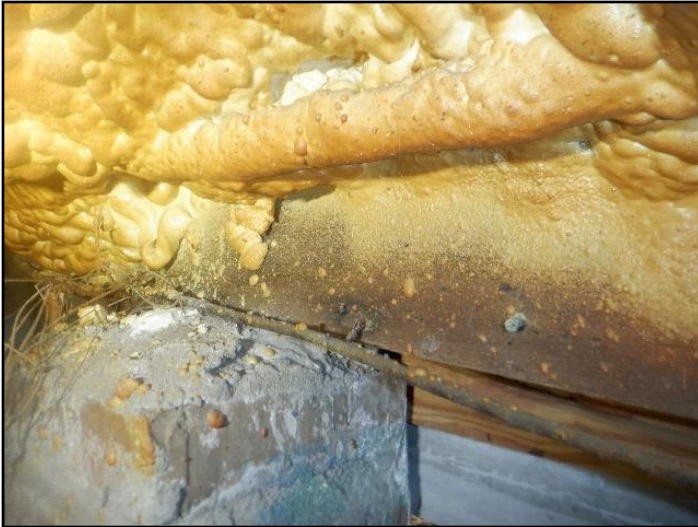
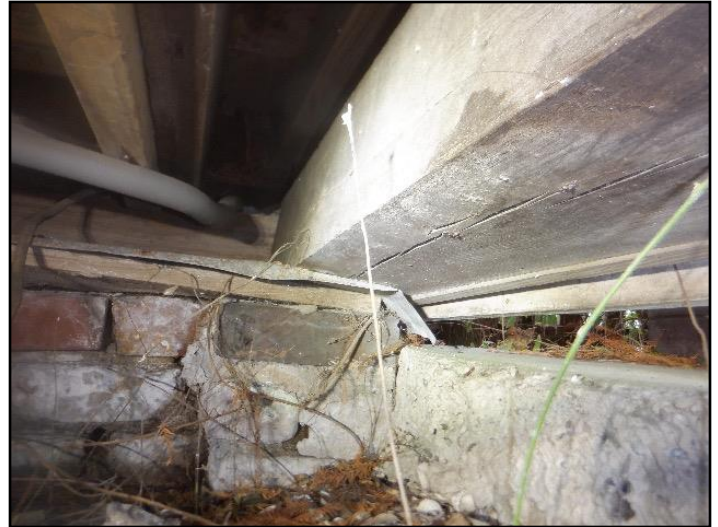
**Condition:** • Rotated

*Rotated*

**Task:** Repair.

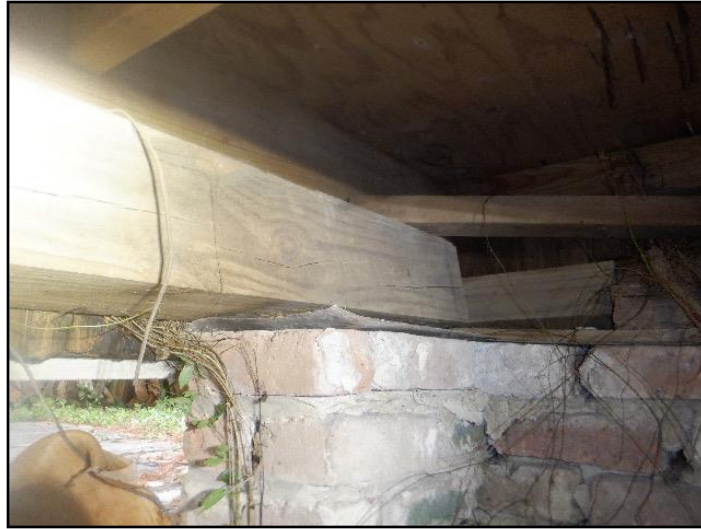
*Rotated*

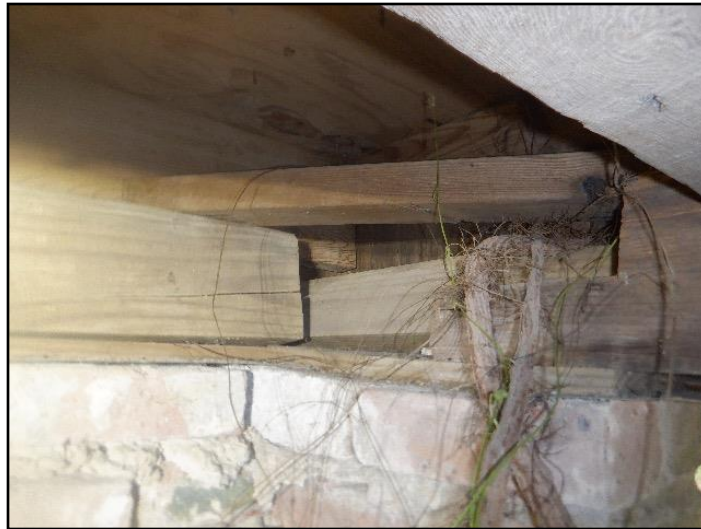
**Condition:** • Improper repair

**Location:** Crawl Space

*Improper repair*

**Task:** Replace.

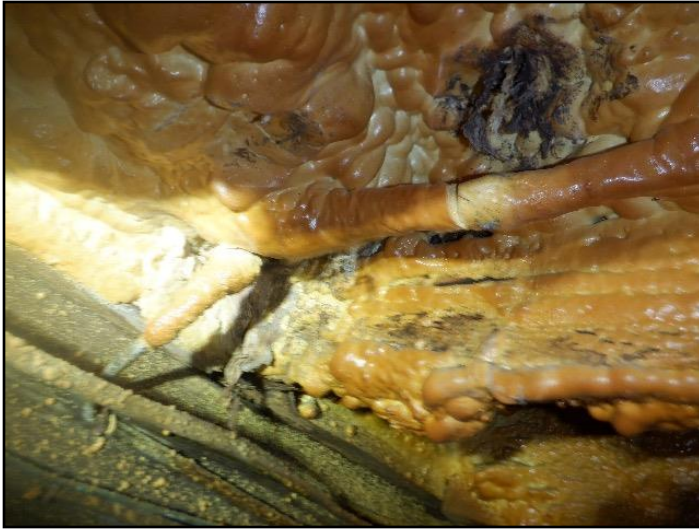
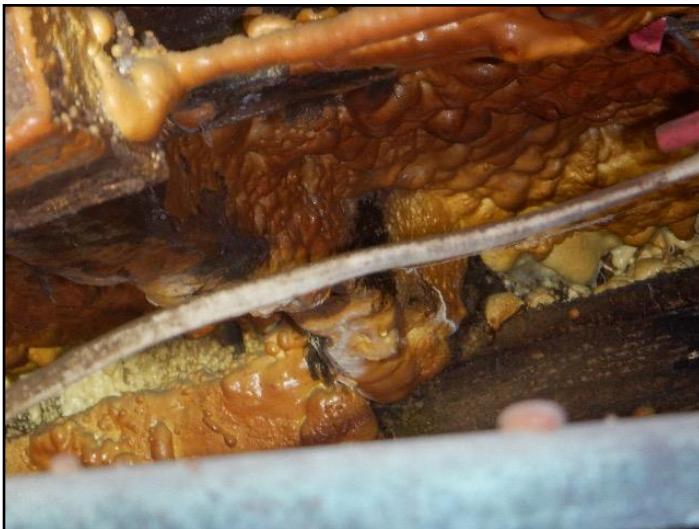
**Condition:** • Rot and/or insect damage

Damaged joists have lost some structural integrity from rot and/or insect damage. Repair by sistering is recommended. Sistering is adding a new joist to the old, attaching a same dimensional member to the damaged one with nails or bolts. The sister member should span the supporting piers if possible and this may require the area to be raised a quarter inch by jacking, in order to place the new joist into position.

*Rot and/or insect damage*

**Task:** Repair should be done by a licensed contractor.

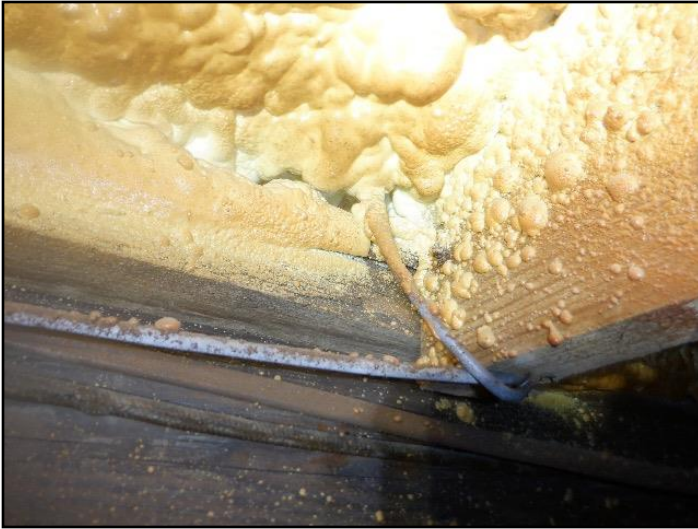
A fair amount of joists have been excessively notched when sills were replaced. The joists were originally only slightly notched and then pocketed inside the sill. When the sill was replaced, the joist was notched further to then rest on the new sill. This additional notch is excessive and greatly reduces the structural capacity of the joist, increasing the likelihood of splitting, damage, and structural movement. Sometimes a joist hanger installed under the notch can provide support. In some cases the notch is too large or too far away from the sill, where a ledger board or bounce beam may be more appropriate. Consult with structural contractor for repair options.

**Location:** Crawl Spaces

*Notched post-pocket*

**Task:** Further evaluation.

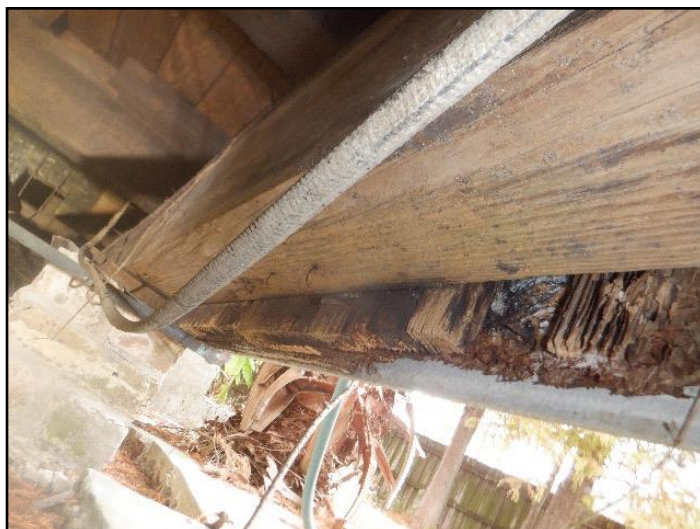
**Condition:** • Rot or insect damage

Unable to verify extent of damage to wall studs or sheathing. Hidden damage possible.

*Rot or insect damage*

**Task:** Repair.

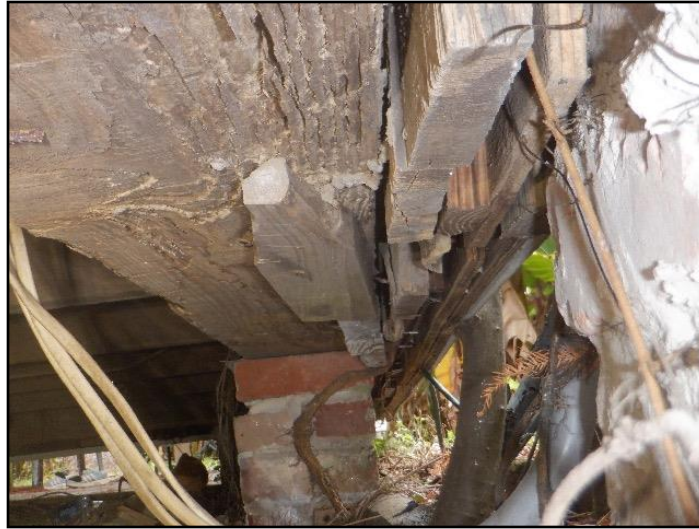
**Condition:** • Incomplete framing

*Incomplete framing*

**Task:** Repair.

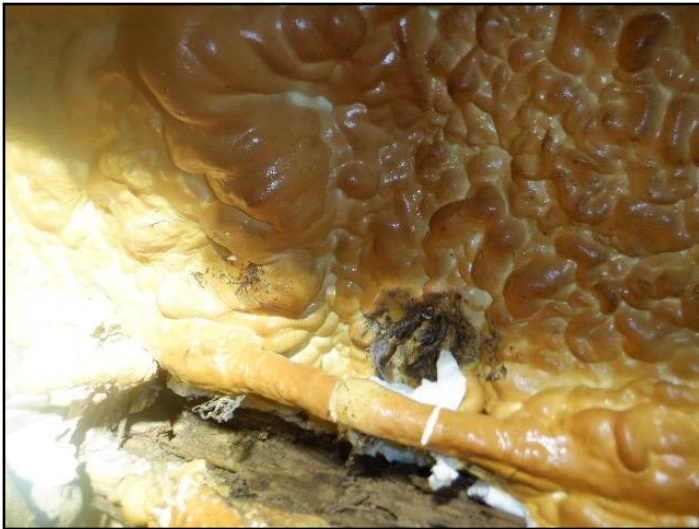
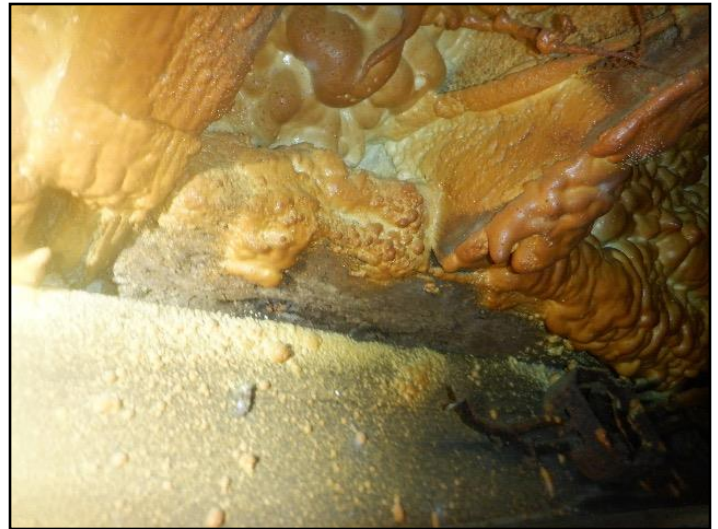
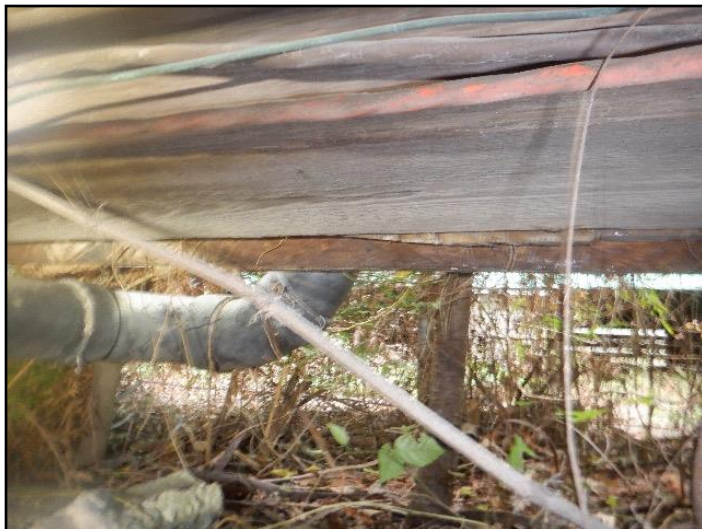
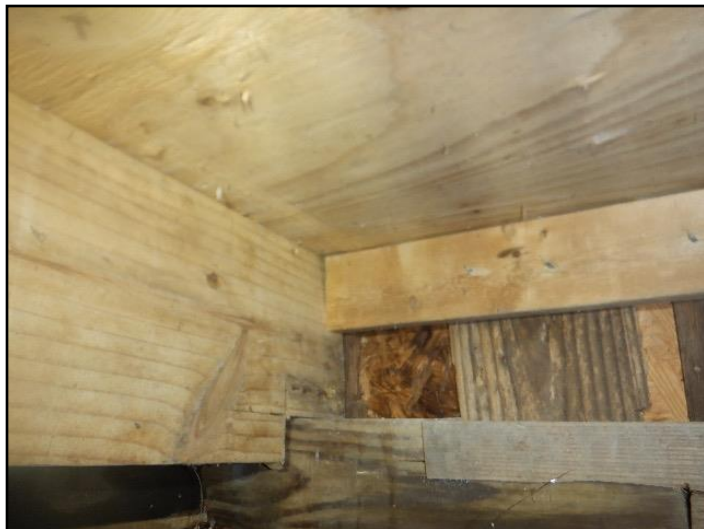
**Condition:** • Water intrusion

**Location:** Right side of rear building crawl space

*Water intrusion*

Water intrusion

**Task:** Further evaluation. Hidden damage possible.

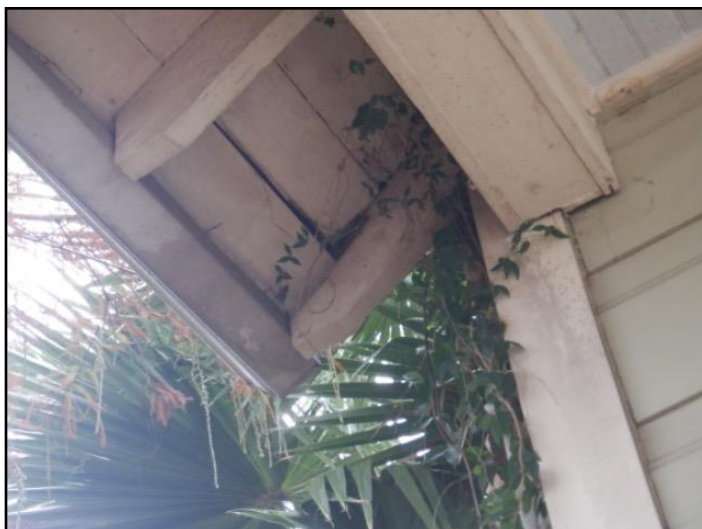
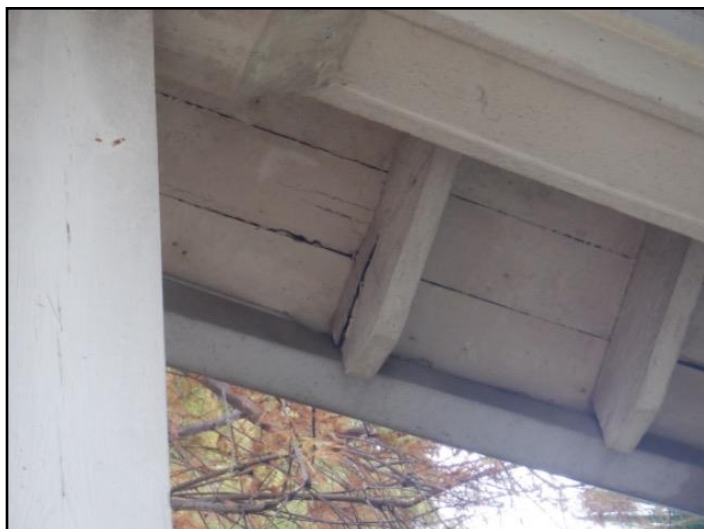
**Condition:** • Rot/insect damage

**Location:** main house exterior

Rot/insect damage

*Rot/insect damage*

**Task:** Repair

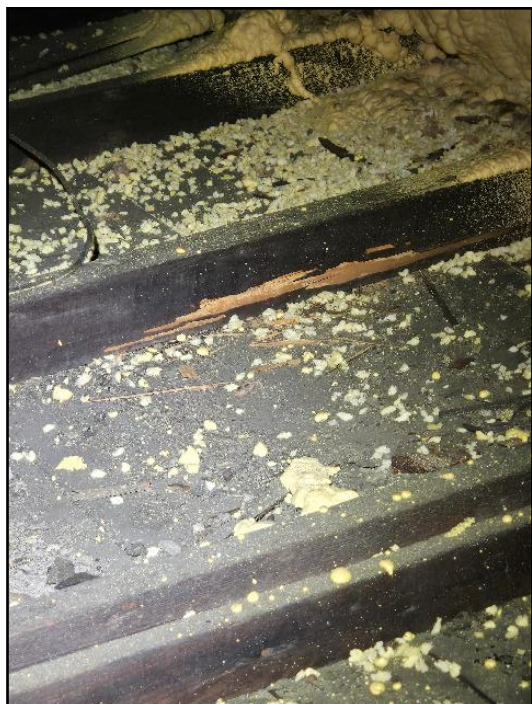
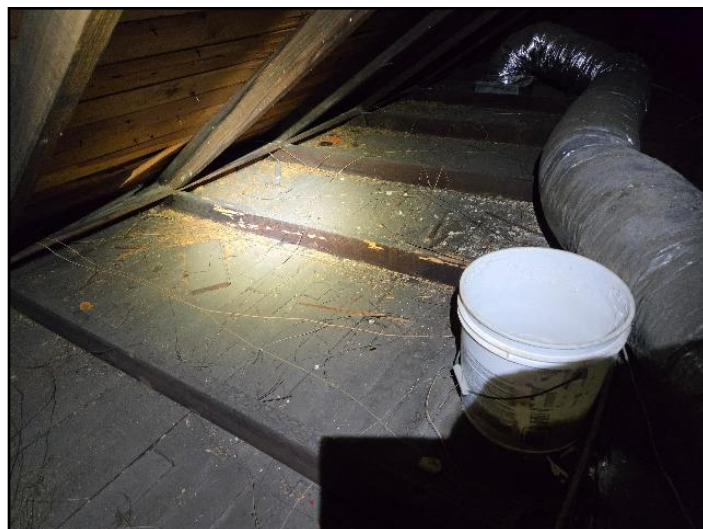
**Condition:** • Insect damage

**Location:** Rear building

*Insect damage*

**Task:** Repair. Maintain insect protection program

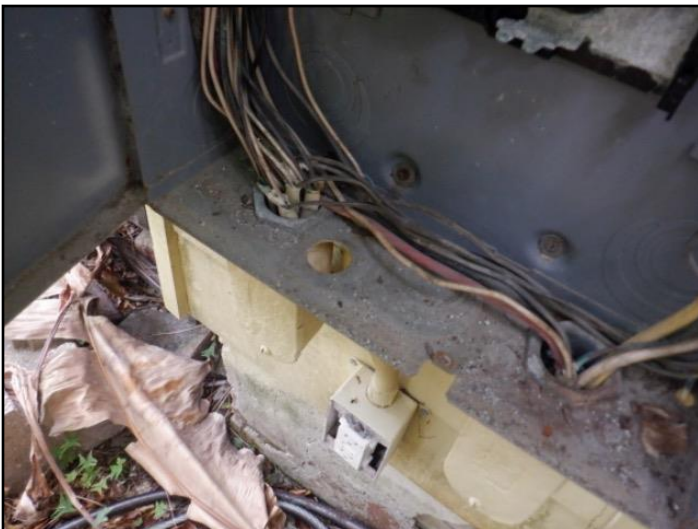
**Condition:** • [Openings in panel](#)

**Location:** rear building

Openings in panel

**Task:** Correct.

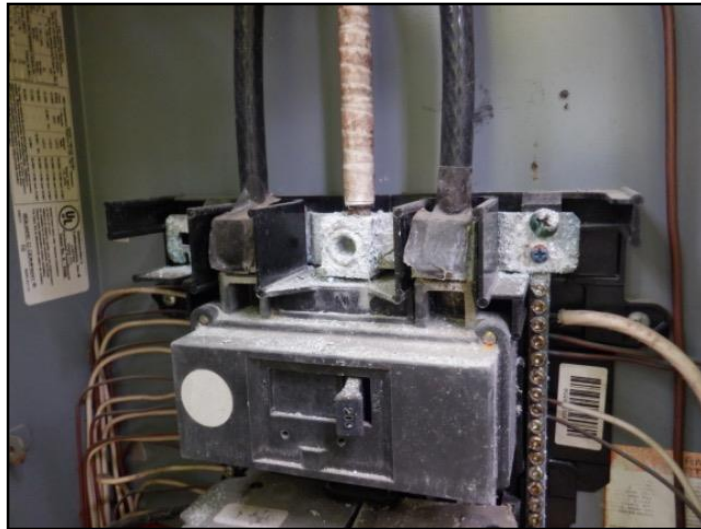
**Condition:** • Corrosion

**Location:** Rear building

*Corrosion*

**Task:** Repair.

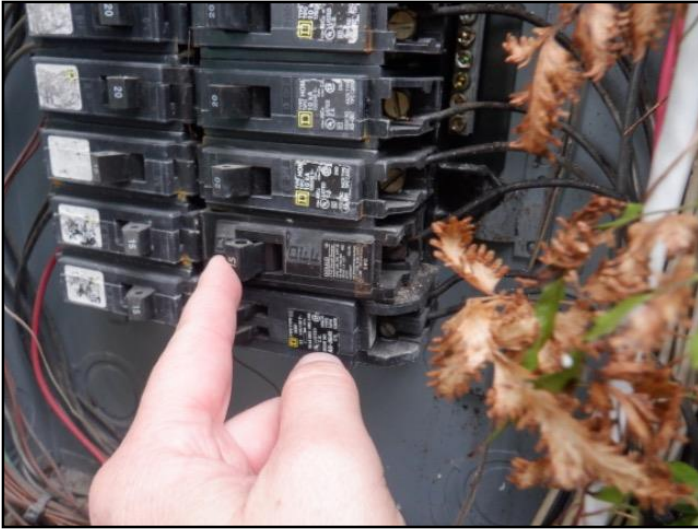
**Condition:** • Undersized breakers may cause frequent tripping. One or more breakers is connected to a wire that is too large. Though this is not a fire hazard, it may cause nuisance breaker tripping if the circuit is overloaded. No safety hazards present.

*Undersized breakers may cause frequent...*

**Task:** Repair.

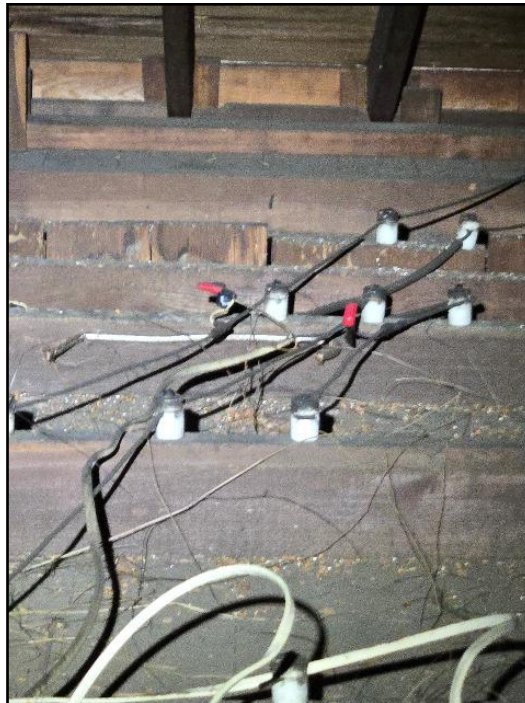
**Condition:** • Active knob and tube

Active knob and tube wiring was found. The recommendations for properties with active knob-and-tube wiring is as follows:

**Location:** Main building front attic (Some may be concealed)

**Task:** Replacement of all knob and tube wiring with current system standards.

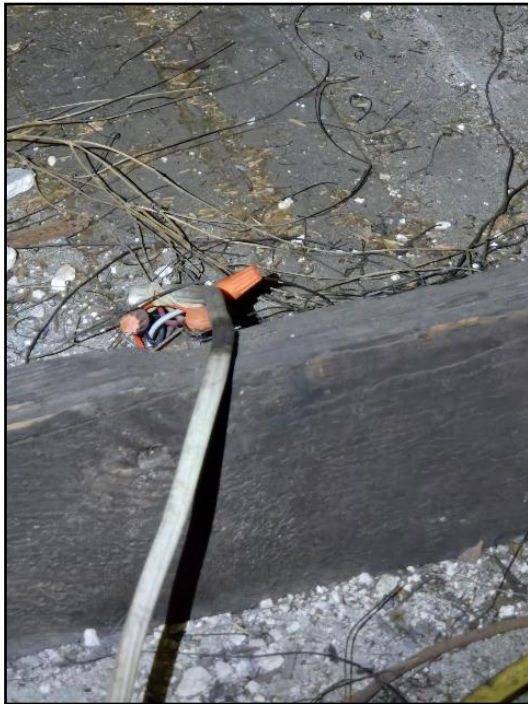
**Condition:** • [Open splices](#)

*Open splices*

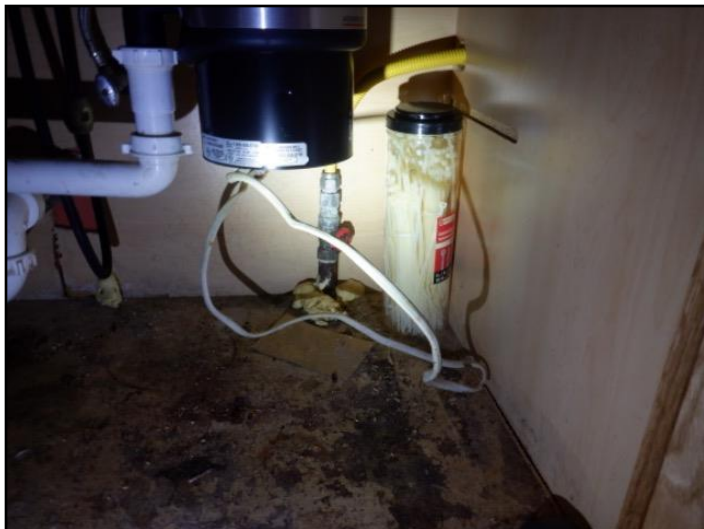
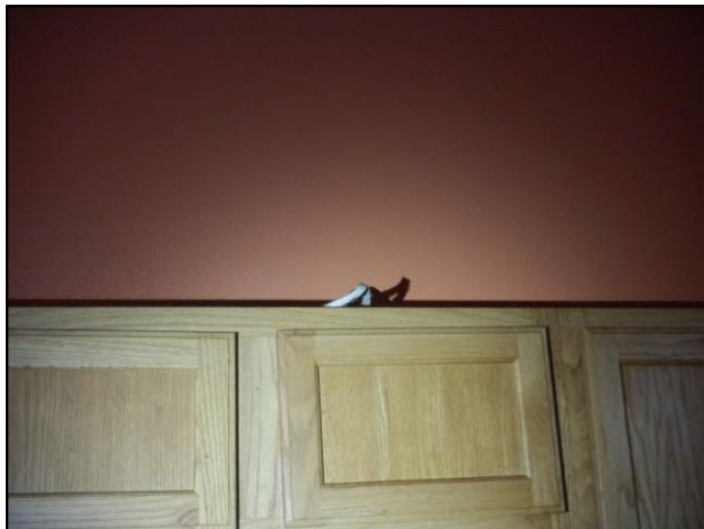
**Condition:** • Conduit needed

*Conduit needed*

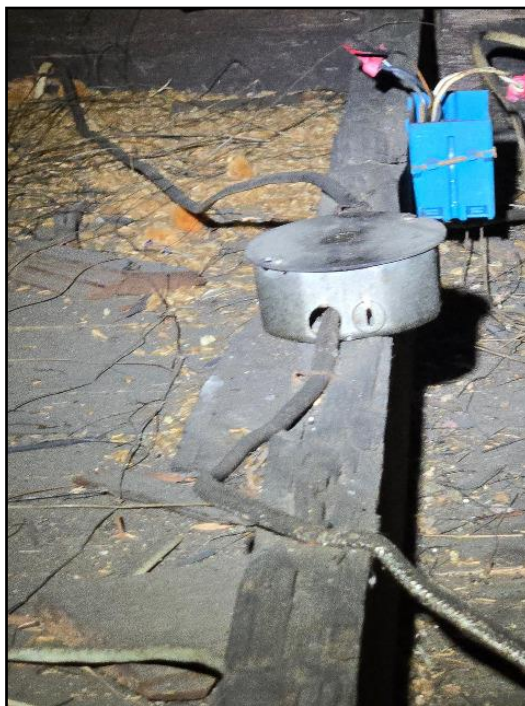
**Condition:** • Cloth wiring

Older cloth-sheathed wiring was noted in the panel or distribution system. Potential insurance issue.

*Cloth wiring*

**Task:** For information only

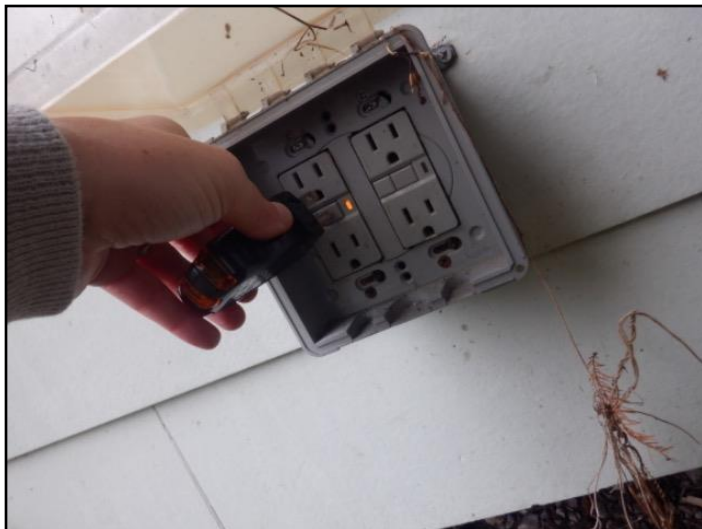
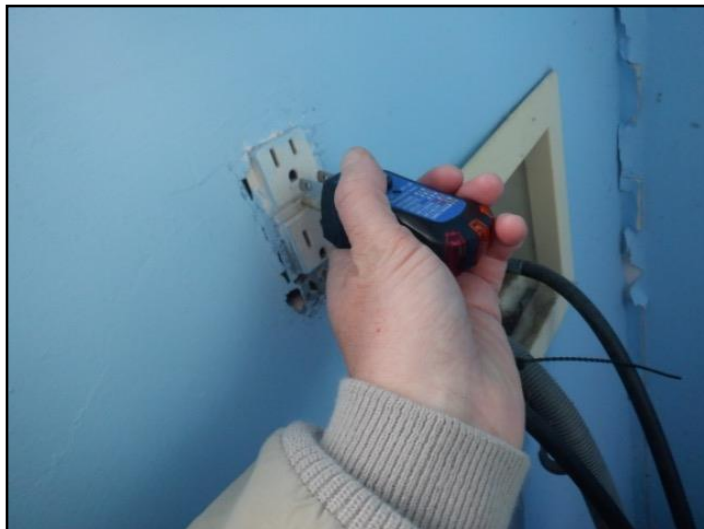
**Condition:** • GFCI was tripped and reset was inoperative.

**Task:** Repair.

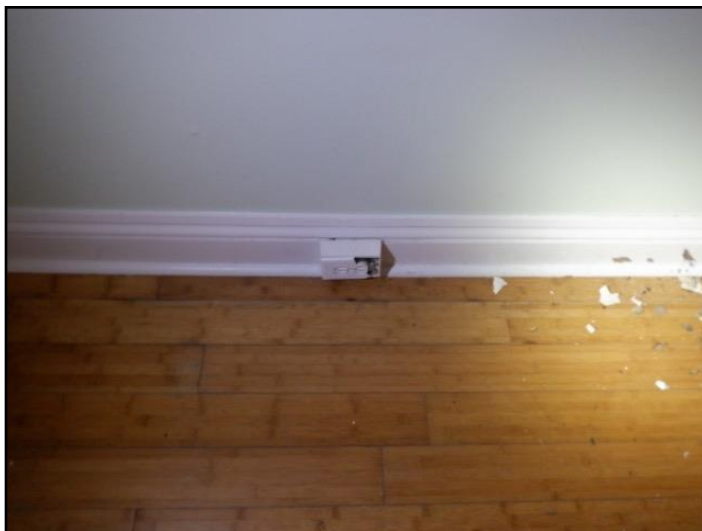
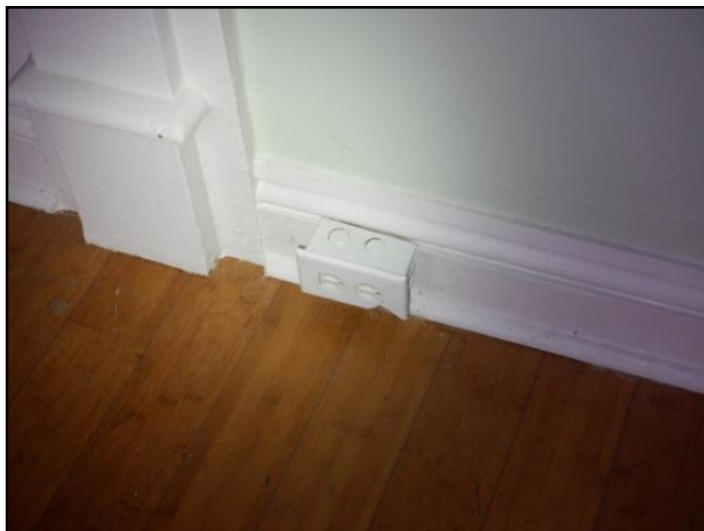
Condition: • [Damaged](#)

Location: rea building

*Damaged*

Task: Replace.

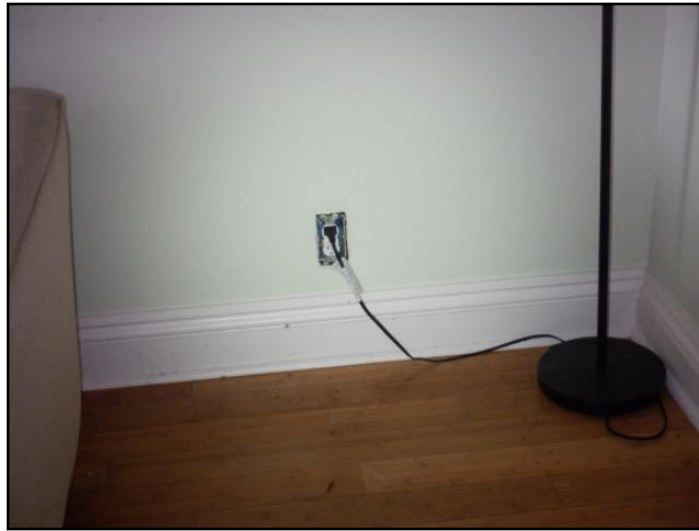
Condition: • [Missing](#)

*Missing*
