# Inspection Report

938 N Gayoso St  
New Orleans, LA 70119

**Inspection Date:**  
Monday, December 1, 2025

RE: Report No. 19955  
938 N Gayoso St  
New Orleans, LA  
70119

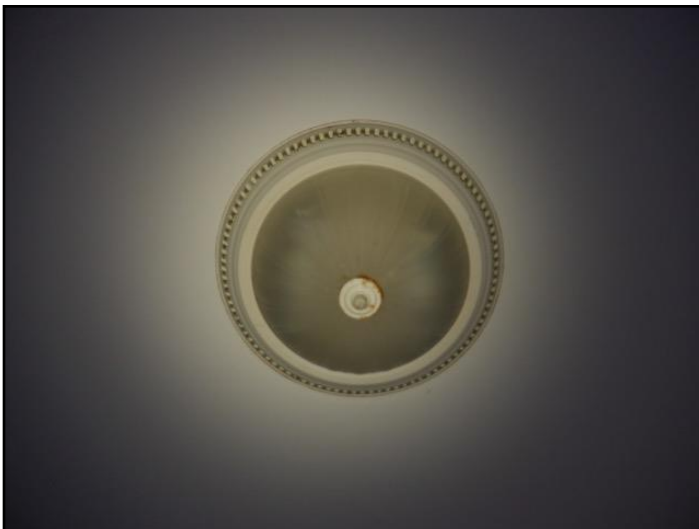
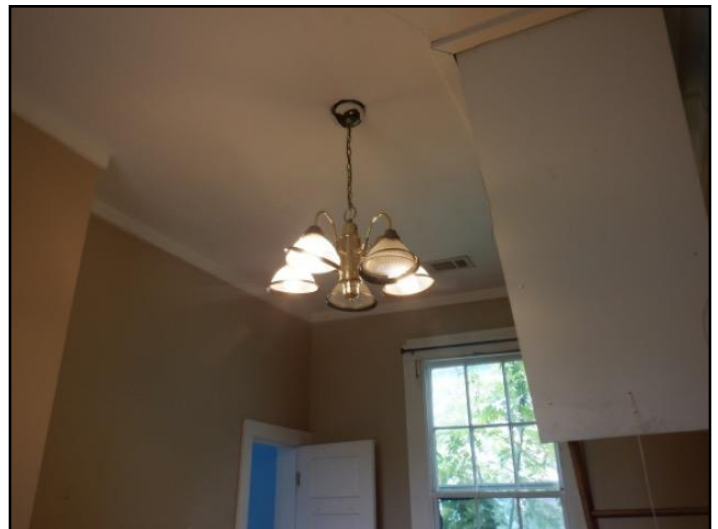
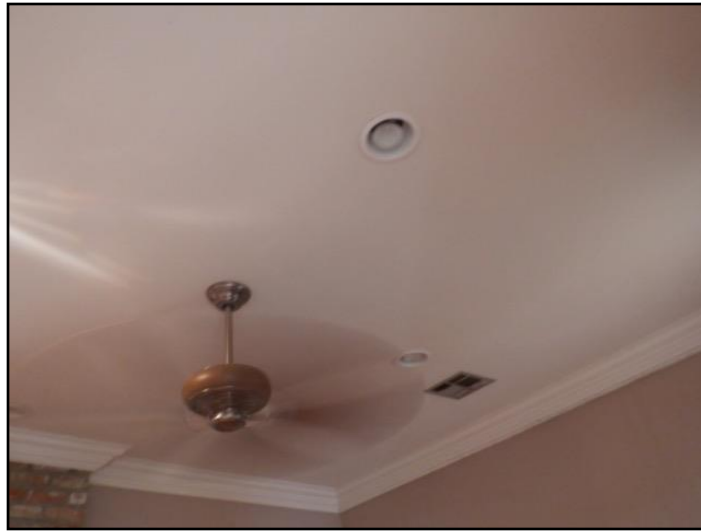
Condition: • [Inoperative](#)

Location: various

*Inoperative*

Task: Replace bulbs and test.

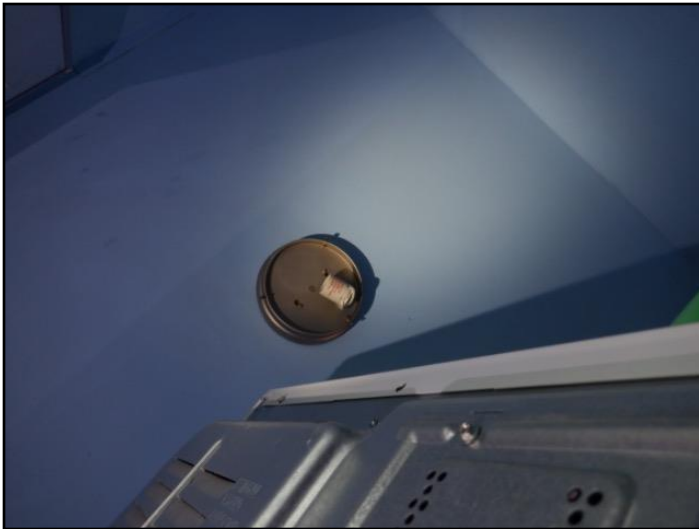
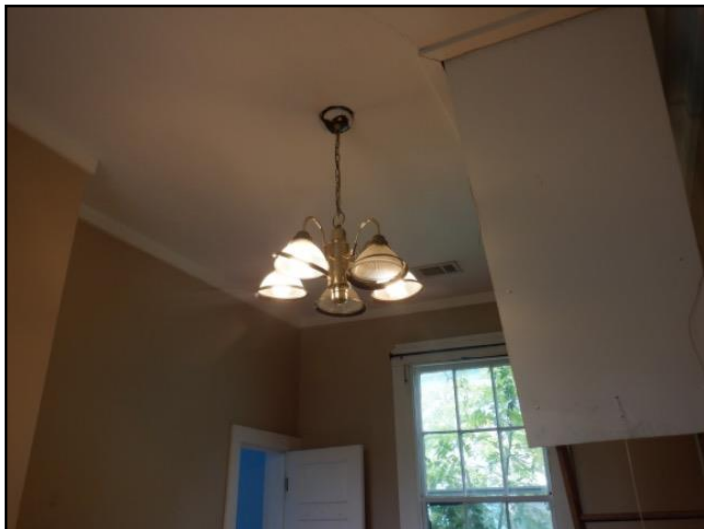
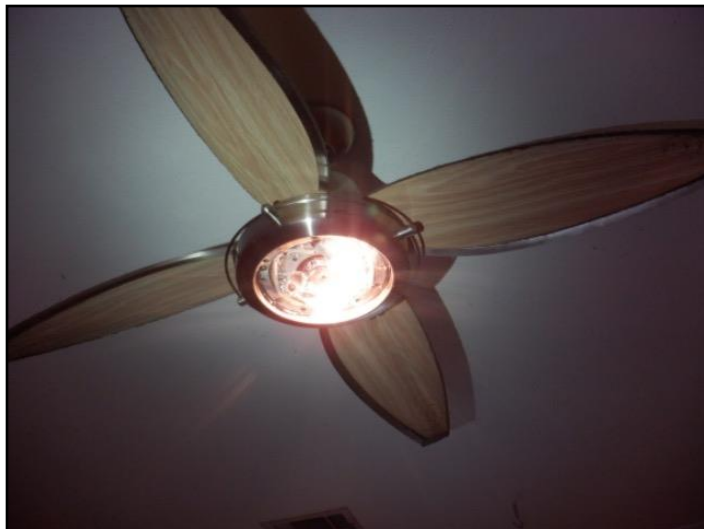
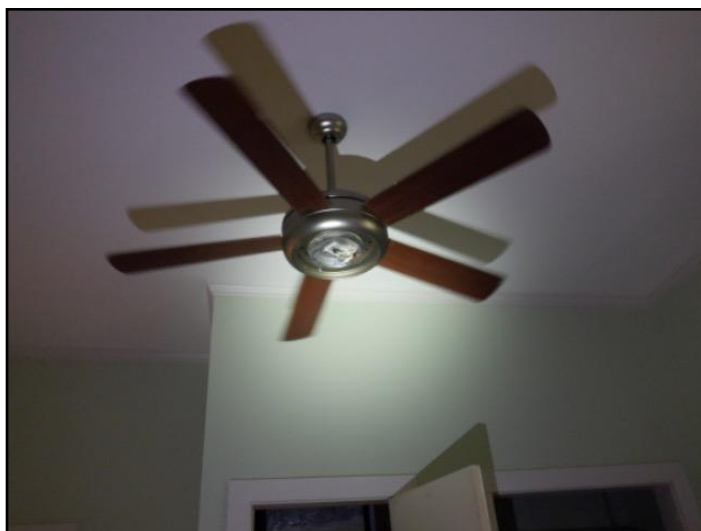
**Condition:** • Trim kit or globe is loose or missing

**Location:** various

*Trim kit or globe is loose or missing*

**Task:** Install.

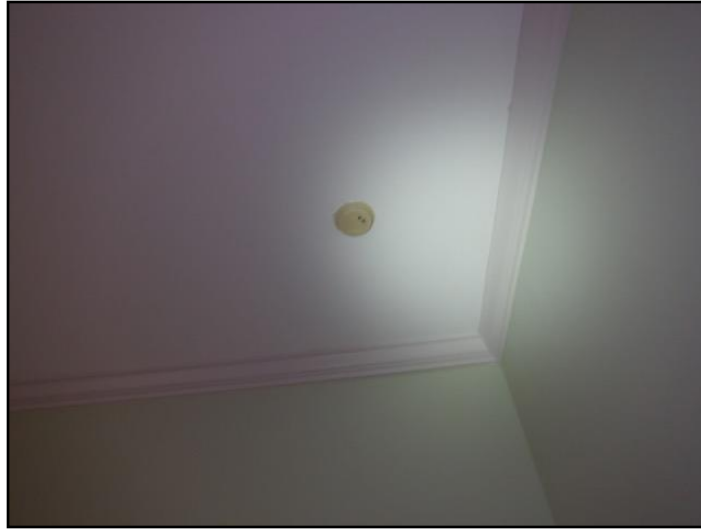
**Condition:** • Past life expectancy

*Past life expectancy***Condition:** • [Reminder to replace units when necessary](#)

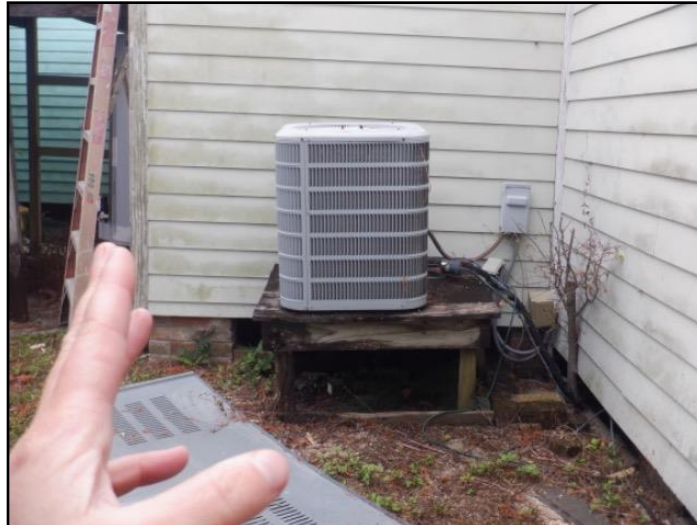
**Condition:** • Not level

The compressor should be level (within roughly ten degrees). The compressor or the refrigerant lines may be damaged if the unit is out of level.

*Not level*

**Task:** Further evaluation. Correct.

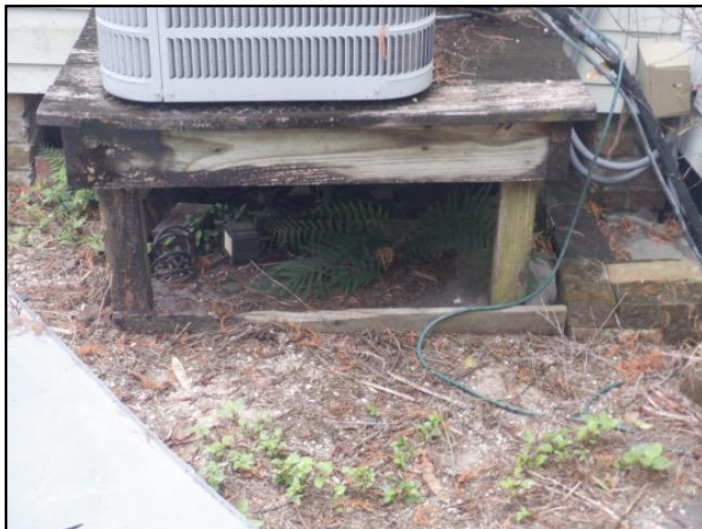
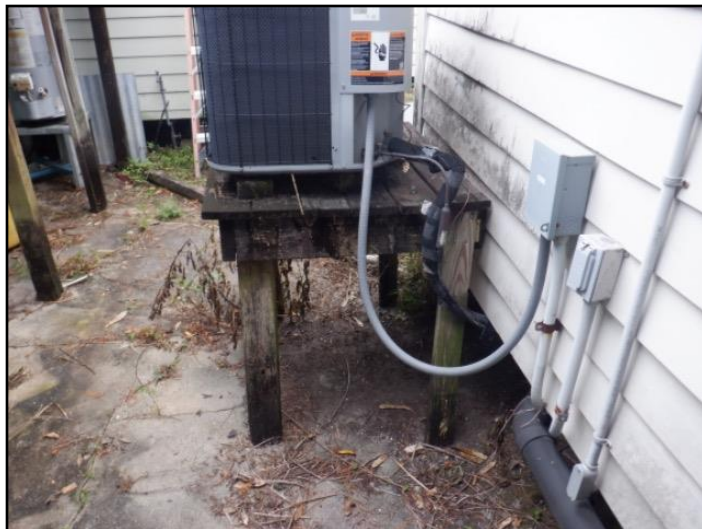
**Condition:** • Suspect platform

Suspect platform

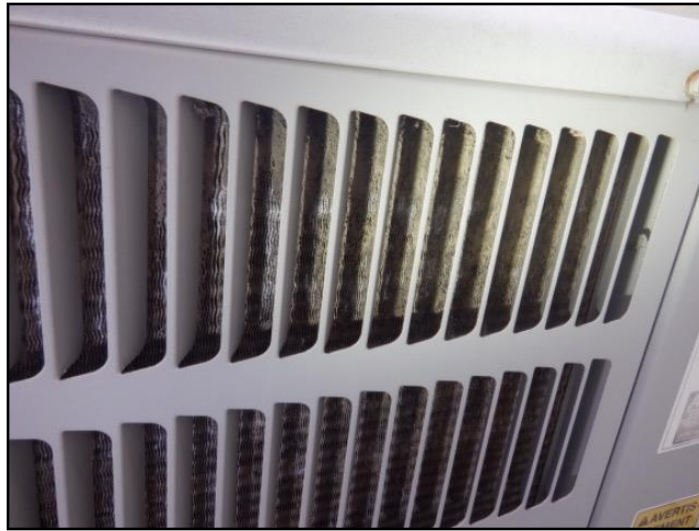
Condition: • [Dirty](#)

*Dirty*

Task: Service. Clean.

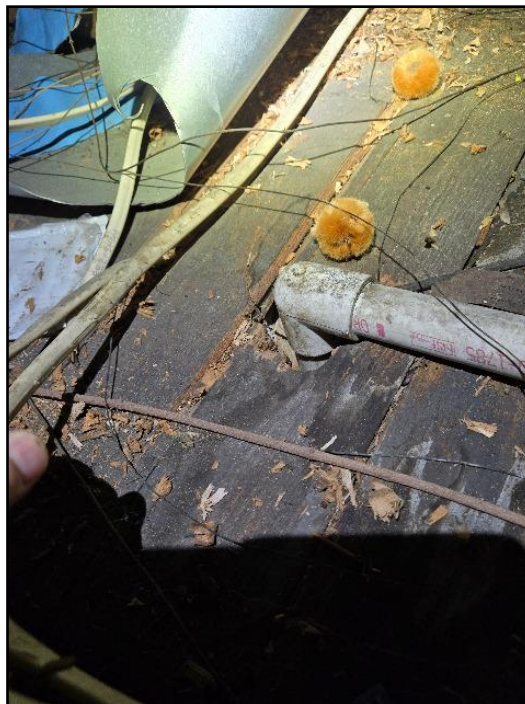
There was no trap observed on the primary drain line at the time of the inspection. This can cause sewer gases from the line to be blown back into the unit.

No trap

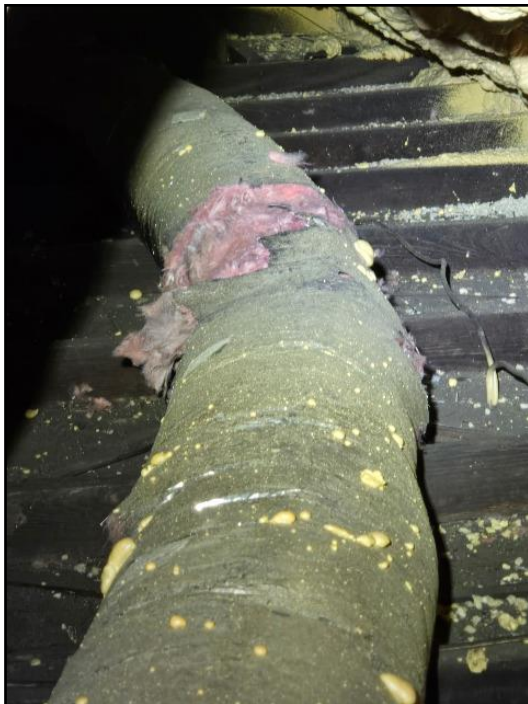
The ductwork was not well supported in all areas. Ducts should be suspended from and not in contact with the framing, the ground, or other ducts (best practice). Poor support could reduce airflow and efficiency, and can cause condensation to form in and around the ductwork, which can cause water intrusion and possible mold. Recommend properly supporting ducts approximately every five feet with proper supports.

Poor support

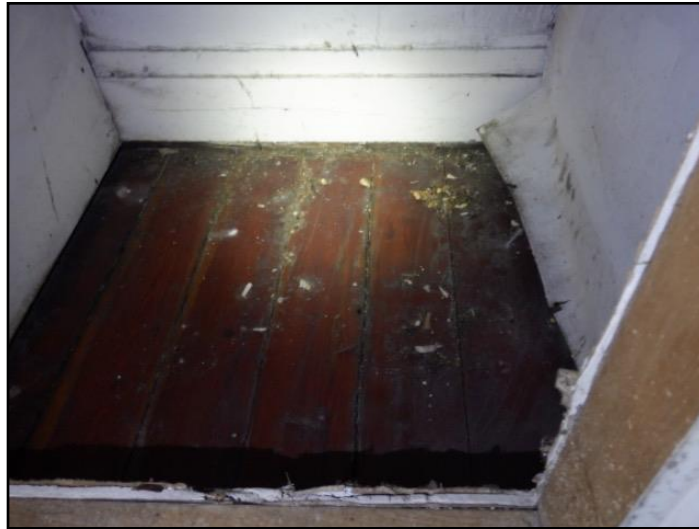
**Condition:** • Return air chase unfinished.

Openings in the return can cause unfiltered air to enter the equipment, which can reduce the performance and efficiency of the HVAC system.

*Return air chase unfinished.*

It is recommended to cover the walls and floor of the return chase with fiberglass duct board and seal all seams.

**Task:** Improve.

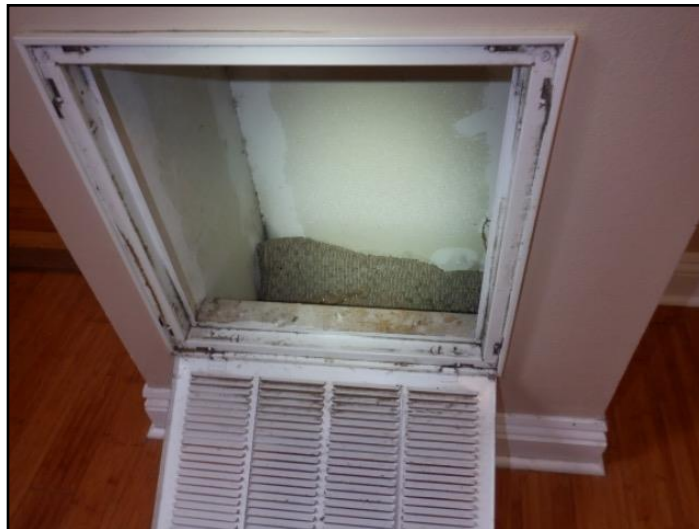
**Condition:** • Air return chase dirty

*Air return chase dirty*

**Task:** Clean.

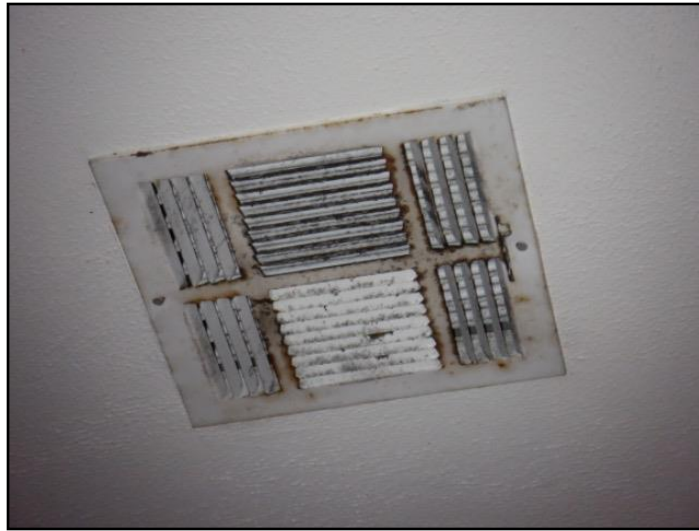
**Condition:** • Possible mold or microbial growth

This is likely due to condensation build-up and air leaks at the register connection.

*Possible mold or microbial growth*

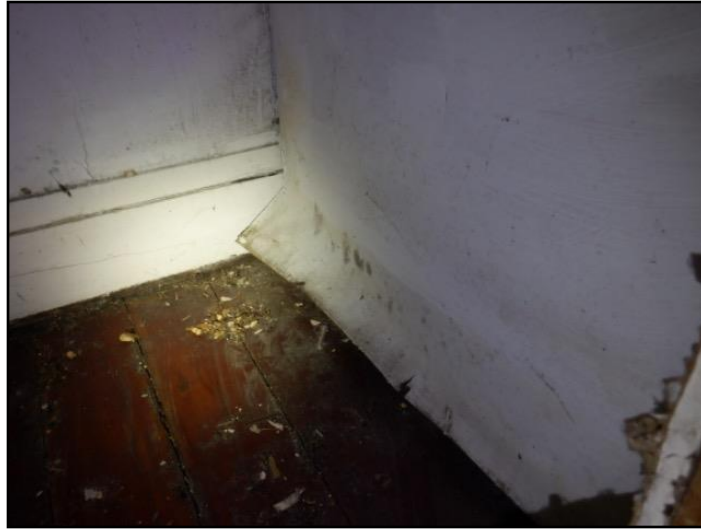
**Condition:** • Water damage in return air chase.

**Task:** Repair. Possibility of hidden mold growth - see appendix.

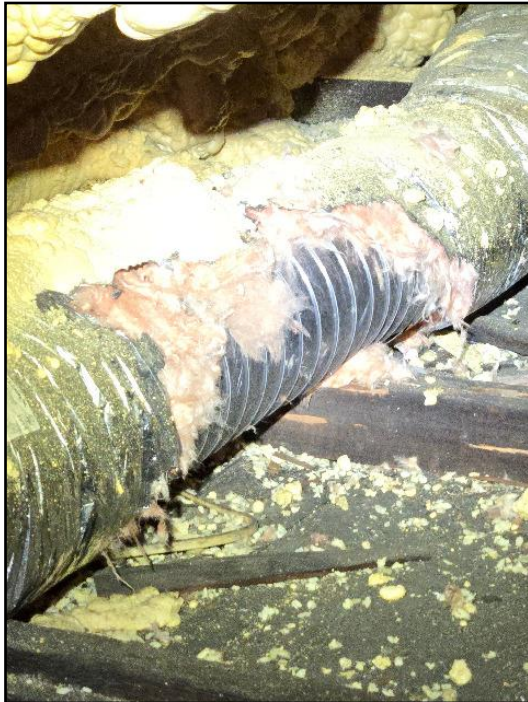
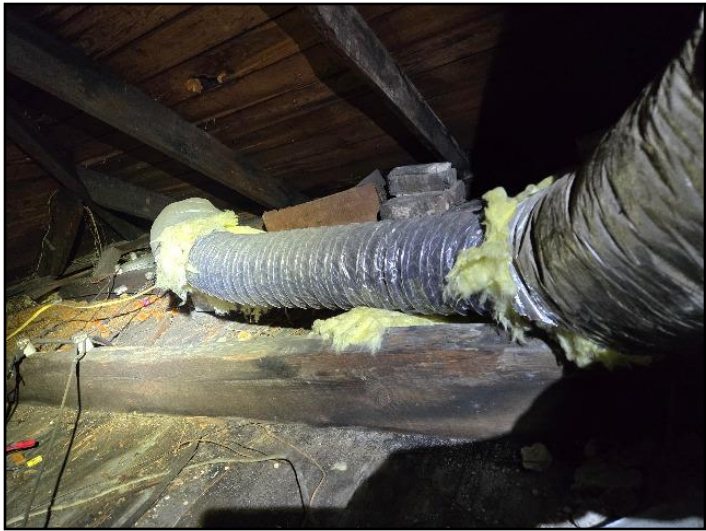
Damaged insulation is torn and missing in many places, exposing the metal duct. Insulation should completely cover duct from air handler to register.

*Damaged*

Damaged

**Task:** Repair or replace

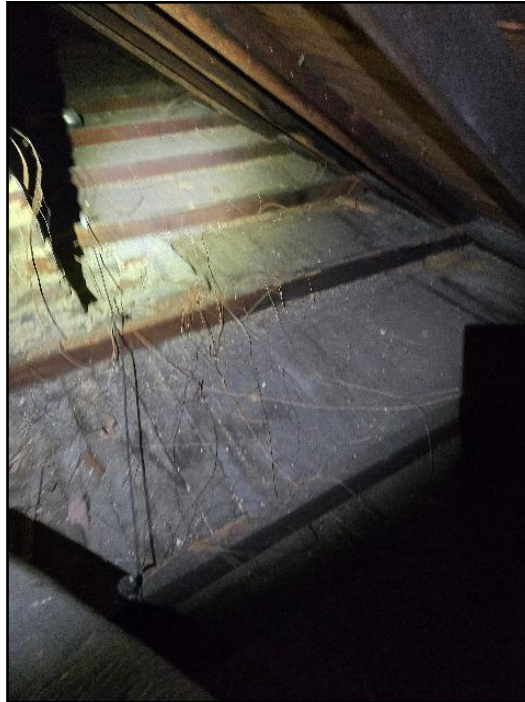
There is little to no attic insulation. R-30 is considered the current standard in this climate zone. There are many insulation options that include fiberglass laid between the ceiling joists, or loose cellulose blown in.

*Missing throughout*

**Task:** Install

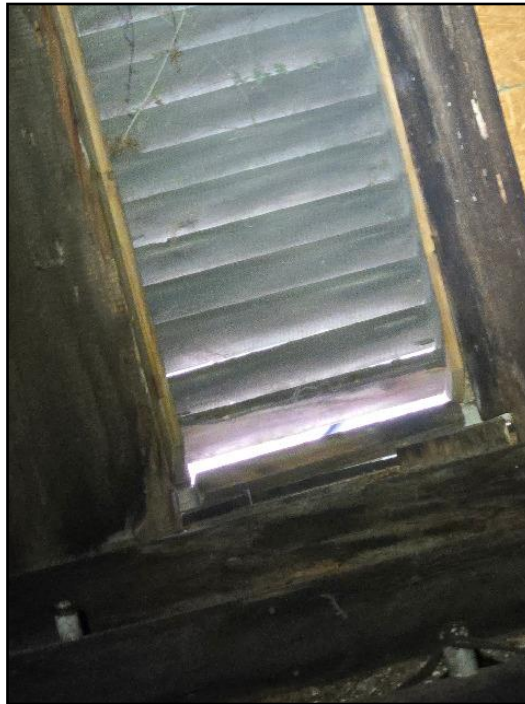
**Condition:** • Missing screen

*Missing screen*

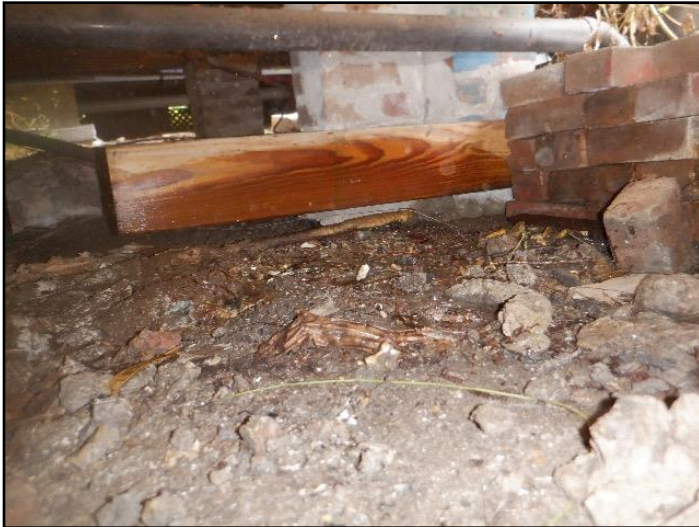
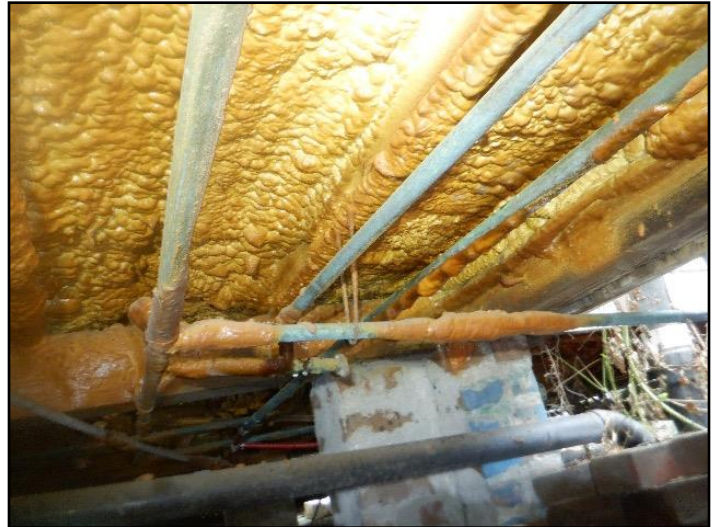
Condition: • [Leak](#)

Leak

Task: Repair.

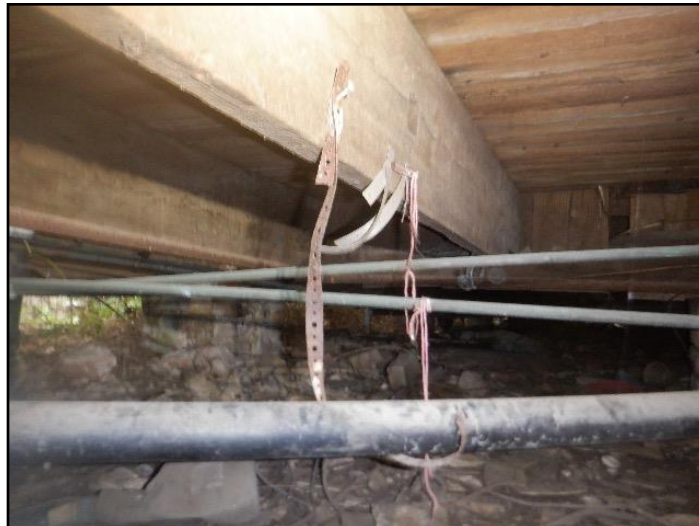
Condition: • [Poor support](#)

Poor support

Task: Correct.

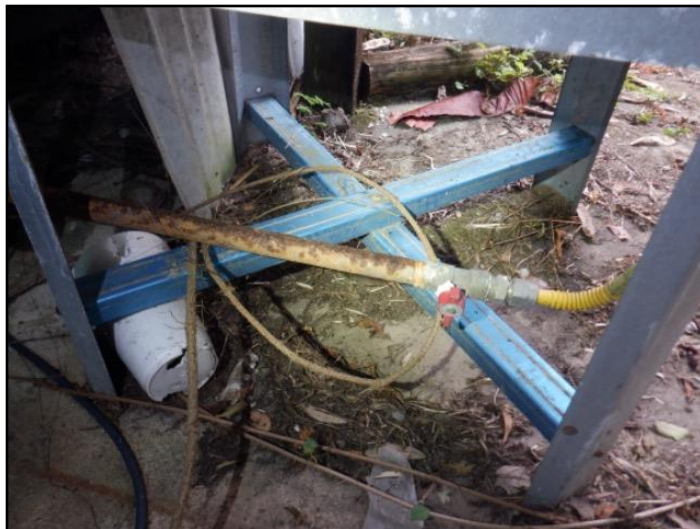
Condition: • [Rust](#)

*Rust*

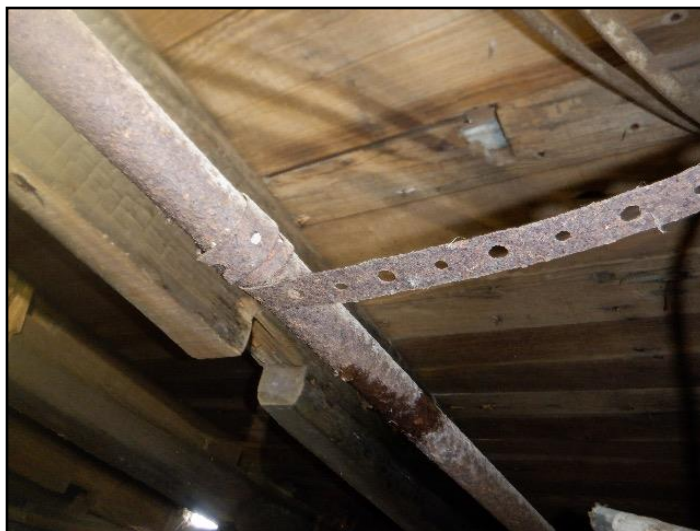
**Condition:** • [Inadequate support](#)

**Location:** Crawl Space

*Inadequate support*

**Task:** Remedy.

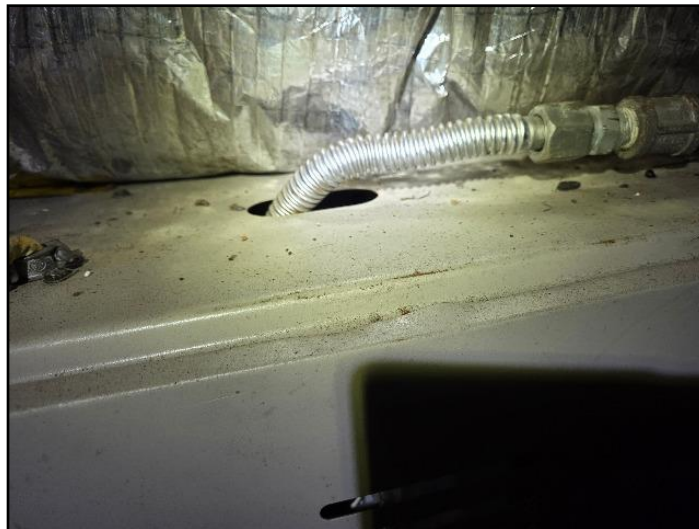
**Condition:** • Passes through an appliance housing

*Passes through an appliance housing*

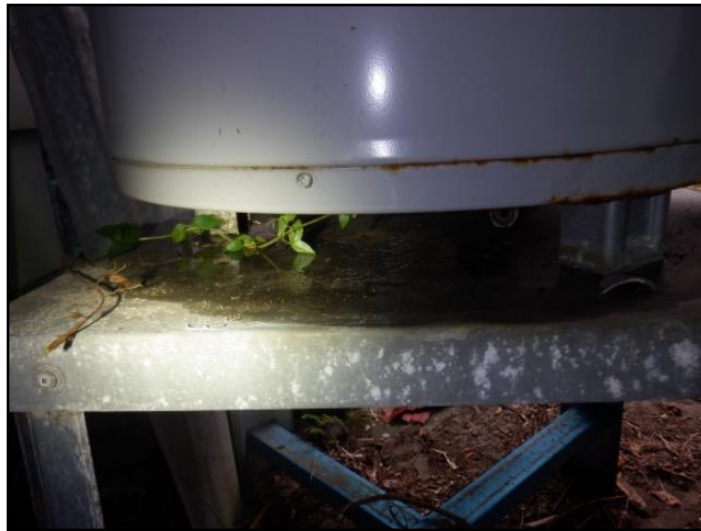
**Condition:** • [Leak](#)

**Location:** Main Building

*Leak*

**Task:** Repair or replace.

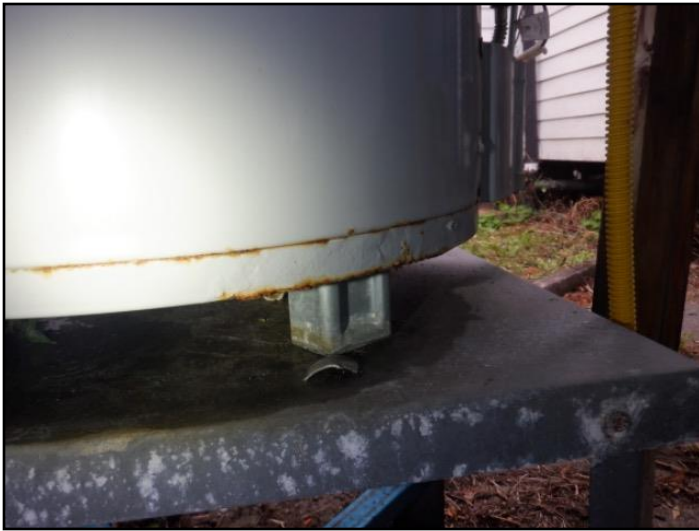
**Condition:** • [Rust](#)

There is rust on the outer lining of the water heater. The outer lining is a protected shell, and it is a minor concern if it is rusted. However, if rust penetrates to the inner lining, the tank may be at risk of leaking. Rust appears superficial, however, consulting with a licensed plumber is suggested.

Rust

**Task:** Further evaluation. Monitor and budget to replace.

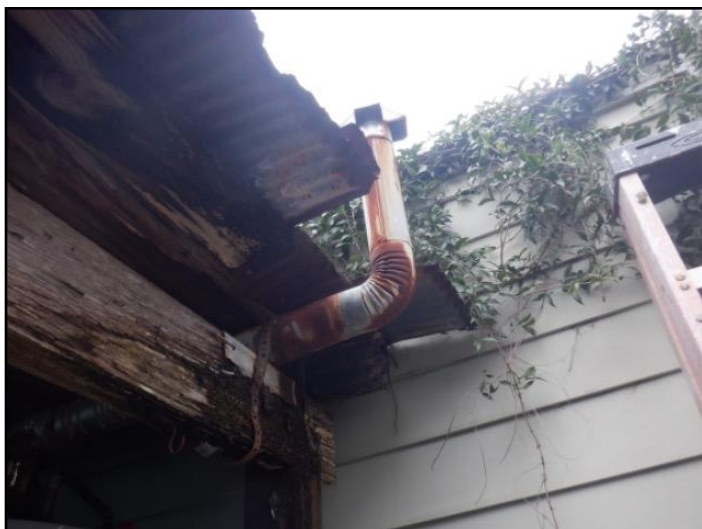
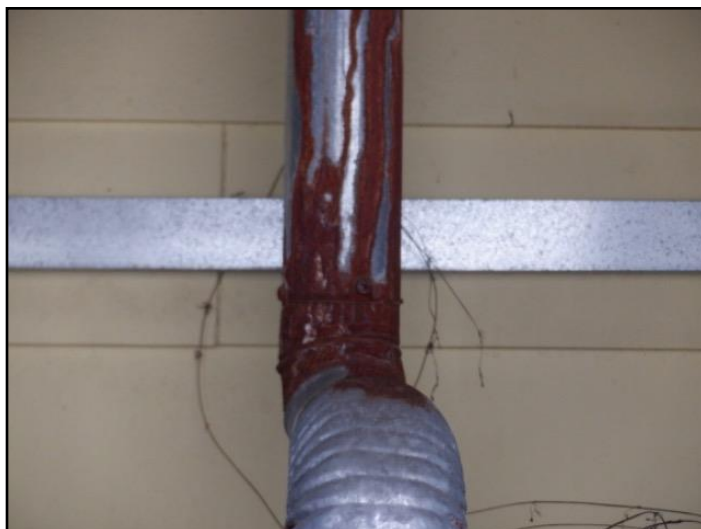
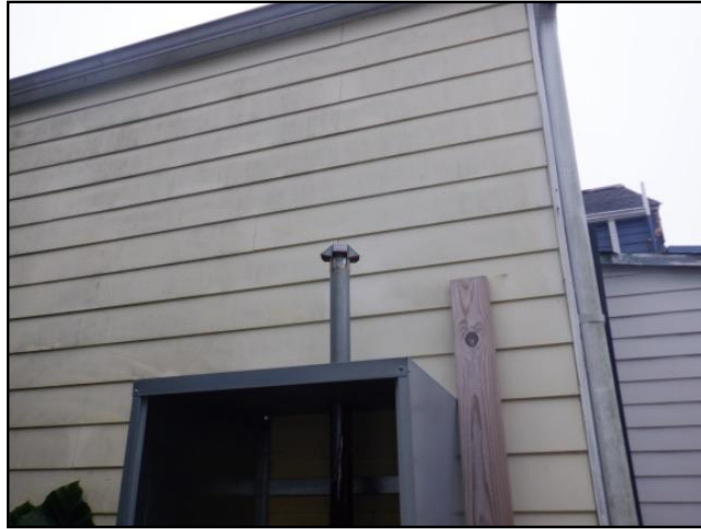
**Condition:** • Vents were rusted, damaged, had poor connections and did not terminate high enough.

**Location:** Throughout

**Task:** Repair.

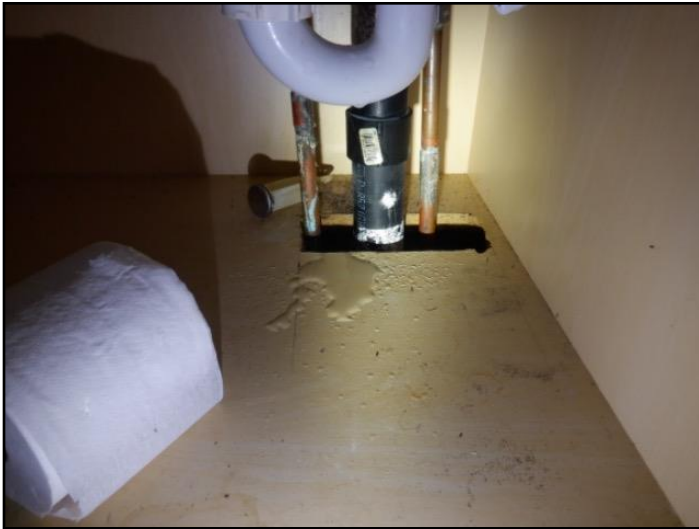
**Condition:** • Leak

**Location:** main house bathroom, crawl space

Leak

**Task:** Repair.

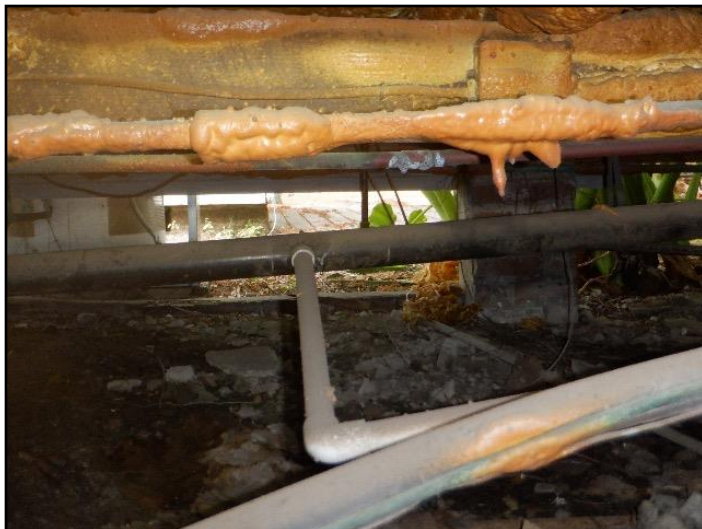
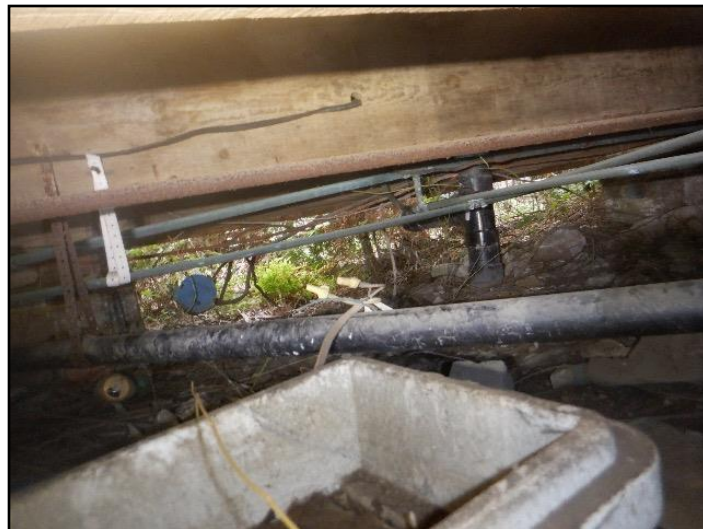
**Condition:** • [Poor support](#)

Poor support

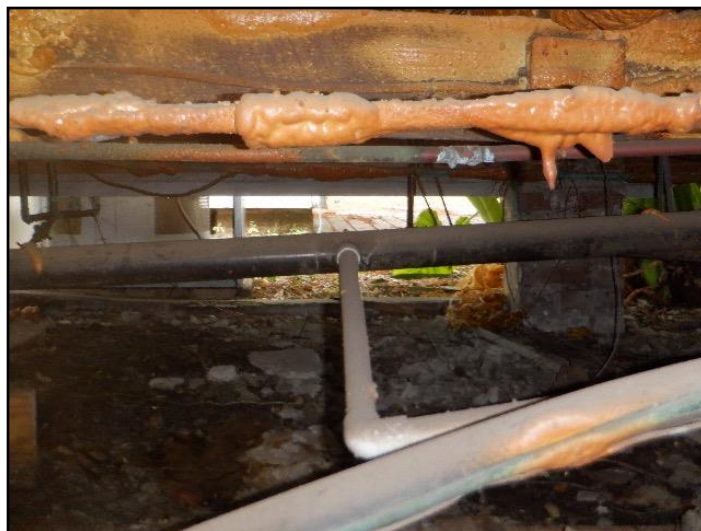
**Condition:** • Reverse/improper slope

**Location:** Crawl Space

Reverse/improper slope

**Task:** Correct.

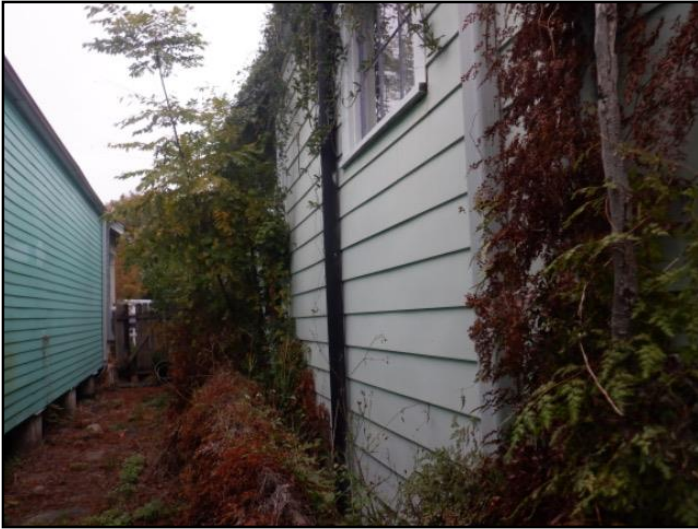
**Condition:** • ABS is susceptible to UV damage and should be painted where exposed to sunlight.

*ABS is susceptible to UV damage and should...*

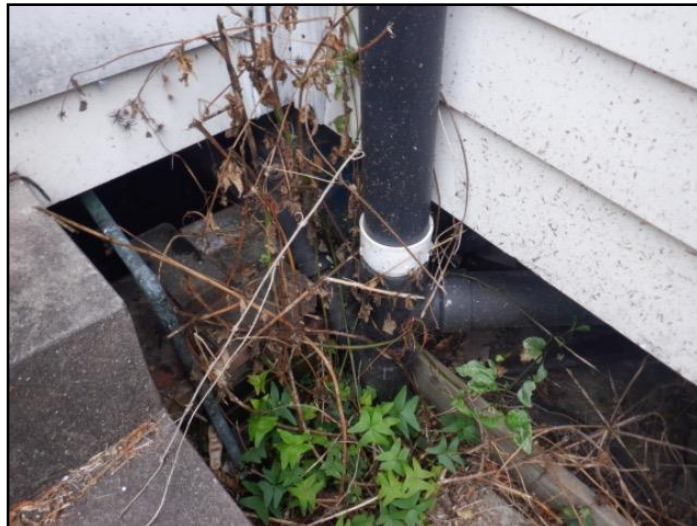
## **Condition:** • PVC/ABS connections

PVC/ABS connections are prone to leakage. These dissimilar plastics have different expansion rates which will cause connections to eventually loosen and leak. The only approved method of connecting the two materials is to use a mechanical transition coupling such as one that consists of a neoprene rubber sleeve that fits over each pipe, tightened with a stainless steel metal jacket and integral clamps. While ABS/PVC adhesive exists it is no longer considered an appropriate joining method. It is best practice to have as few of these connections as possible.

**Location:** rear building

*PVC/ABS connections*

**Task:** Correct.

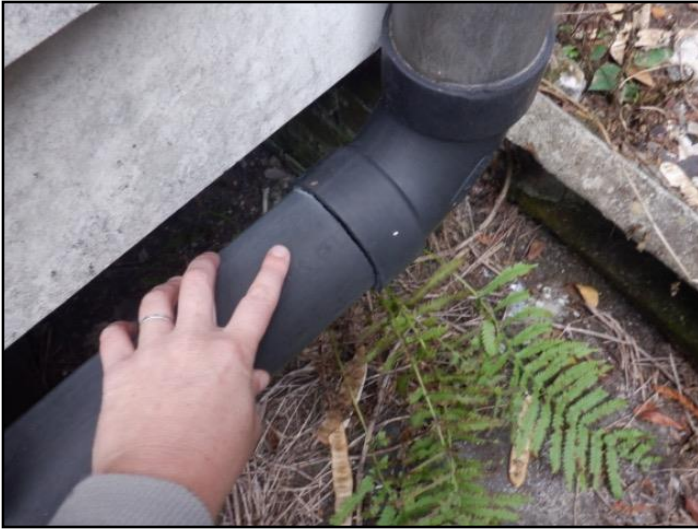
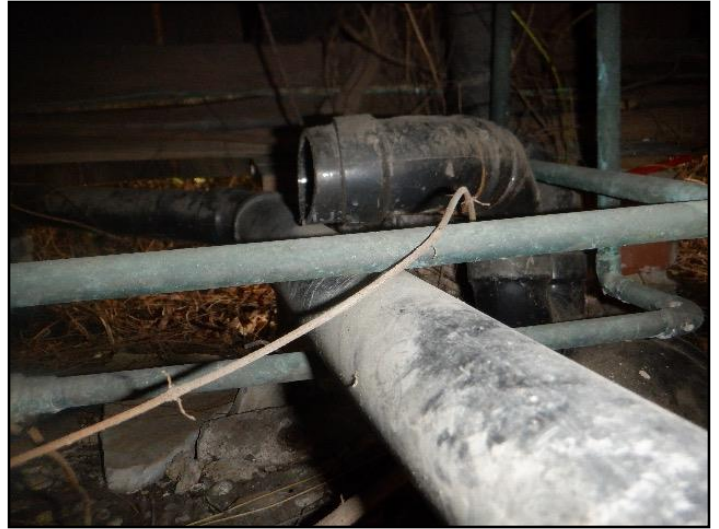
## **Condition:** • Disconnected

Disconnected

**Task:** Repair.

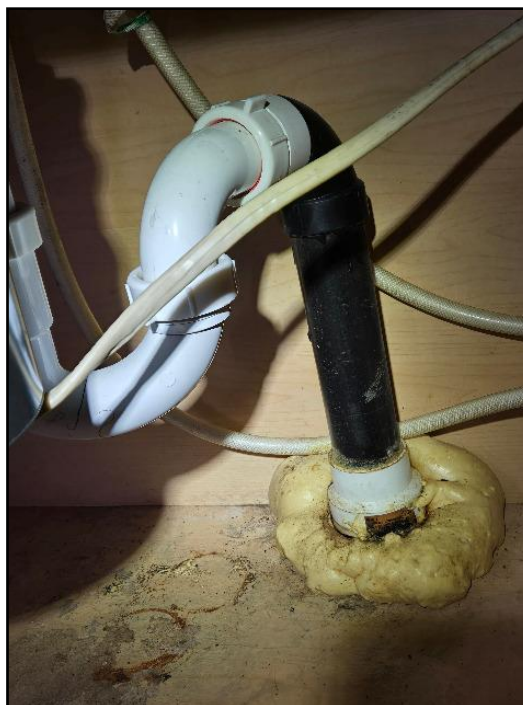
**Condition:** • S-trap

S-trap(s) observed. These can lead to siphoning. As the last bit of water flows down the drain, a vacuum forms at the top part of the trap, air from the basin pushes the water out of the bottom of the trap, allowing odors into the building.

*S-trap*

**Task:** Replace with P-trap.

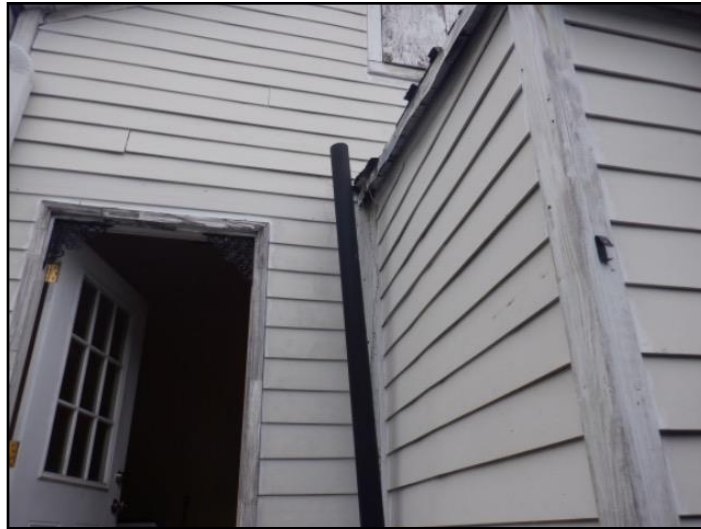
**Condition:** • Poor support

**Location:** rear building

*Poor support*

**Task:** Repair.

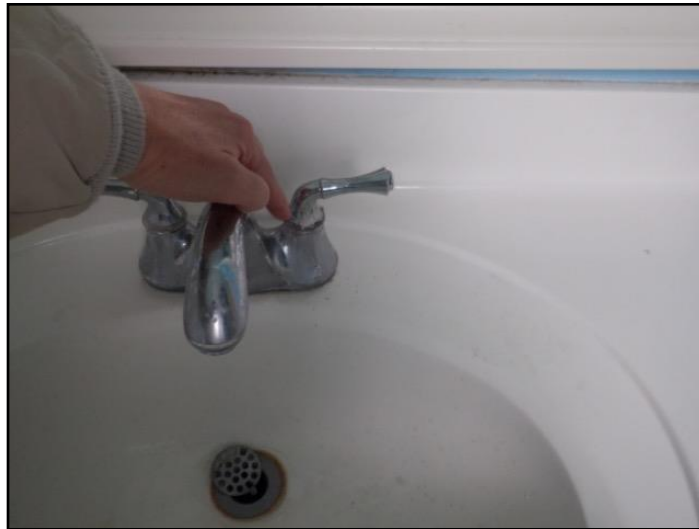
**Condition:** • [Drip, leak](#)

*Drip, leak*

**Task:** Repair.

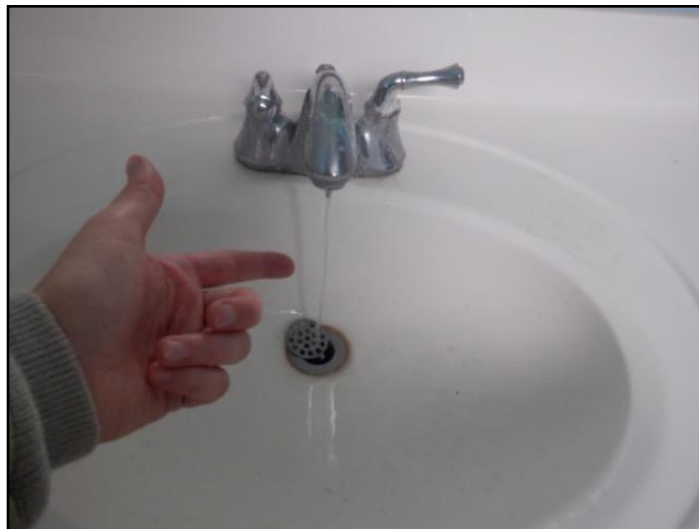
**Condition:** • Weak pressure or flow

**Location:** main house bathroom sink

*Weak pressure or flow*

**Task:** Remedy.

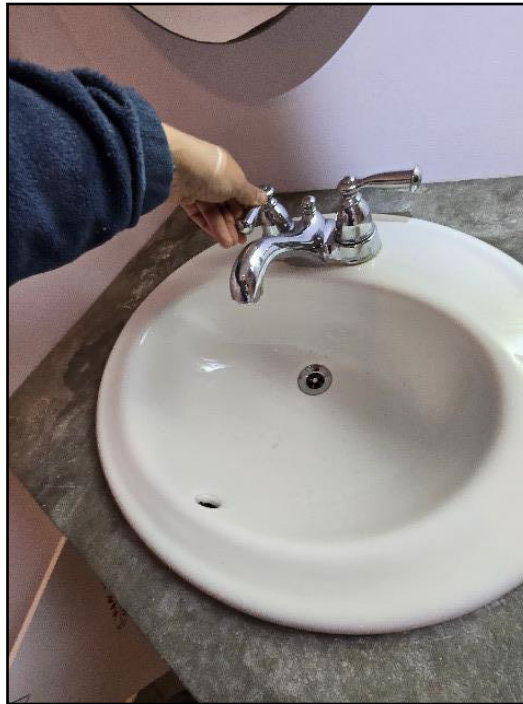
**Condition:** • No hot water

*No hot water*

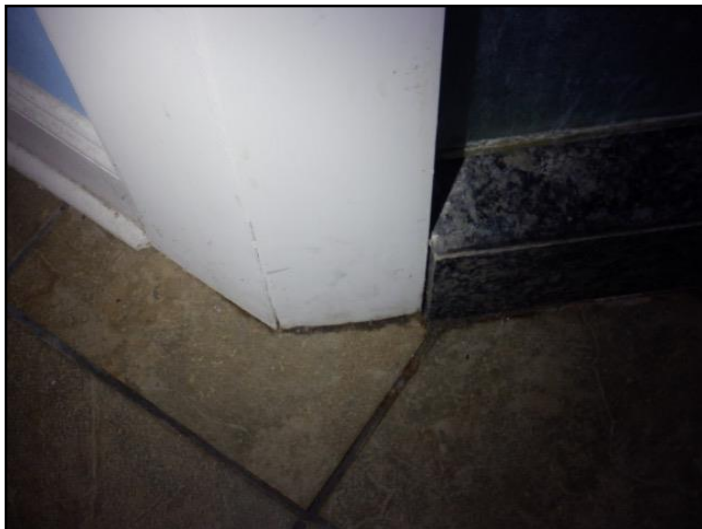
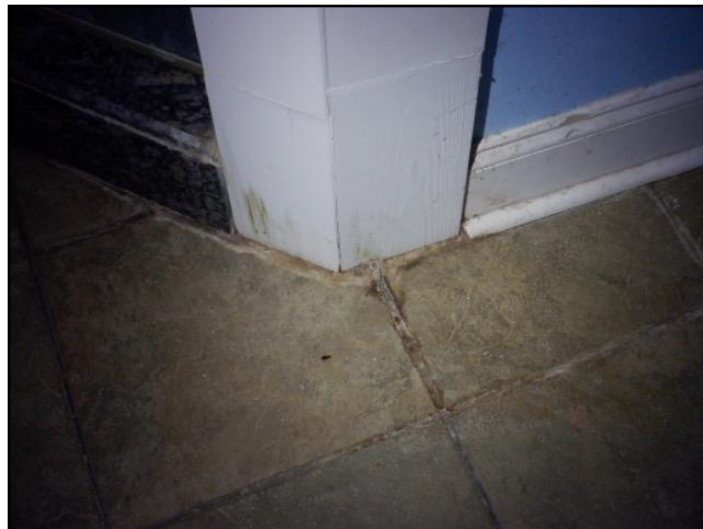
**Condition:** • Indications of leakage outside shower surround.

**Location:** Main Building Bathroom

**Task:** Repair. Possibility of hidden mold growth - see appendix.

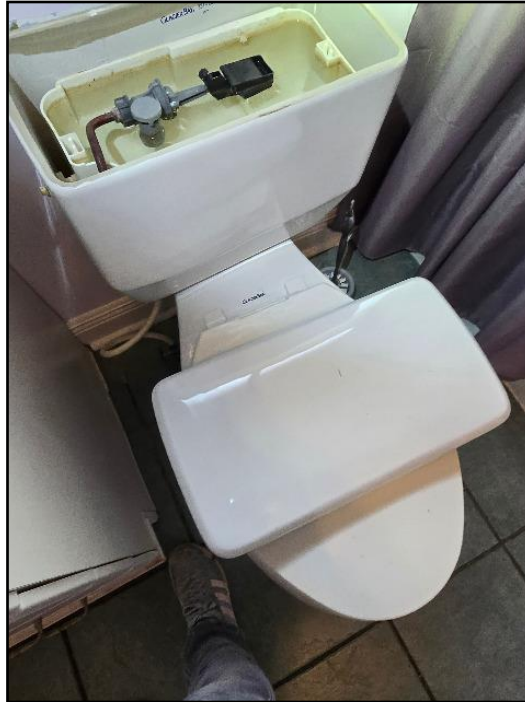
**Condition:** • Inoperable/not in service

*Inoperable/not in service*

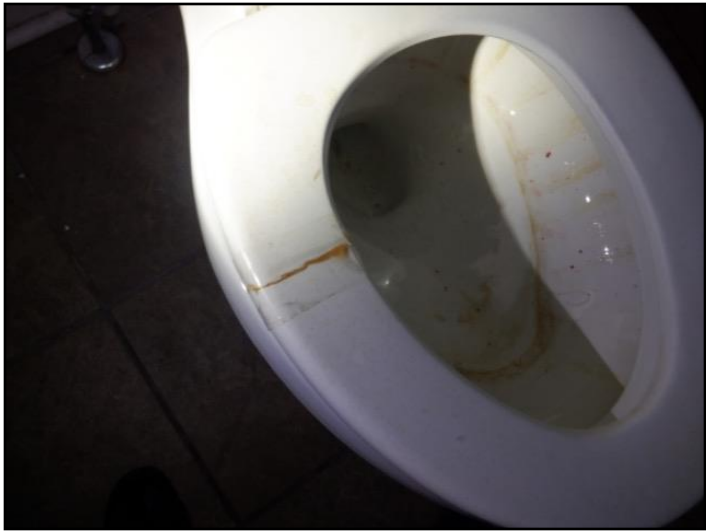
**Condition:** • Damaged seat.

**Task:** Repair.

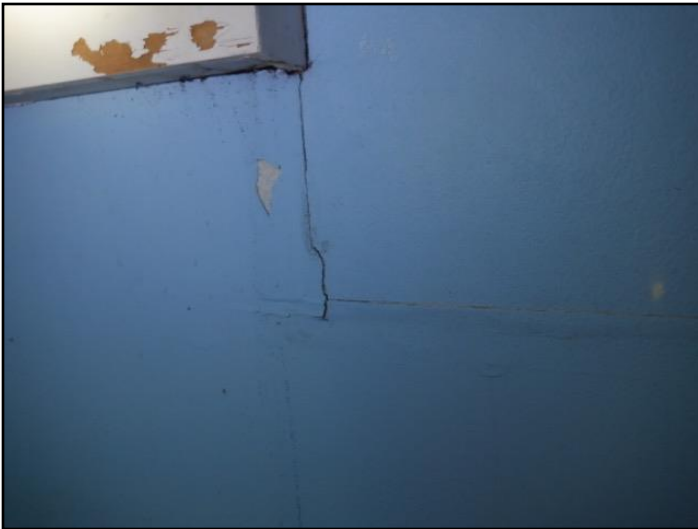
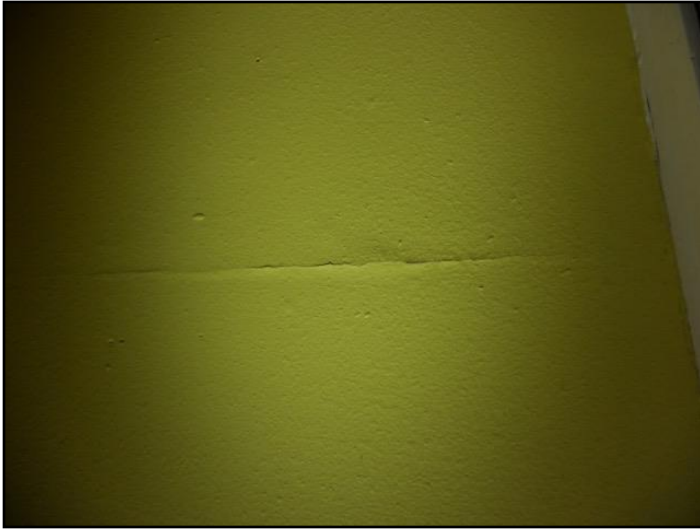
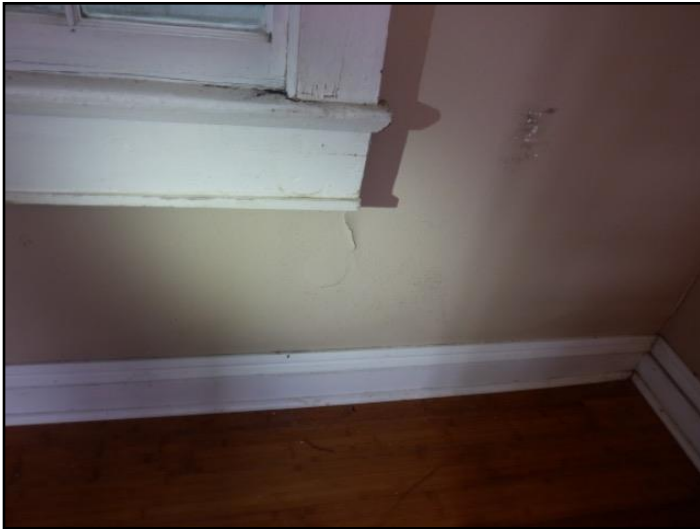
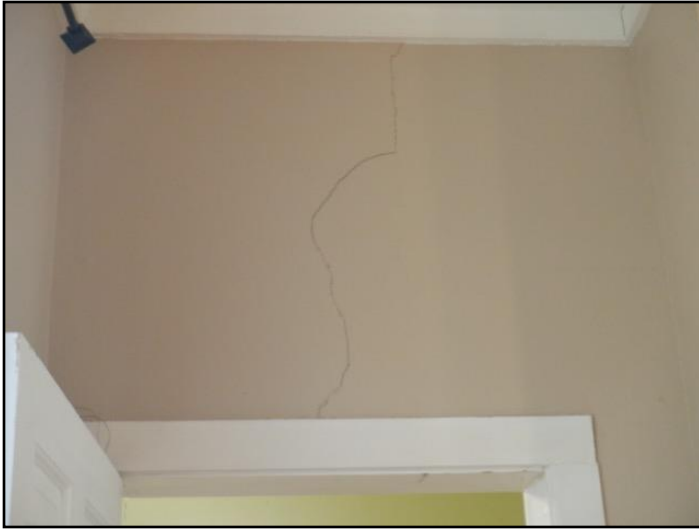
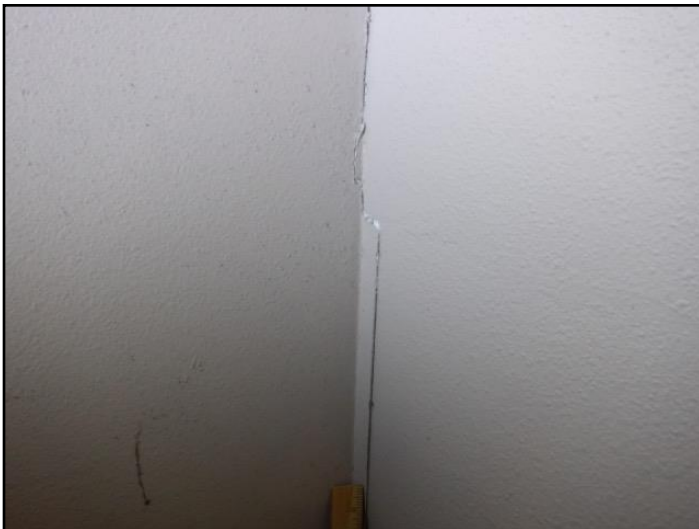
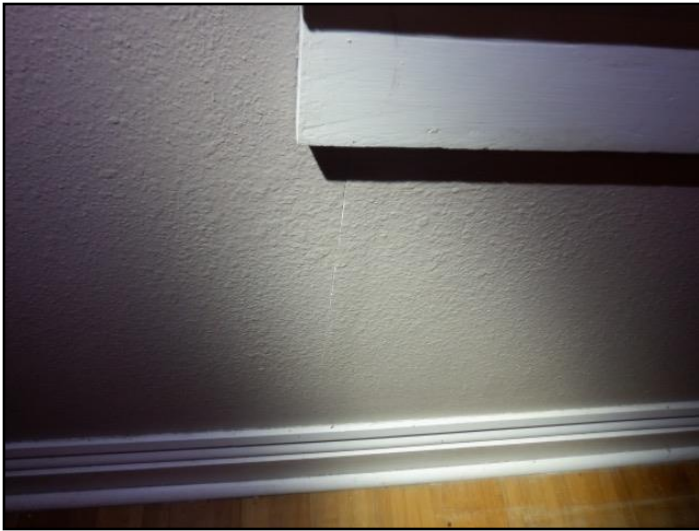
**Location:** Various

**Condition:** • [Cracks](#)

Cracks

**Task:** Repair.
