# Inspection Report

938 N Gayoso St  
New Orleans, LA 70119

**Inspection Date:**  
Monday, December 1, 2025

RE: Report No. 19955  
938 N Gayoso St  
New Orleans, LA  
70119

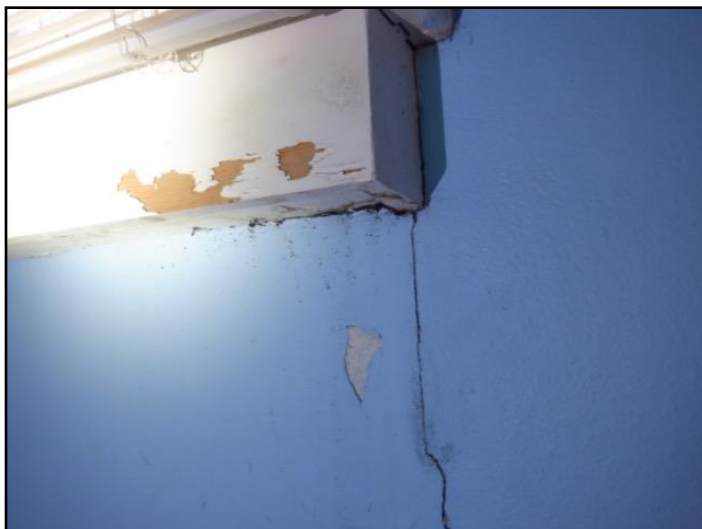
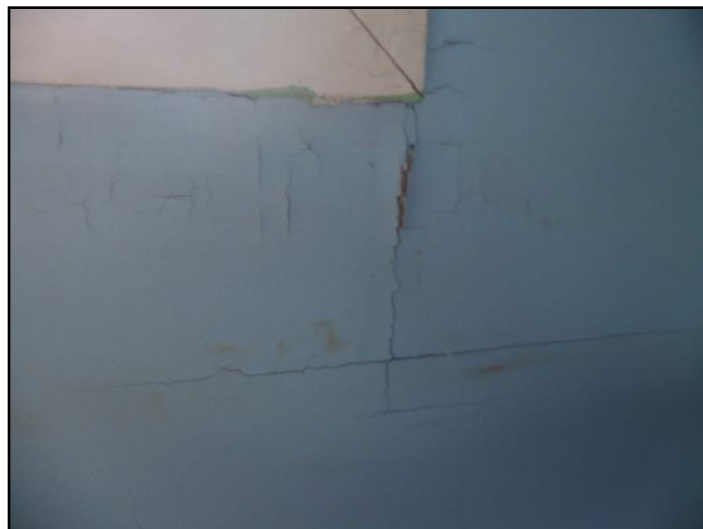
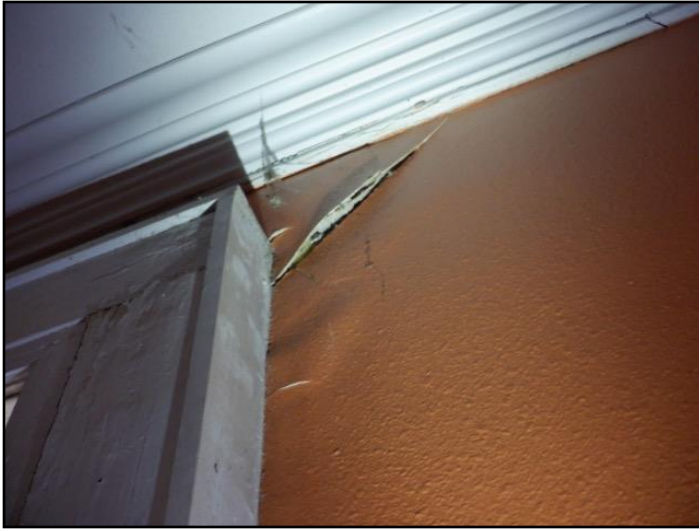
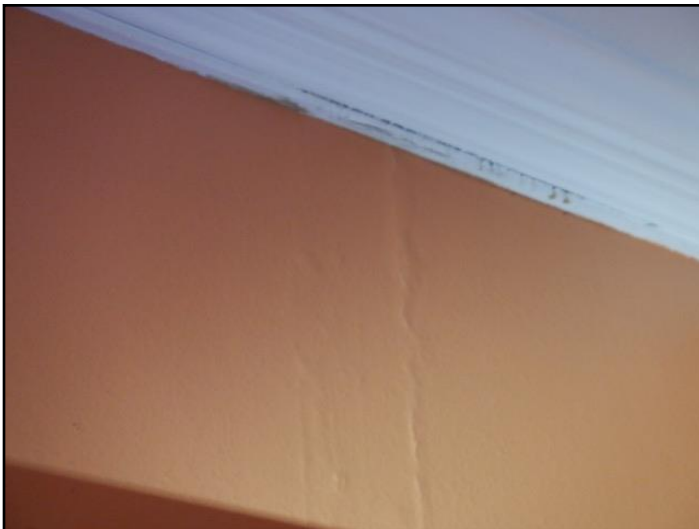
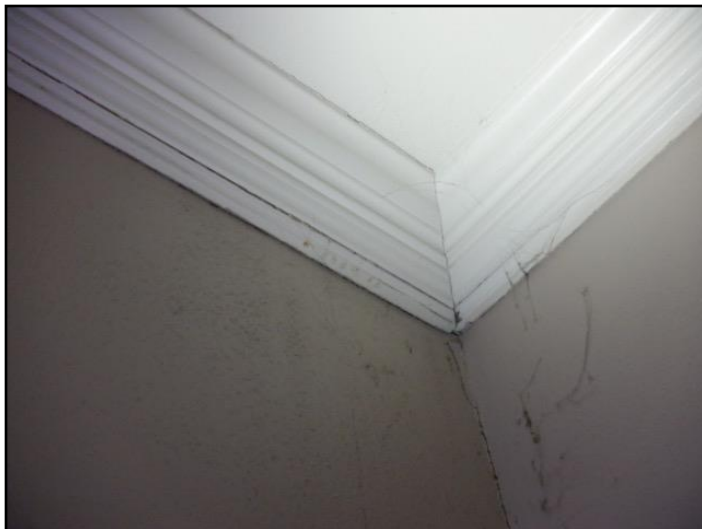
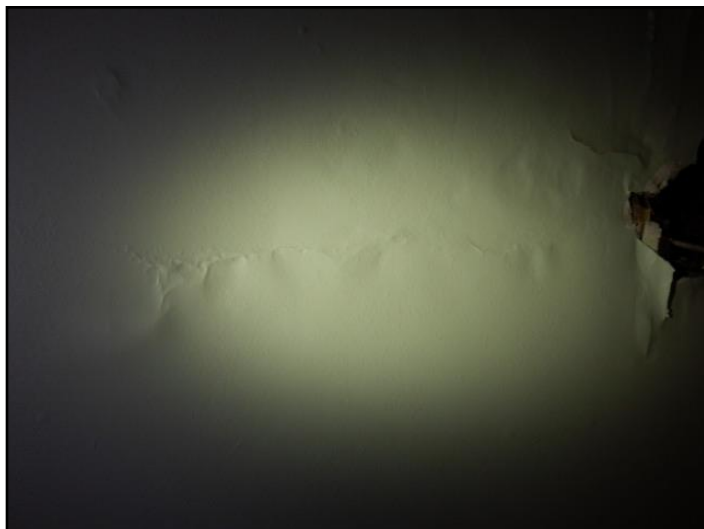
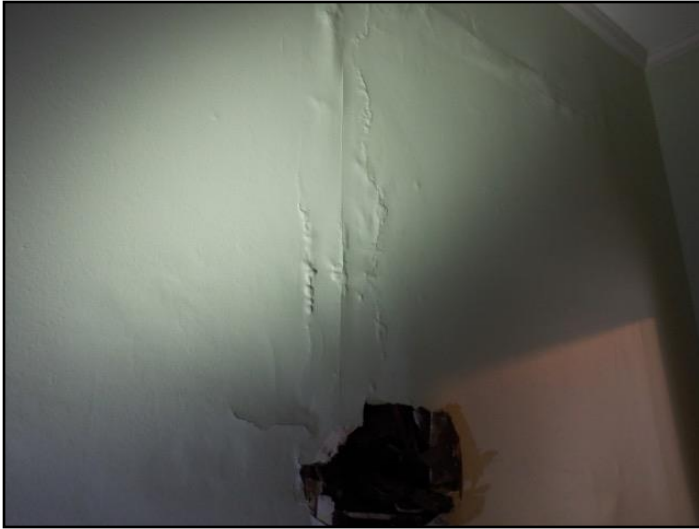
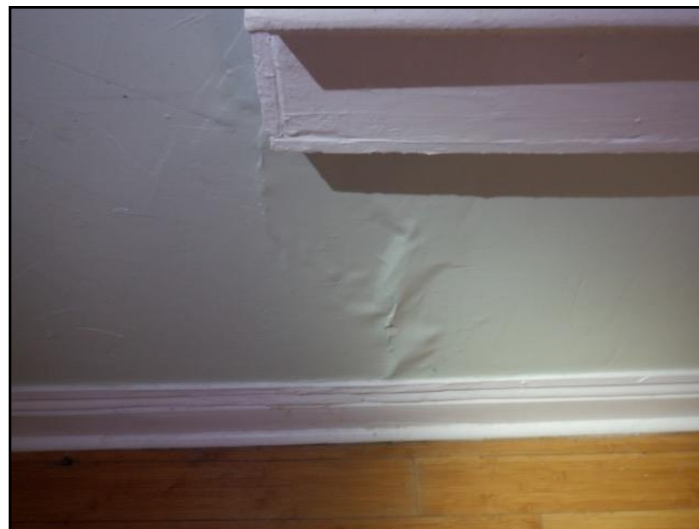
**Condition:** • [Water damage](#)

Water damage

*Water damage*

**Task:** Repair. Possibility of hidden mold growth - see appendix.

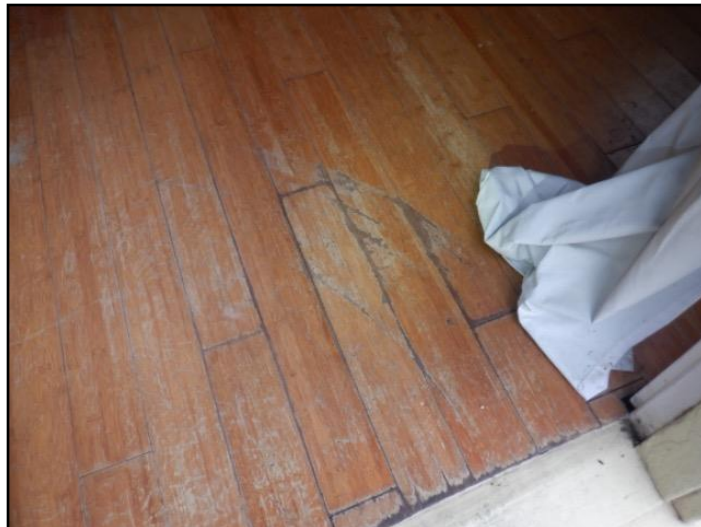
**Location:** Various Throughout

**Condition:** • Worn

*Worn*

**Task:** Repair.

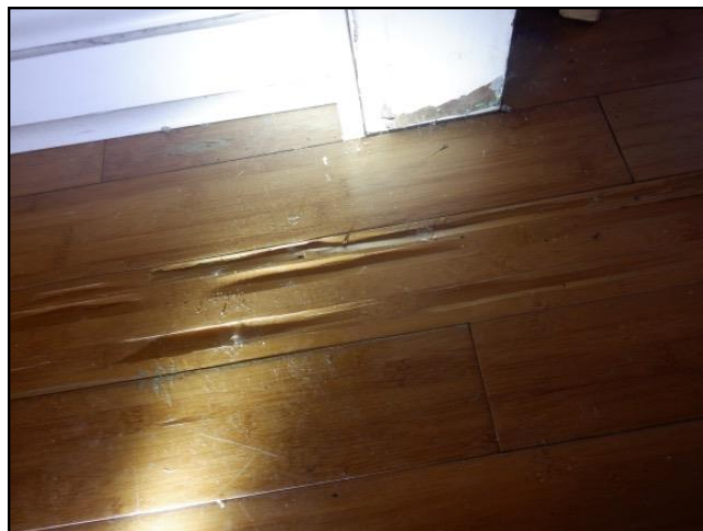
**Location:** Main Building Bedroom

**Condition:** • Insect damage

*Insect damage*

**Task:** Repair. Maintain insect protection program.

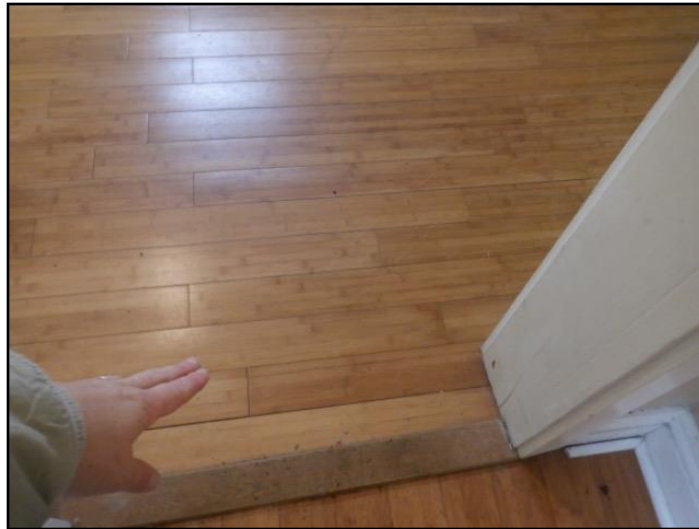
**Condition:** • Soft or weak area

*Soft or weak area*

**Task:** Repair.

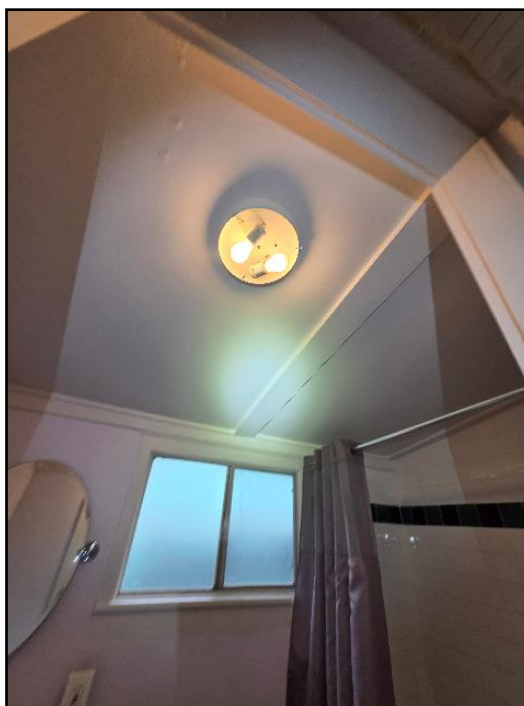
**Condition:** • [Missing](#)

No bathroom exhaust fans found in bathroom. Exhaust fans will pull trapped moisture out of the bathrooms, preventing moisture problems such as peeling paint and mildew/microbial growth. Though an operable window is considered

Missing

**Task:** Install.

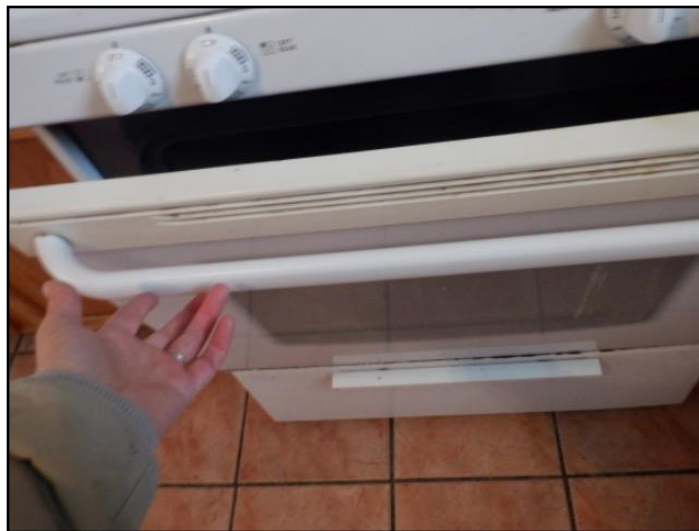
**Condition:** • Handles missing/loose

*Handles missing/loose*

**Task:** Repair.

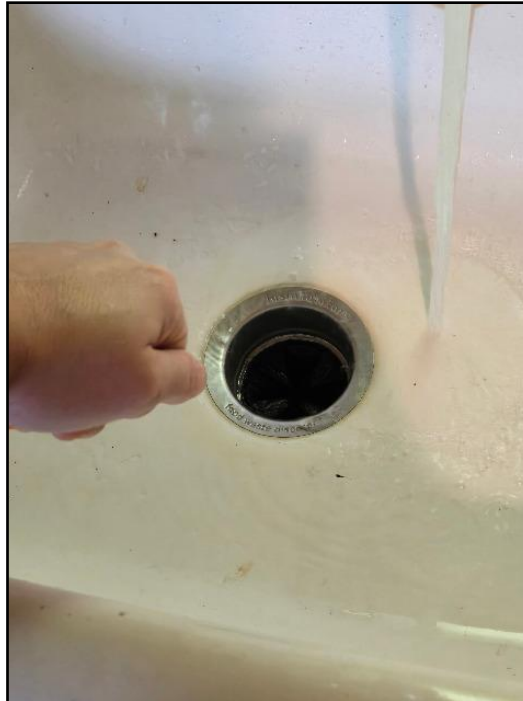
**Condition:** • Inoperative

*Inoperative*

**Task:** Repair.

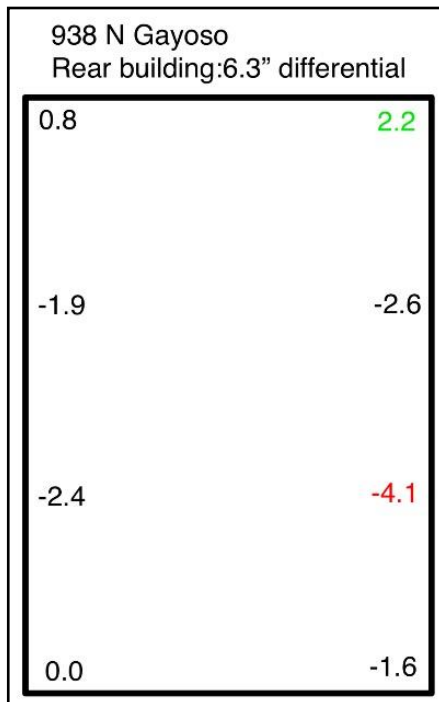
**Condition:** • Differential of 5" or more

The differential found is generally considered above average or excessive for a property of this age, construction type, and location. it is mostly due to settlement, usually associated with age, but some structural issues may be a contributing factor (See structural recommendations of this report). Repair any structural issues. Further investigation by a structural engineer or structural contractor is suggested.

The maximum differential found was 7" for the main house and 6.3" for the rear house as shown on the drawing below. According to one of the leading local engineering firms, the average differential for all residential foundations in the New Orleans area is about 3.2". The average for reinforced concrete slabs about 2.9" and for pier and beam foundations about 3.6". Allowances are made for floor coverings and materials. Additions and enclosed areas built with a designed slope are not included. All measurements taken are not shown. The drawing is not to scale and locations are approximate.

More than 5" differential
